PRELIMINARY REPORT

Accident Investigation Bureau

Preliminary Report on the Serious Incident involving BAe125-800B aircraft with nationality and registration marks 5N-B00 operated by Gyro Air Limited which occurred at Osubi Airport Warri; Nigeria on 10th September, 2020.

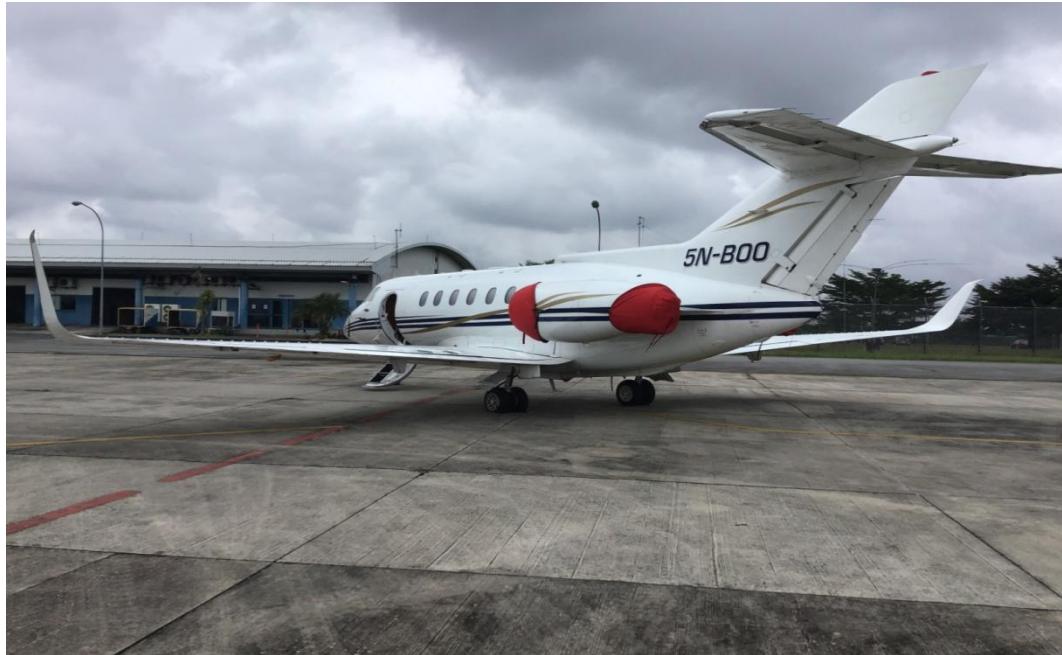
Figure 1: 5N-B00 parked at the apron after the incident

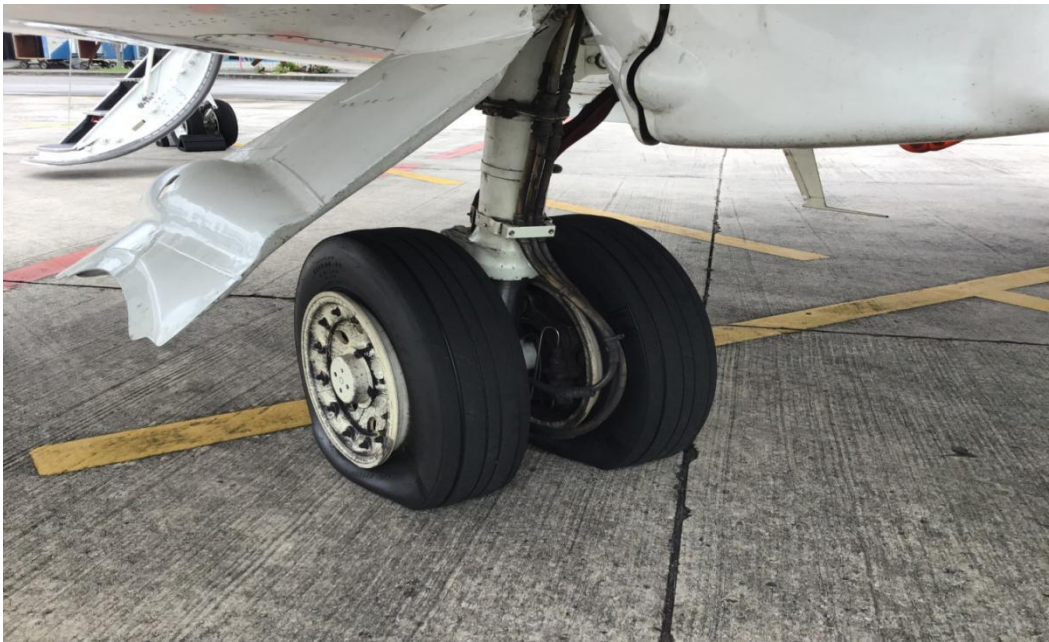
After the rejected takeoff, 5N-BOO came to a stop at a distance of about 1164.45m from the threshold of RWY 24 and taxied back to the apron. The crew disembarked unhurt and discovered that the left main wheel tires (No.1 and No.2) had deflated due to high temperature which led to the melting of the fusible plugs.

The aircraft came to a stop at a distance 1164.45 m from the threshold of RWY 24 leaving 635.55 m remaining RWY length. The left main landing gear tires, No.1 and No.2 were deflated. There was no impact.

Figure 2: The left main wheel tires (No.1 and No.2) deflated
