PRELIMINARY REPORT ON THE SERIOUS INCIDENT INVOLVING AIRBUS 330-243 AIRCRAFT WITH NATIONALITY AND REGISTRATION MARKS OD-MEA OWNED AND OPERATED BY MIDDLE EAST AIRLINES AND A PARKED TURKISH AIRLINES BOEING 777 AIRCRAFT WITH NATIONALITY AND REGISTRATION MARK TC-LJC WHICH OCCURRED AT MURTALA MUHAMMED INTERNATIONAL AIRPORT, LAGOS ON 29TH JULY, 2020

Registered owners and operators:	i) Middle East Airlines ii) Turkish Airlines Inc.
Aircraft types and models:	i) Airbus 330-243 ii) Boeing777-3F2ER
Manufacturers:	i) Airbus Industry, France ii) Boeing Company, USA
Years of manufacture:	i) 2009 ii) 2015
Nationalities and registration marks:	i) OD-MEA ii) TC-LJC
Serial numbers:	i) 0984 ii) 44123
Location:	Murtala Muhammed Airport, Ikeja International Wing
Date and time:	29th July, 2020 at about 17:23 h

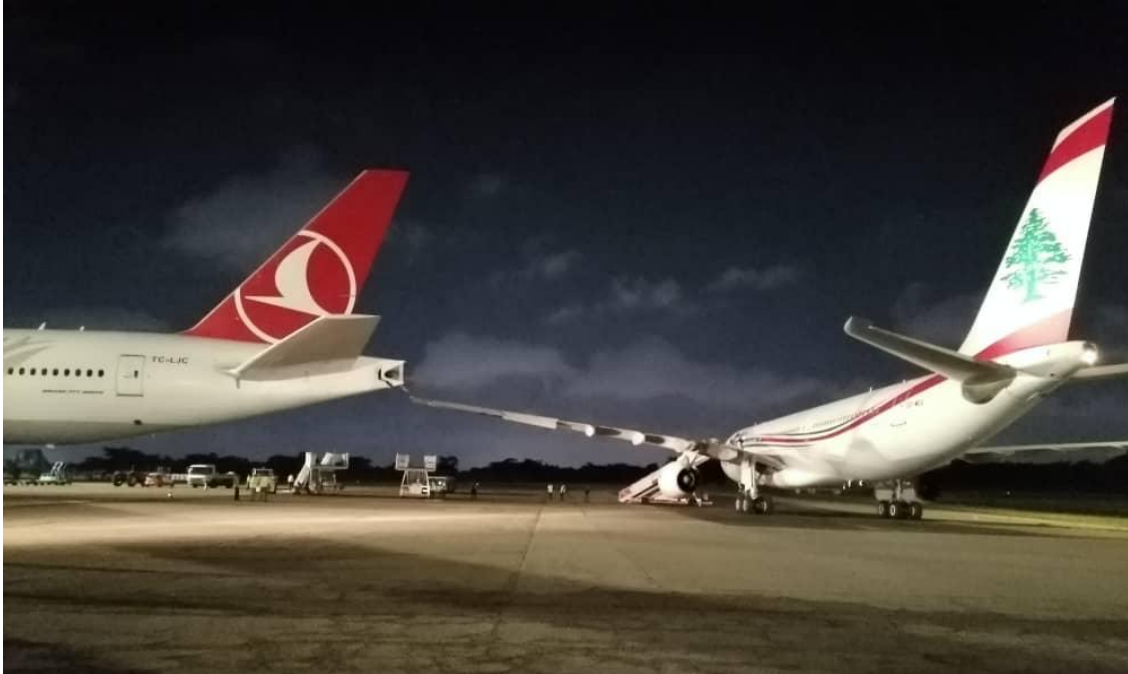
While taxiing on the Apron, the left winglet of MEA572 cut through the APU area and clipped the right horizontal stabilizer of a Turkish Airlines Boeing 777-300 parked at E55. The left winglet of the MEA572 an Airbus 330-243 was damaged while the tail cone and the right horizontal stabilizer of Turkish aircraft was also damaged as a result of the impact.

Figure 3: Photo of MEA aircraft winglet clipping the APU exhaust of the Turkish aircraft

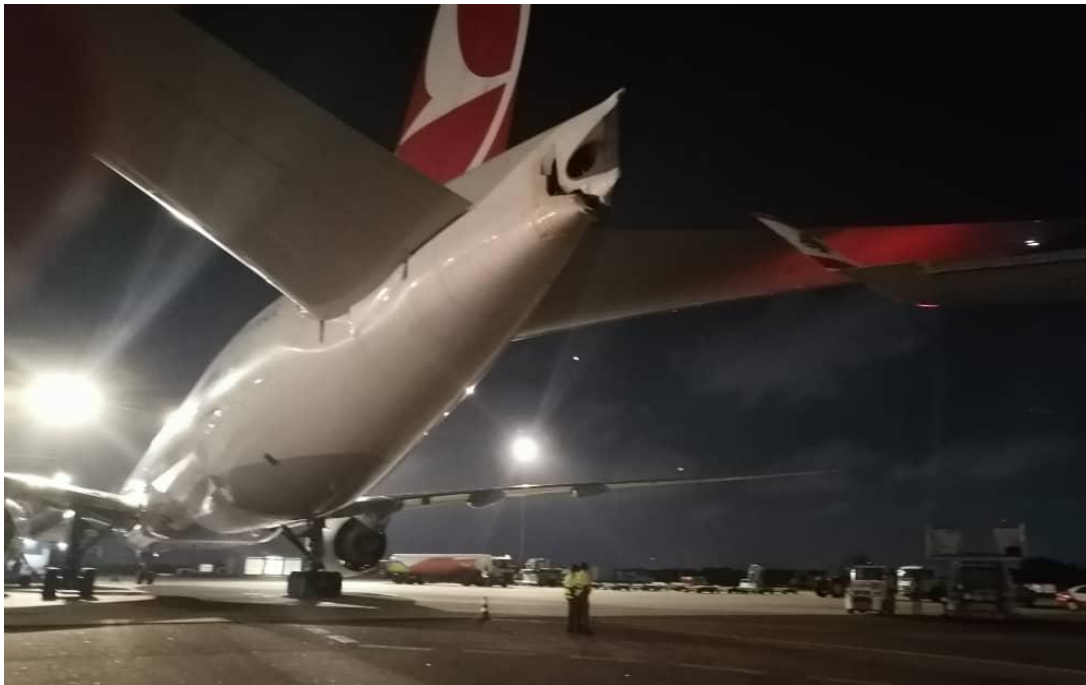
Figure 4: Damaged APU exhaust area of the Turkish Airlines Aircraft

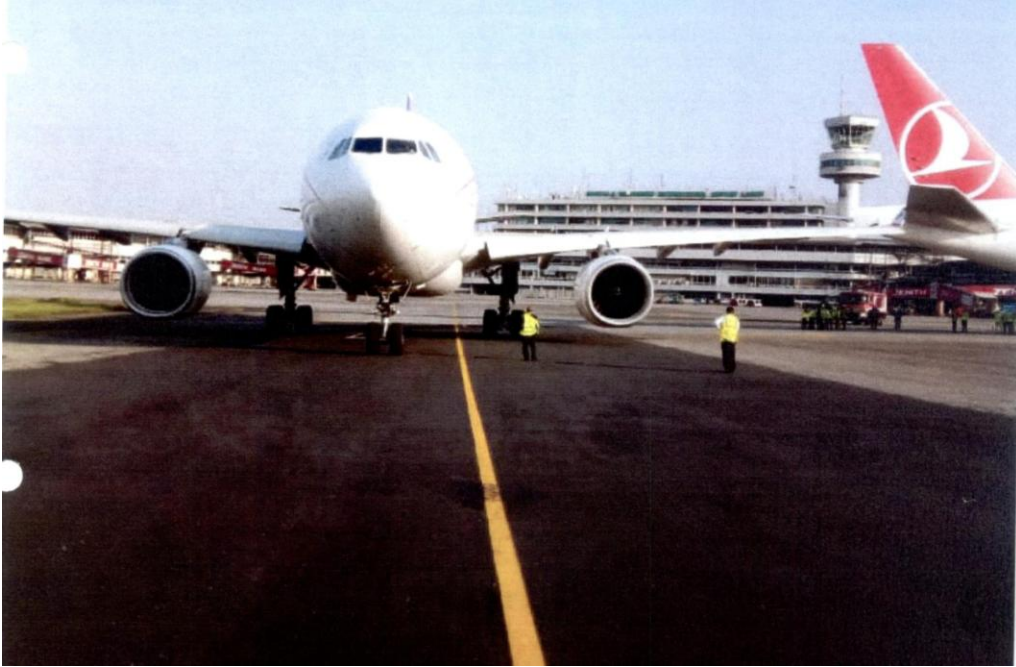
11. At 17:25 h, MEA572 reported the occurrence to ATC stating "We have hit the Turkish was parked very far away".
12. MEA572 maneuvered about 6.5 m right of the yellow track on the apron trying to avoid collision with the parked TC-LJC B777.

Figure 5: Photo of deviation of MEAs airlines aircraft from the Taxi line

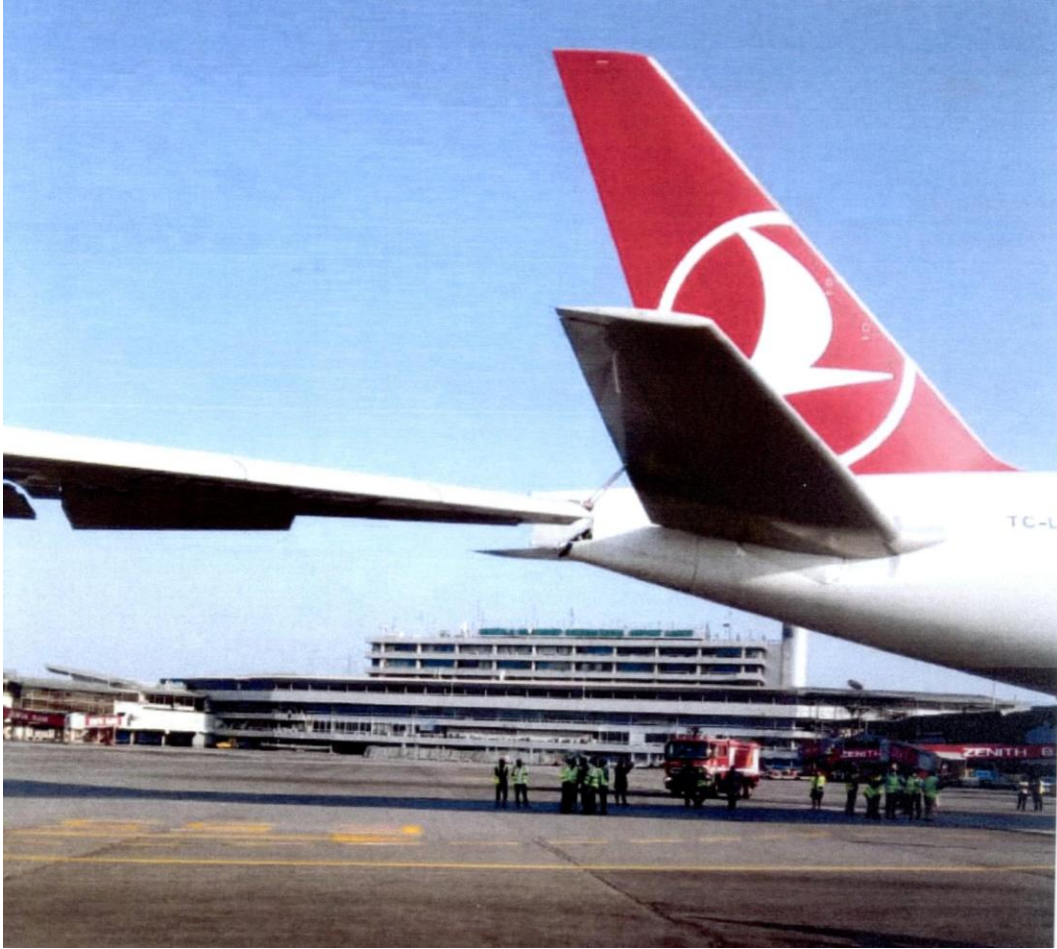
Figure 6: A close-up of the impact

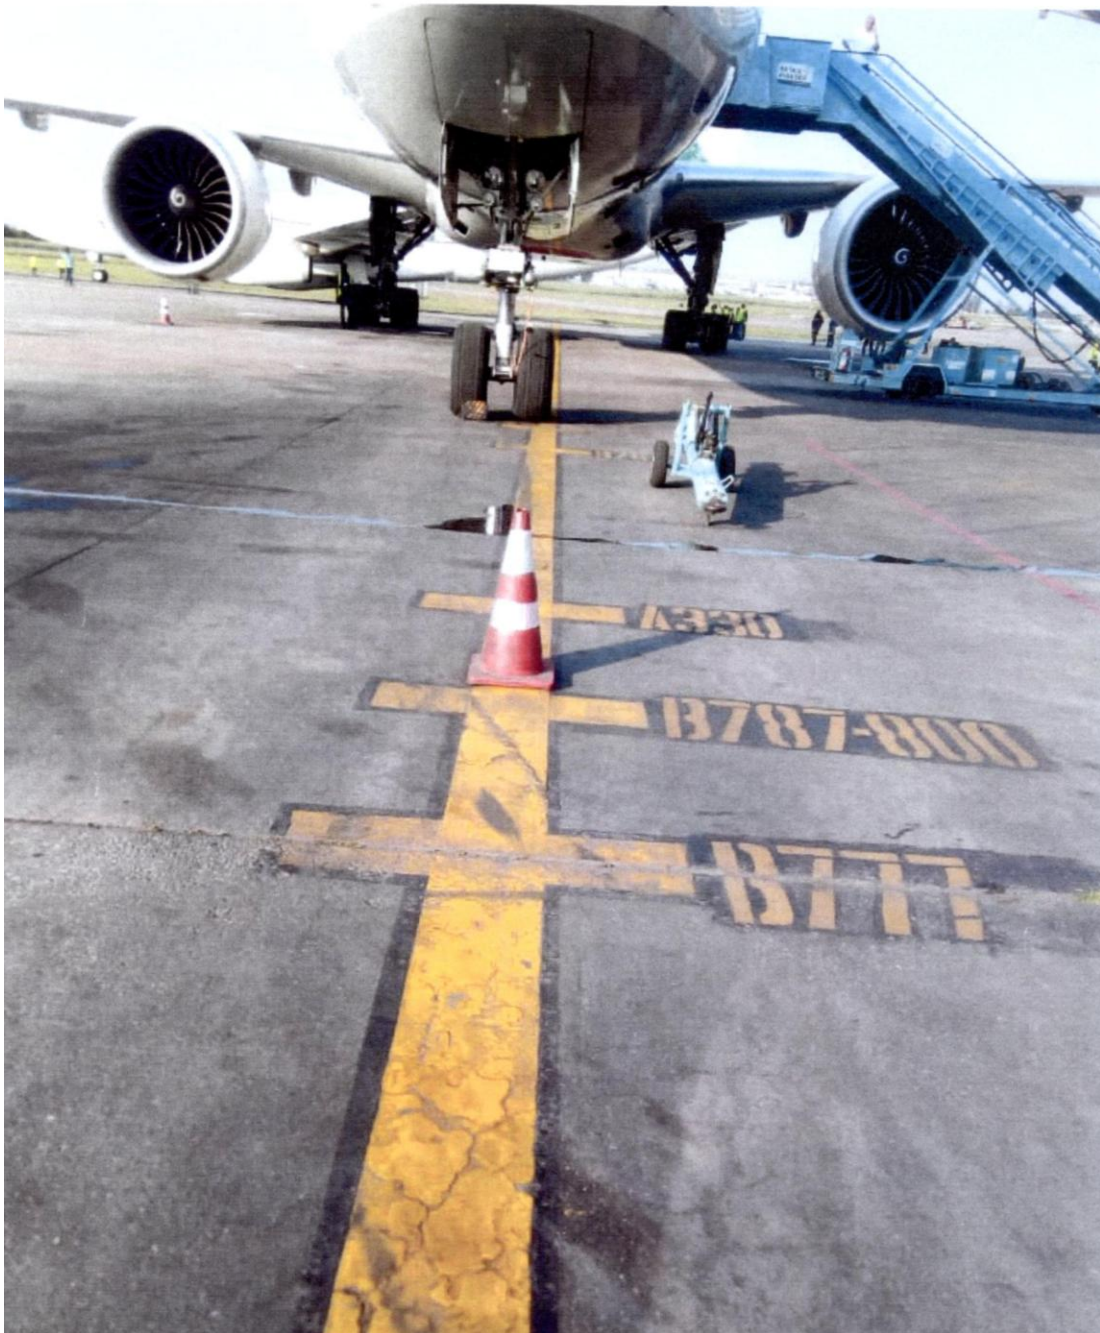
6. The Turkish flight THY6108 was parked 13.5m short of the stop line marking on the Apron.
7. On landing at 15:58 h, ATC instructed MEA571 inbound DNMM to proceed, parking gate E51.

Figure 7: Photo of the parked B777-3F2ER Turkish Airline aircraft
