CIVIL AVIATION ACCIDENT REPORT No. 382

I have the honour to present the final report on the accident to the Executive Airlines Services' BACI-II-525FT aircraft registered 5N-ESF that erashed at Mallam Aminu Kano International Airport (MAKIA), Kano State on Saturday, 4th May 2002.

REPORT ON THE ACCIDENT TO THE EAS BAC 1-11-525 AIRCRAFT AT MALLAM AMINU KANO INTERNATIONAL AIRPORT, KANO

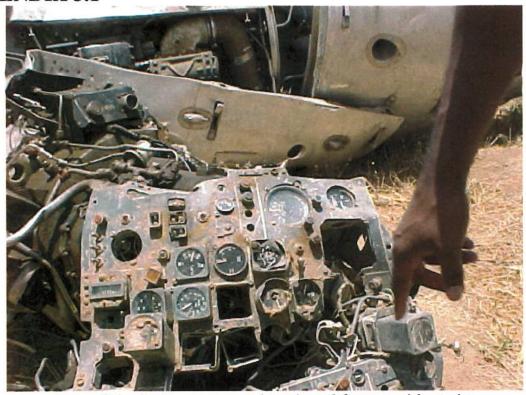
A portion of the instrument panel retrieved from accident site.

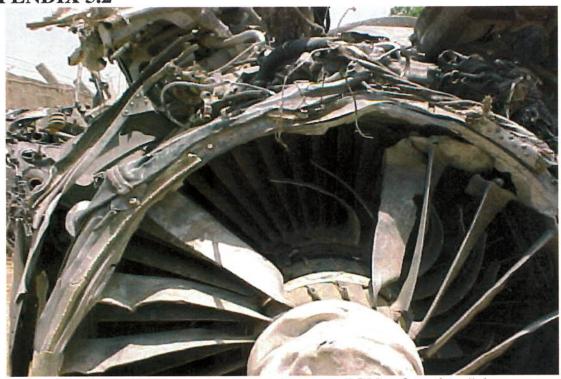
- The fan blades were generally intact with marks of impact damage;
- The forward stator blades were generally intact with marks of impact damage and, the joining strips between the blades were cracked;
- There was ingestion of debris inside the compressor casing.
- The compressor casing was crimped and the skin was cracked;
- There was no evidence of internal or external fire damage;

- (iii) Type of damage to the No.1 engine's High Pressure Compressor Section was suggesting that the observed impact depression on the external surface of the compressor casing could have affected the compressor blades and stators while the engine was still turning at high RPM.

The damaged Inlet Guide Vane (IGV) of engine # 1

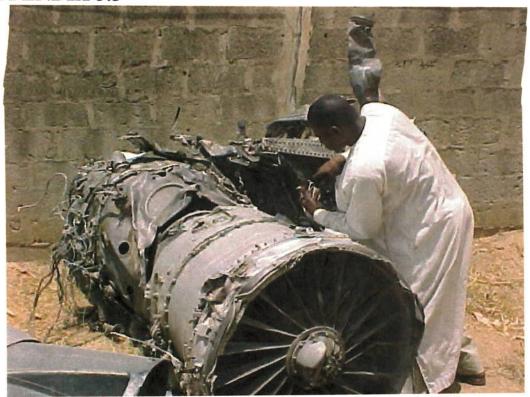
- All fan blades were missing and were ruptured at the base;
- Half of the second stage of IGV was missing and the IGV were ruptured at the base;
- The blades of the second stage were bent and seven blades were sheared at the base;
- The third stage of IGV had impact marks;
- There was ingestion of debris inside the compressor casing;
- There was no evidence of internal or external fire damage;
- The compressor discharge pressure outlet duct had no deposit of soot; and
- The general condition of this engine indicated high rotation at impact.

- (v) The No.2 engine's Inlet Guide Vane and the Low Pressure Compressor Rotors and Stators showed a great deal of damages and ruptures at the base of the rotors. All the Fan Blades were missing, which was indicative of damage at high engine rotation.

Engine No.2 showing relatively an undamaged IGV.

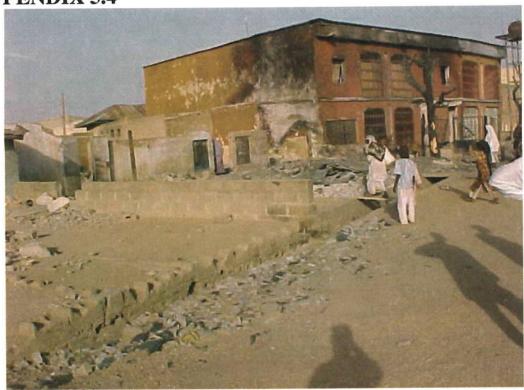
Many private homes and buildings were either damaged or destroyed. Houses and properties on the streets were burnt. Thirty people on ground suffered fatalities, while 24 suffered serious injuries.

A close view of the Gwammaja Quarters' house destroyed in the accident.

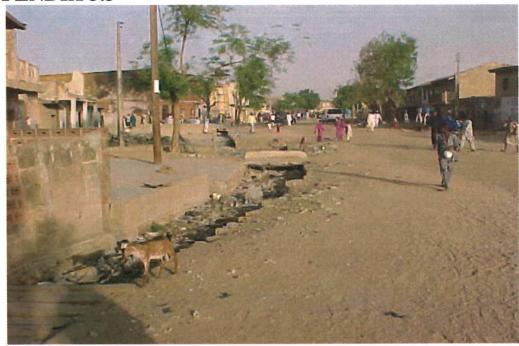
The aircraft crashed into residential houses in the Gwammaja Quarters of Kano. Gwammaja Residential Quarters is located at about 3 km from the end of runway 23 and directly under the flight path. On the consequential impacts with buildings, the aircraft disintegrated into fragments and many parts were scattered all over the streets, leaving many houses damaged or destroyed or burnt. The wreckage trail covered a large area and many segments of the aircraft caught fire on impact. The wreckage distribution consisted mainly of the two engines, tail components, portions of the wings, the landing gear, a portion of the fuselage and parts of the cockpit area, specifically the center portion of the instrument panel and the pedestal (Please see appendix 5.1). The wreckage exhibited signs of repeated impact forces and a post impact fire.

A section of Gwammaja Quarters mostly affected by the disaster.

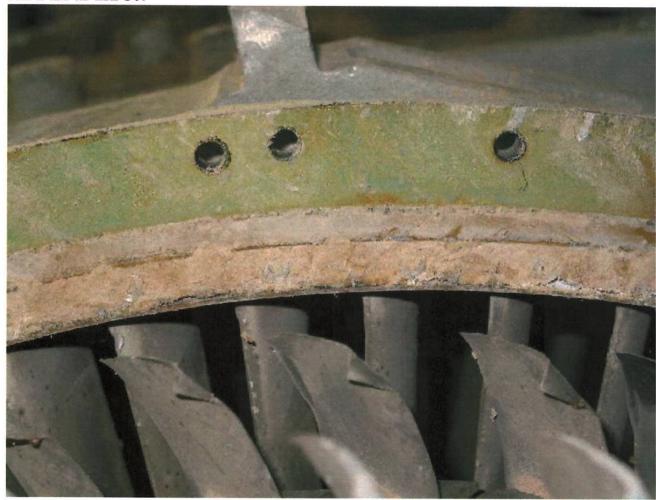
To confirm the 'great burst of dust', AIPB found out at the Rolls Royce Facility where both engines were stripped, that the two turbine engines had acted like "giant vacuum cleaners" and sucked in the dust. The dust was found compressed and compacted in the intercase front flange of the high-pressure compressor casings of both engines (Please see appendix 5.7).

In the same vein, both engines of this aircraft ingested most or a substantial amount of the stirred-up dust particle when the dry grassy ground was over run at Kano during this take-off. The after effect of this ingested dust particle, which is not too congenial for the performance of any turbine engine, resulted in the momentary reduction of thrust on both engines, which would cause the climbing aircraft to lose height above ground.

Magnified picture of the intercase front flange of the high-pressure compressor casing to depict where the compacted dust lodged.

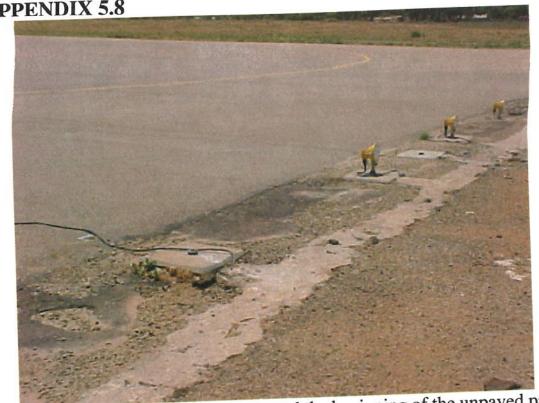
(a) Firstly, the airplane ran out of the runway length of 2,600 metres. It, secondly, over-ran the asphalt surfaced blast pad of 60 metres and thirdly, was still on the ground over-running another 150 metres of dry grass vegetations of the approach lights warning lamps, knocking off two of the lamps before getting airborne (Please see appendices 5.9 to 5.11). The flight data recorder would have given these details if one had been available to the AIPB. The only indication to corroborate the overrun evidence was the tire marks impression that was observed on ground, still visible on the day of the accident (Appendices 5.10 and 5.11). This also, gave credence to the evidence given by the Traffic Controller on duty, who said "I was watching the takeoff from the tower and when I saw the great burst of dust on the runway, I knew that the aircraft had over run the end of the runway".

Photo of the Runway End Stop lights and the beginning of the unpaved path.

These are the two major factors, which prevented the faster rate of climb out of ground obstacles for the aircraft after it had overrun onto the grass and dusty end. If the grassy area had been surfaced with asphalt or concrete, there would have been no dust to reduce the thrust output of the engines. AIPB does not consider it necessary to recommend or suggest that the runway be extended, just because of this accident.

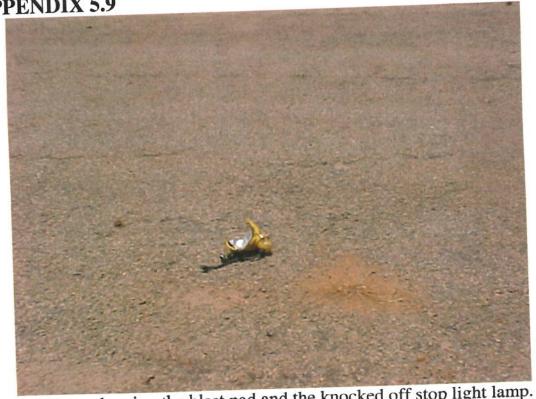
Picture showing the blast pad and the knocked off stop light lamp.

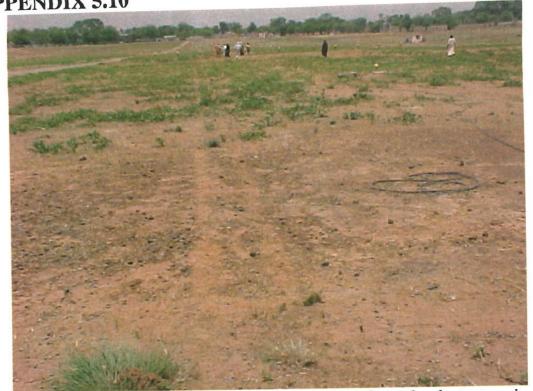
accident further than tire marks on the runway and the evidence of the eyewitnesses. The tire marks remained perfectly on the center-line of the runway, indicating that the two engines were delivering power equally and therefore, there was no asymmetric thrust, i.e. no engine failure.

Photograph showing the tire marks of the aircraft on the dusty terrain.

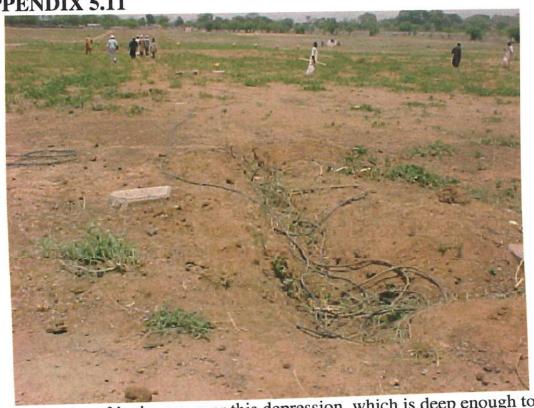
The aircraft's tire ran over this depression, which is deep enough to Inflict serious damage to the aircraft's primary structure.
