CIVIL AVIATION ACCIDENT
REPORT NO 04/376

FINAL REPORT
ON THE ACCIDENT TO THE
PAN AFRICAN AIRLINES (NIGERIA) LTD.
HELICOPTER BELL - 206-111B,
REGISTERED 5N-AVU
AT
CHEVRON PETROLEUM OKAN PLATFORM
ESCRAVOS, DELTA STATE, NIGERIA

ON SATURDAY 11TH NOVEMBER, 2000.

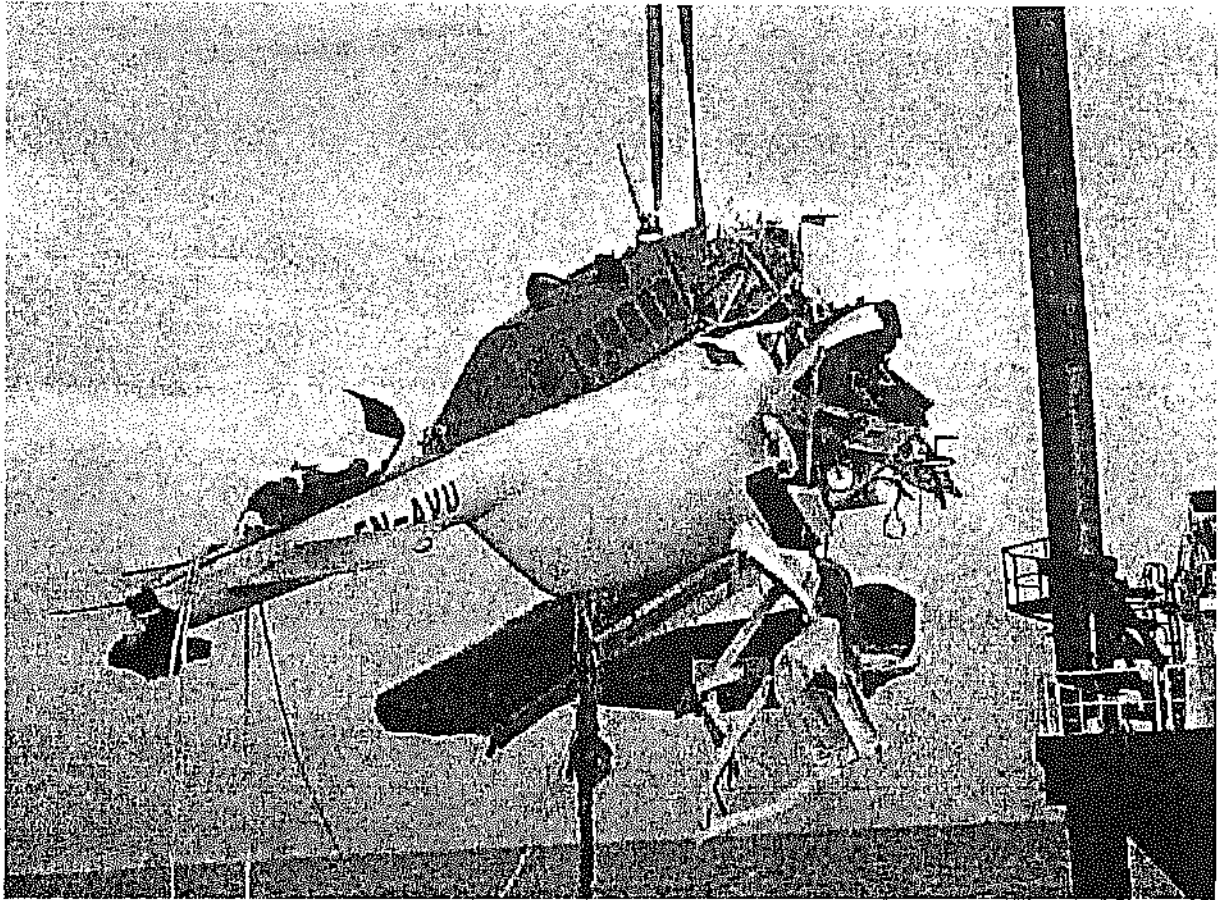
APPENDIX 5.1

Recovering the wreckage from the sea

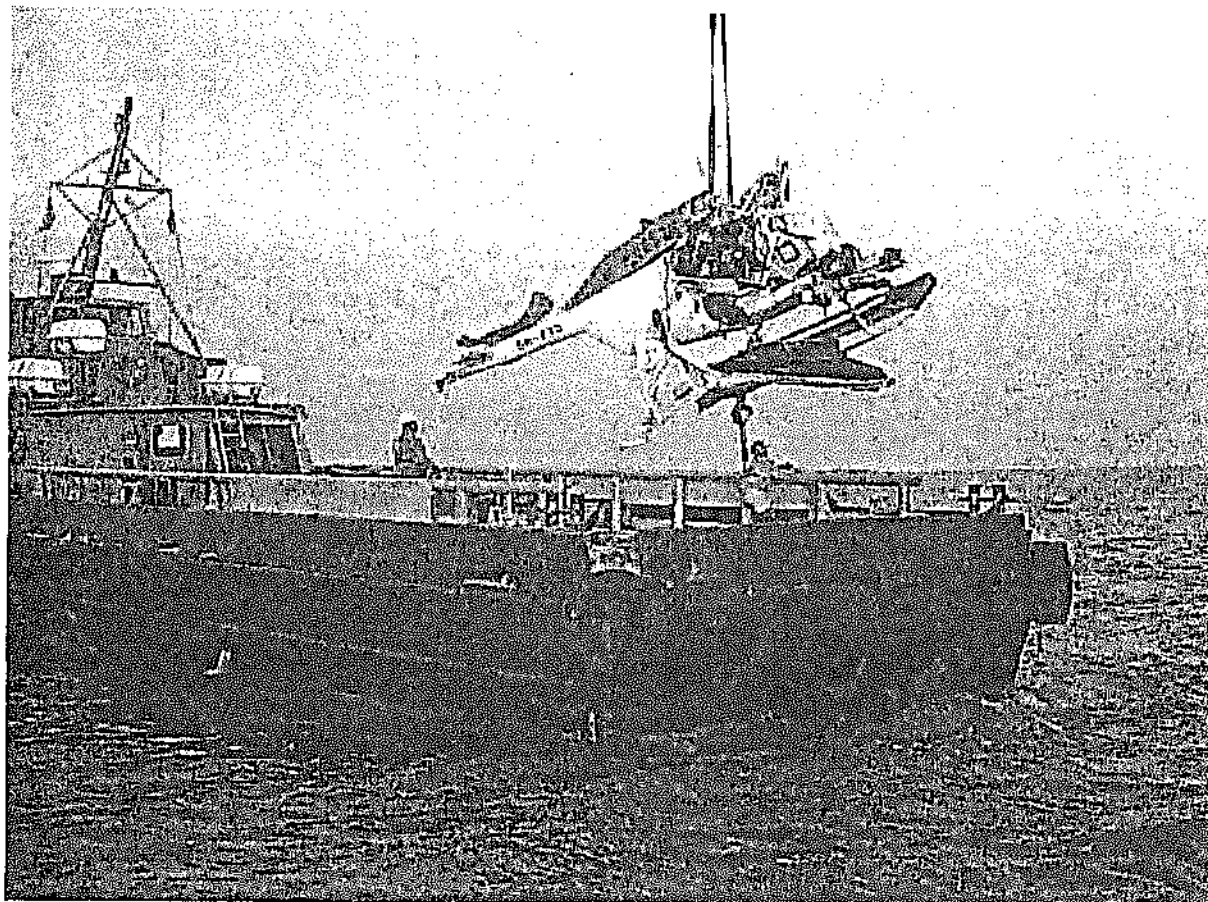
Uploading the wreckage onto the recovery boat at sea for transportation to Chevron Tank Farm at Escravos.

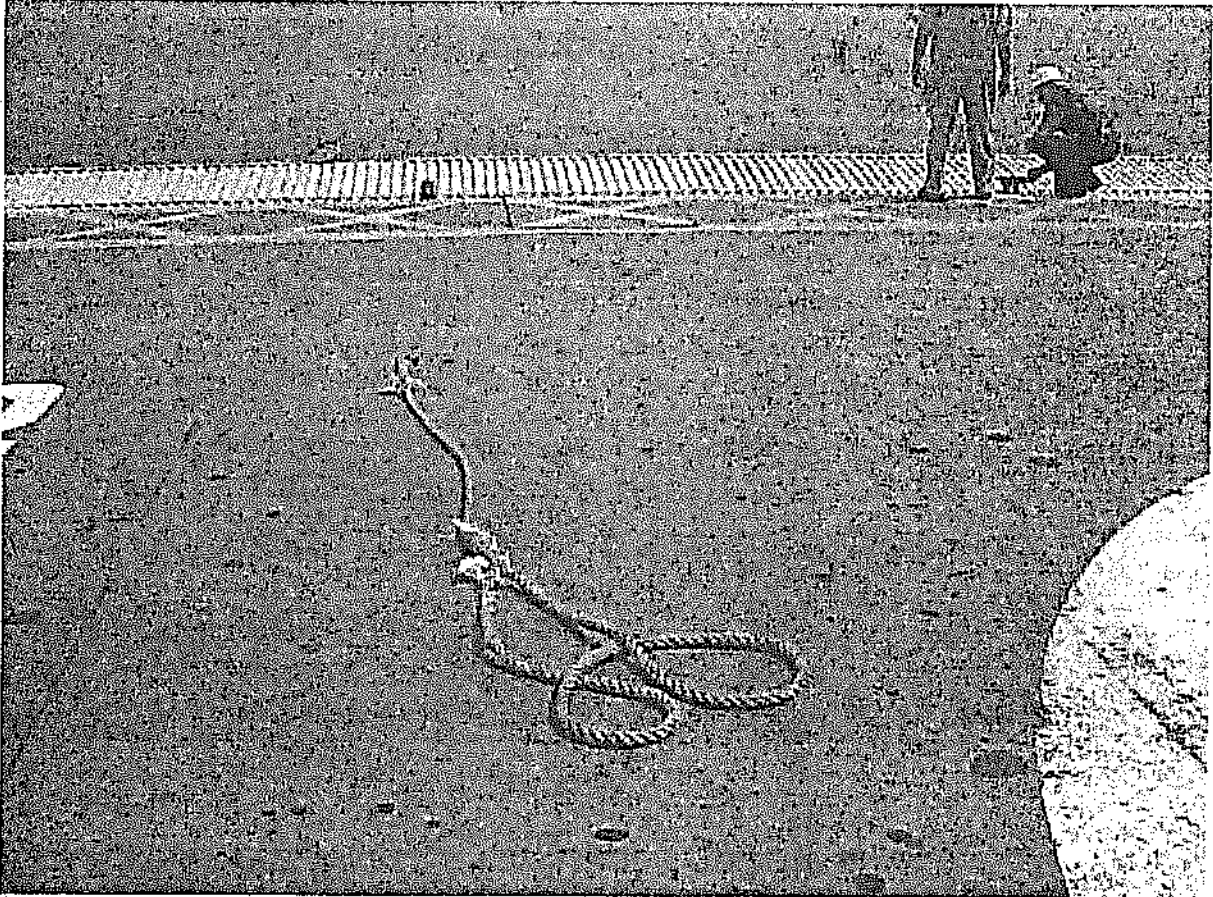
APPENDIX 5.3

There was not any significant damage to other properties, except for the outward edge of the platform's helipad-area safety skirt (appendix 5) which was slightly scraped by the rope when the helicopter was briefly suspended before the rope snapped.

The outside edge of the flat helipad is known as the "safety skirt" (Please see appendix 4), whose outboard is protected with aluminium plate strips. The plate strip was pulled back at the point of contact by the rope while the helicopter was precariously dangling upside down under full engine power.

A section of the 45' X 45' area helipad after the accident, showing the already failed tie-down rope on the fore ground.
