**FEDERAL REPUBLIC OF NIGERIA
MINISTRY OF AVIATION
LAGOS.**

REPORT ON THE ACCIDENT TO THE OKADA AIR
BAC 1-11 REGISTERED 5N-AOT
PORT-HARCOURT INTERNATIONAL AIRPORT
ON THE 7TH SEPTEMBER, 1989.

CIVIL AVIATION ACCIDENT REPORT
NO. CIA. 148

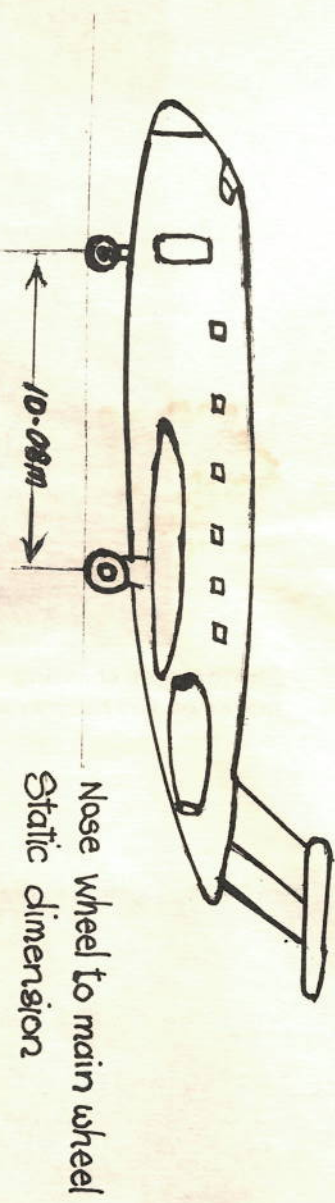
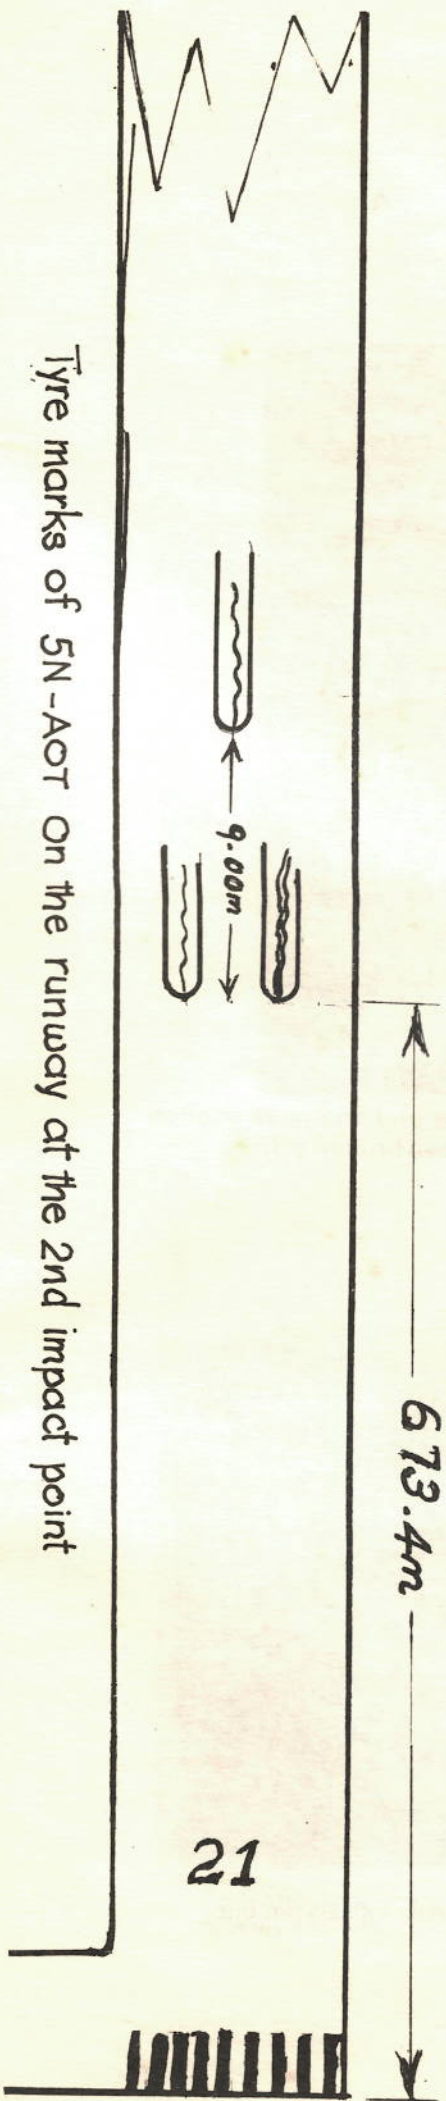
LANDING ACCIDENT TO 5N-AOT AT PHC

Tyre marks of 5N-AOT On the runway at the 2nd impact point

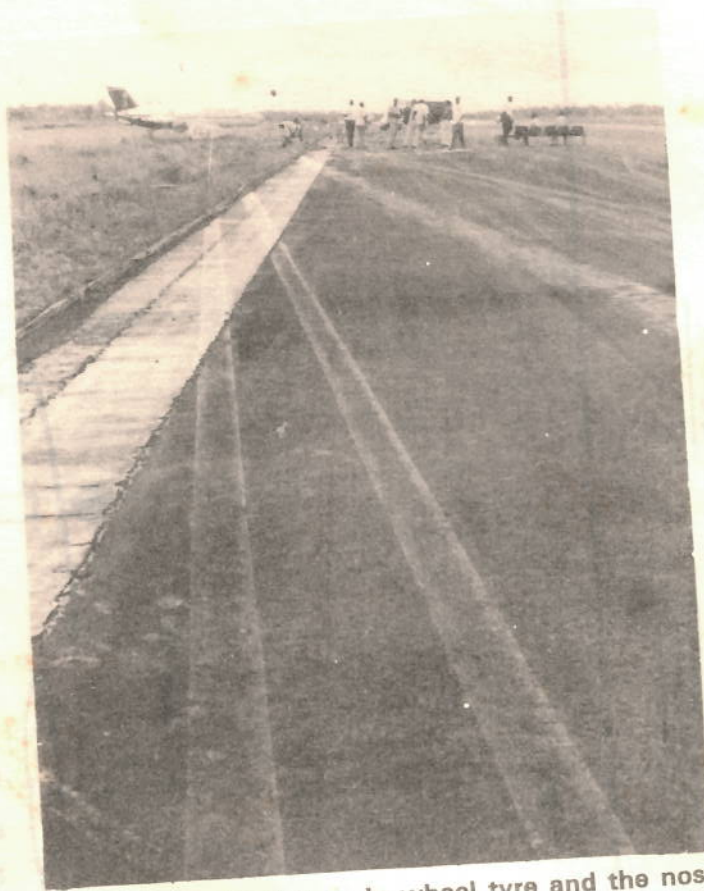
A

After the aircraft lost the two nose-wheels, the axle flanges started to cut grooves onto the runway surface until the nose-gear strut collapsed and the aircraft's nose, under the radome, came in contact with the runway and every ground directional control was lost. The aircraft now drooping nose-down, continued the landing roll towards the left side of the runway onto the unsafe shoulder. (please see picture in the Appendix). The aircraft remained on the paved runway for 660 meters from the touch down point before running into the trench which had been partially refilled with loose soil.

Photograph showing the left main wheel tyre and the nose section marks on the runway after the nose gear had been broken off.

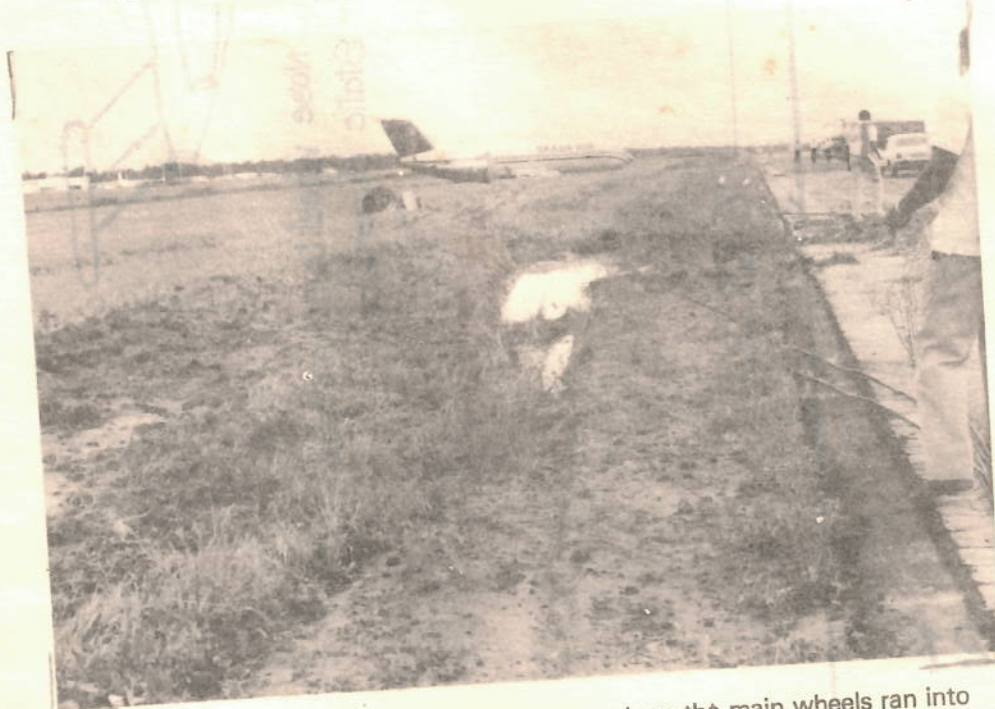
B

The filling did not serve the intended purpose — "to be able to sustain the weight of aeroplane which might be running off runway". Just as had been the case in the previous landing accidents on runway 03/21 of Port-Harcourt International Airport, Flight OKJ 307 ended up, down in the trench and suffered the same catastrophe.

The runway shoulder showing pool of water where the main wheels ran into the poorly filled trench.

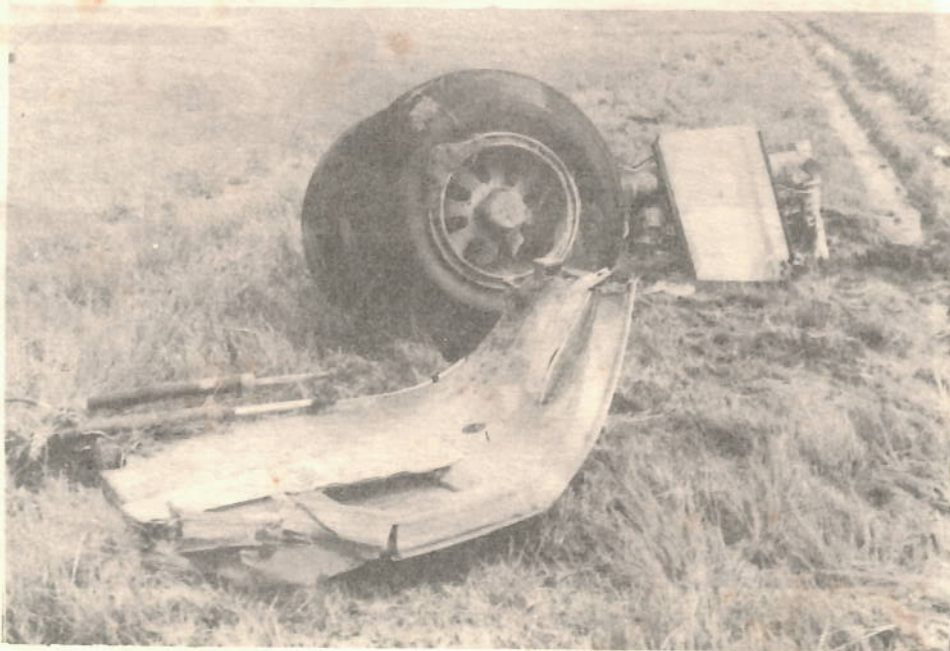
A

The right main landing gear ran into the loosely filled trench and became detached from its pintle bearing in the wheelwell cavity before the aircraft came to rest about 95 metres from the trench.

The severed right landing gear after running into the trench.

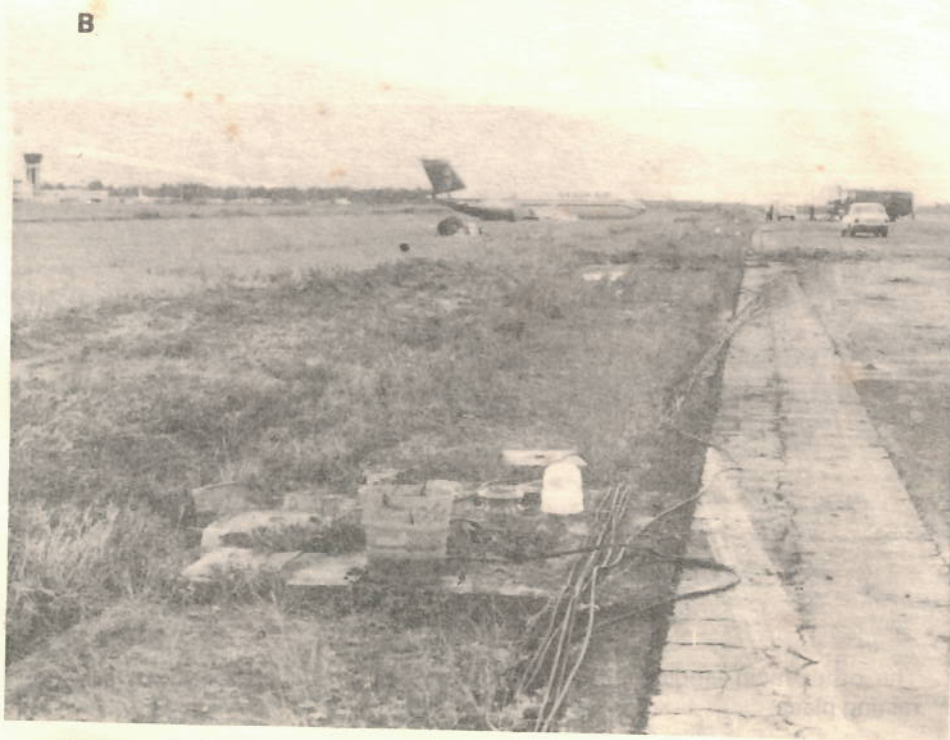
B

The contributory factor to the accident is the excavation and improper re-filling of the outrageous trenches of wide dimensions along the length of runway 03/21.

Photograph showing the type of hazardous refilling job performed along the runway shoulder.

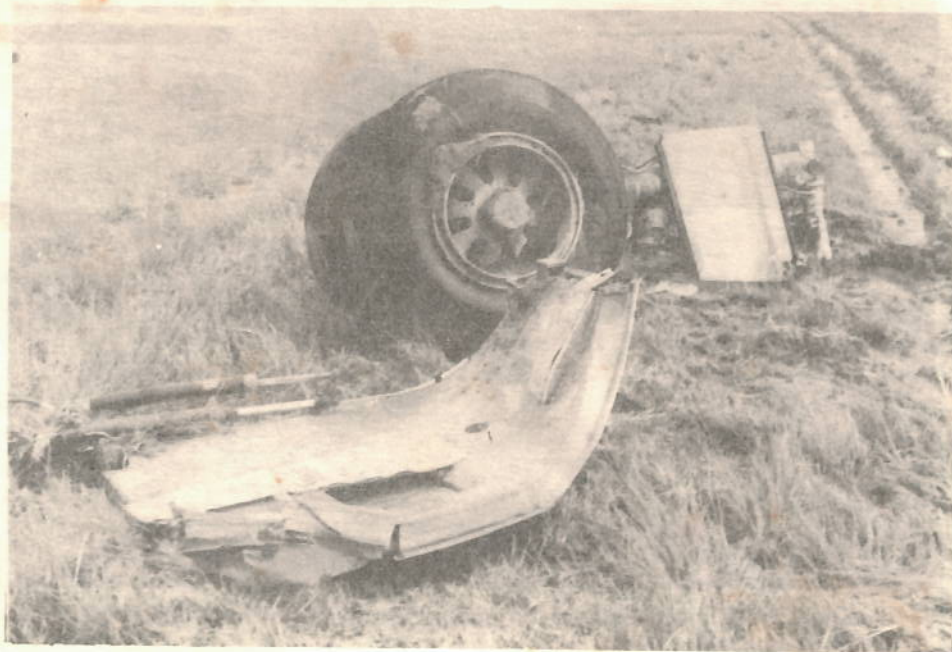
A

The severed right landing gear after running into the trench.

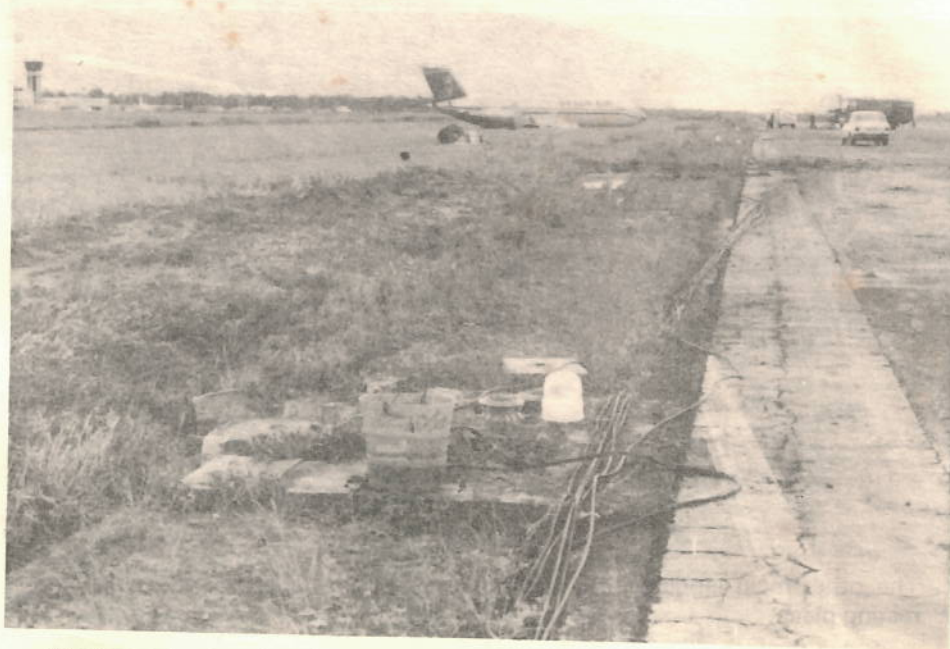
B

Photograph showing the type of hazardous refilling job performed along the runway shoulder.

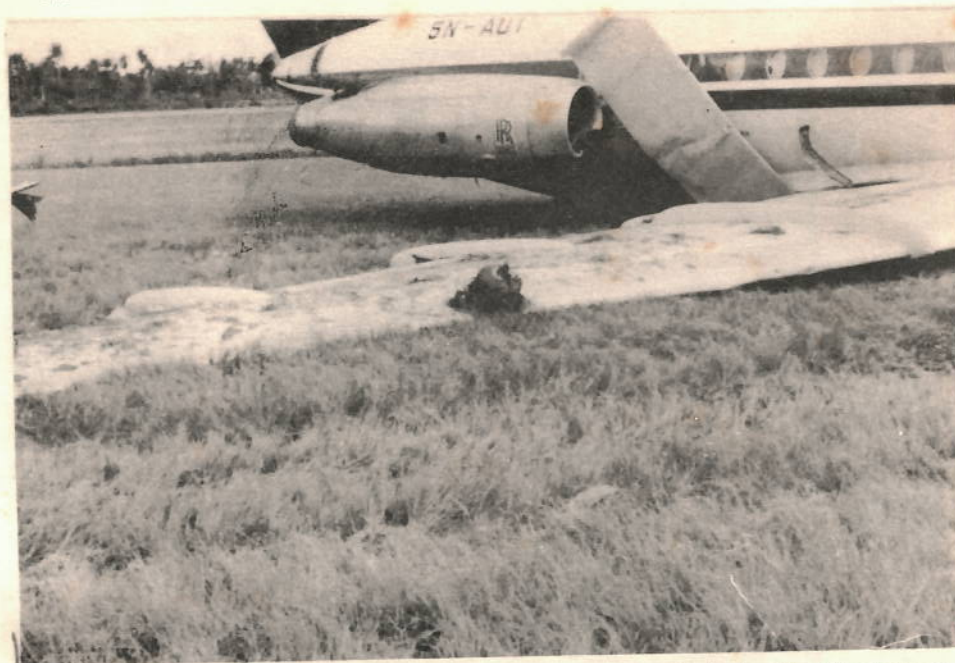
A

The bird dispersal mechanical gun placed on the runway shoulder was crushed and its cylindrical gas tank become imbedded into the leading edge of the aircraft. Two runway edge light fittings were knocked off, one runway edge light isolating transformer was damaged and different sizes and lengths of edge light cables were damaged or severed.

The right wing in contact with ground and showing the imbedded bird dispersal gun's gas tank.

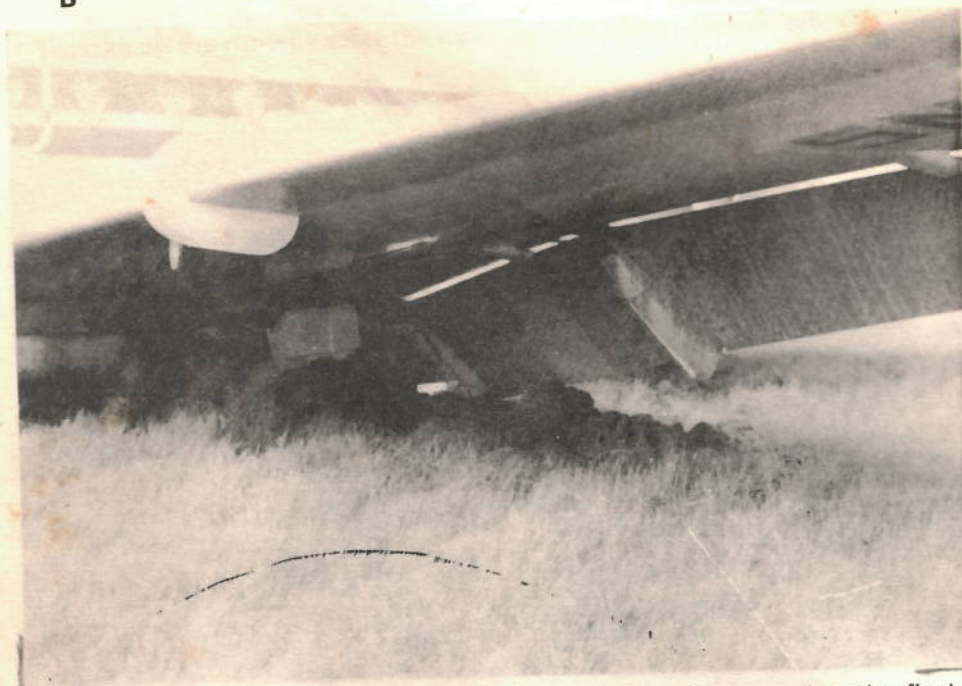
B

At the final point, the aircraft came to rest with its right hand wing in contact with the ground because the right gear had sheared off and the left gear became buried in the soil. (please see photographs in the Appendix). At this stage, the aircraft had lost the nose gear, the right main gear, right inboard flaps and one engine cowlings. The recovery effort escalated the situation of the seemingly salvageable fuselage.

The other main landing gear was deeply sunk into the ground at the final resting place.
