PRELIMINARY REPORT ON SERIOUS INCIDENT INVOLVING A BOEING 737-500 AIRCRAFT WITH NATIONALITY AND REGISTRATION MARKS 5N-SYS OPERATED BY AZMAN AIR SERVICES LIMITED WHICH OCCURRED ON RUNWAY 18R, MURTALA MUHAMMED INTERNATIONAL AIRPORT, LAGOS; NIGERIA ON THE 16TH OF FEBRUARY, 2021

Registered owner and operator:	Azman Air Services Limited
Aircraft type and model:	B737-500
Manufacturer:	Boeing Aircraft Company, USA
Year of manufacture:	1997
Nationality and registration marks:	5N-SYS
Serial number:	28565
Location:	Runway 18R, Murtala Muhammed International Airport, Ikeja, Lagos.
Date and time:	16th February, 2021 at about 17:55 h (<i>All times in this report are local times UTC+1 unless otherwise stated</i>)

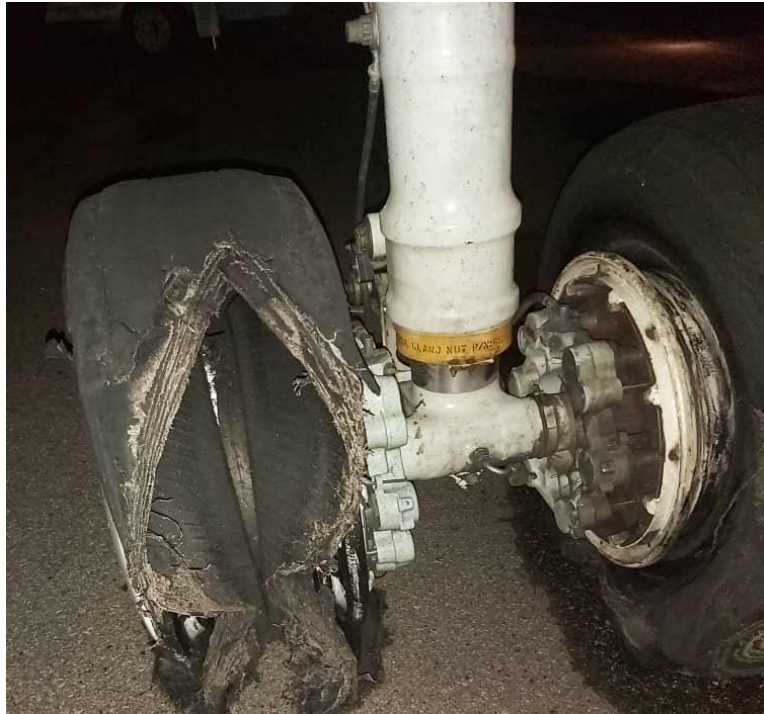
The aircraft remained on the active runway. No. 1, 2, 3 & 4 main landing gear tyres were found burst. Tyres latex were heavily worn-out with heavy canvass. Tyre debris was ingested into No 1 engine and the left rear-side of the fuselage.

Figure 3: Damaged number 1 & 2 main wheel tyres
