PRELIMINARY REPORT

Accident Investigation Bureau

**Report on Serious Incident involving EMB-145LR
with nationality and registration marks 5N-BVD
operated by Air Peace Limited which occurred at
Kaduna airport, Kaduna on 14th January, 2021.**

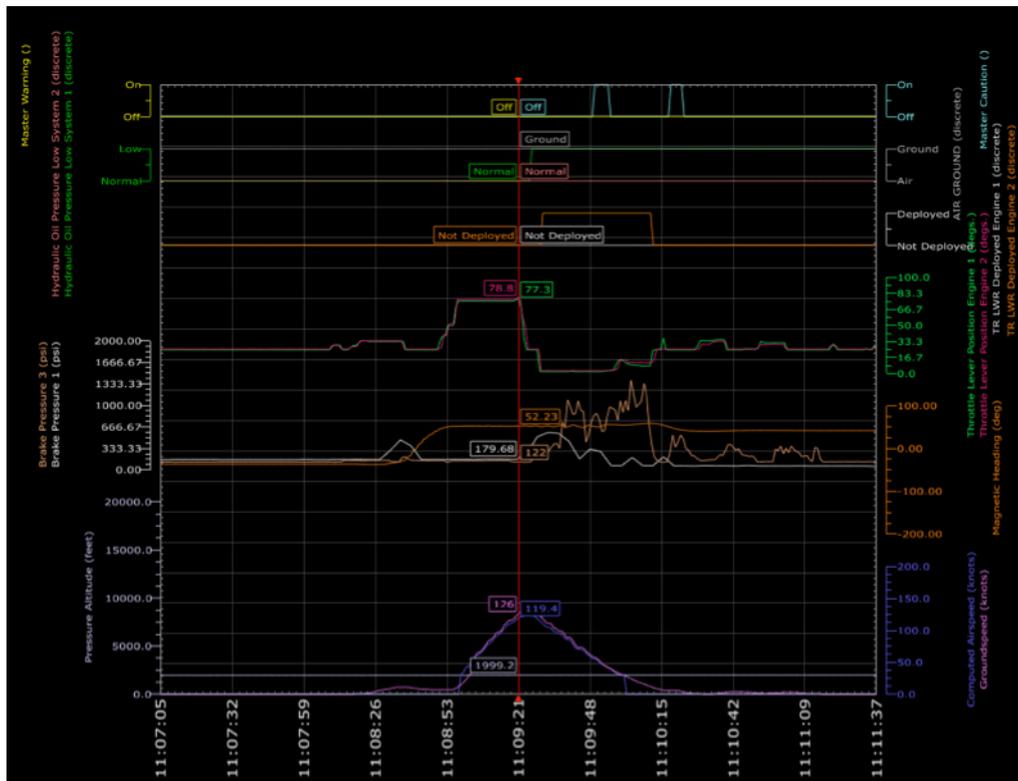
Figure 2: Relevant flight parameters at point of initiation of the rejected take-off¹

The FDR showed that the take-off was rejected at a computed airspeed of 119 kt. The Number 1 Thrust Reverser did not deploy, and hydraulic fluid pressure for Number 1 system was low. Brake pressure was applied to bring the aircraft to a stop.

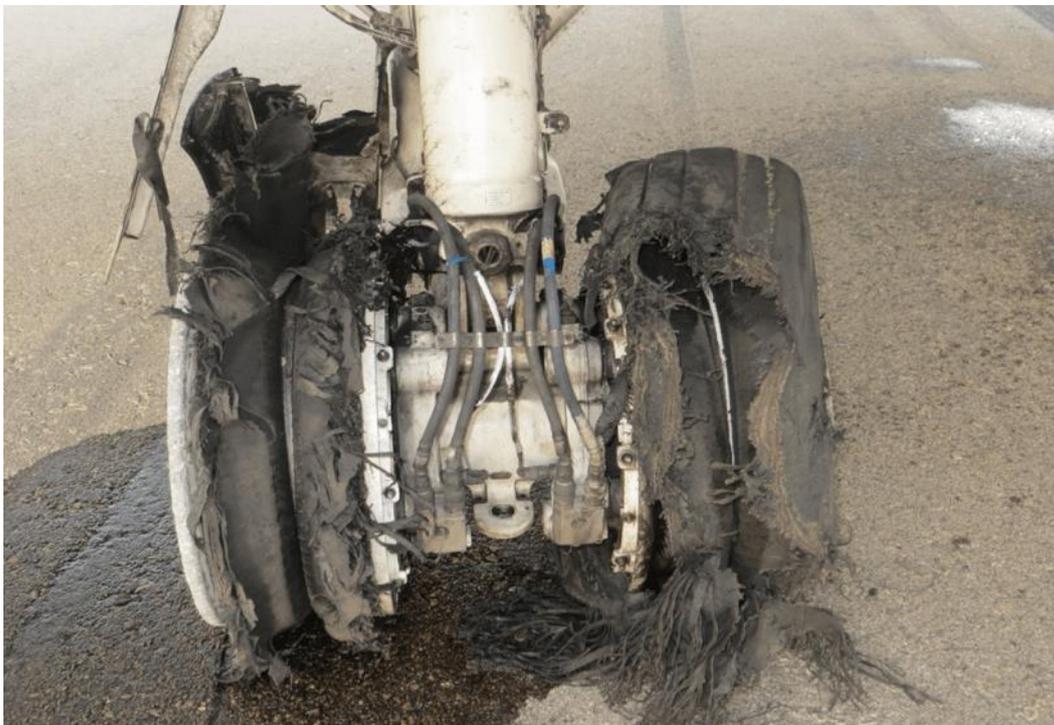
During the take-off roll, at about 756 m from the threshold of RWY 05, the number 2 main wheel tyre (inboard left main wheel) burst and the aircraft continued for a distance of about 1300 m when the number 1 left main wheel tyre (outboard left main wheel) burst. The aircraft continued for another 200 m where runway to metal contact started. The aircraft thereafter, moved in a ground loop pattern for 460 m.

1. The plies of the Number 1 tyre were shredded and the beads remained on the flange.
2. Portions of the plies of the number 2 tyre were shredded and flat spot was found on the remaining; the beads were not detached from the flanges.
3. The flanges of the two left main wheel hubs were abraded.
4. Left main landing gear door was damaged.
5. There was hydraulic fluid spillage underneath the left Main Landing Gear.

Figure 3: Damaged number 1 and number 2 main wheel tyres

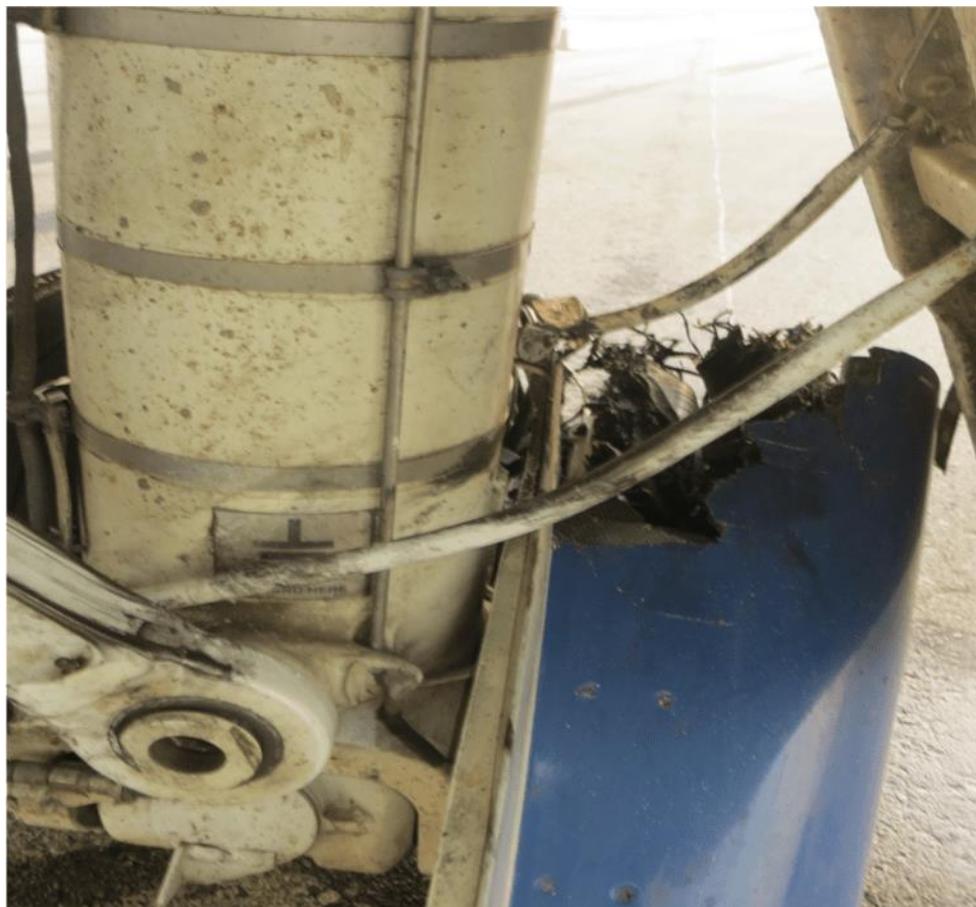
Figure 4: Torn left main landing gear door fairing

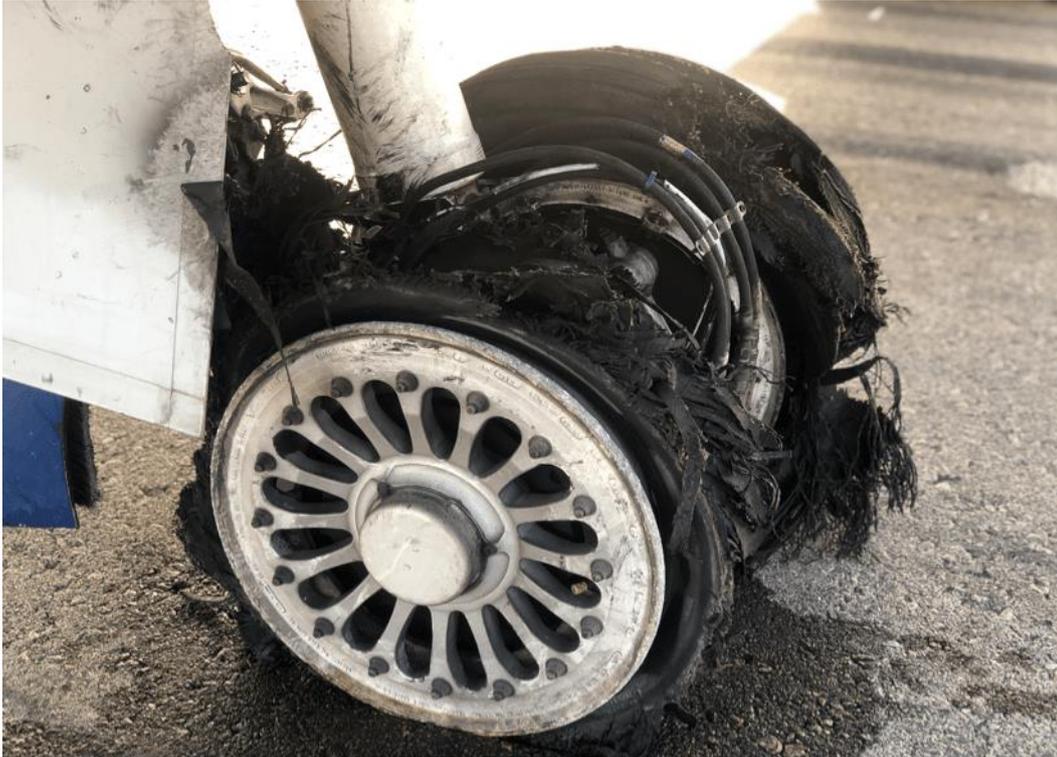
Figure 5: Abraded number 1 left main wheel hub

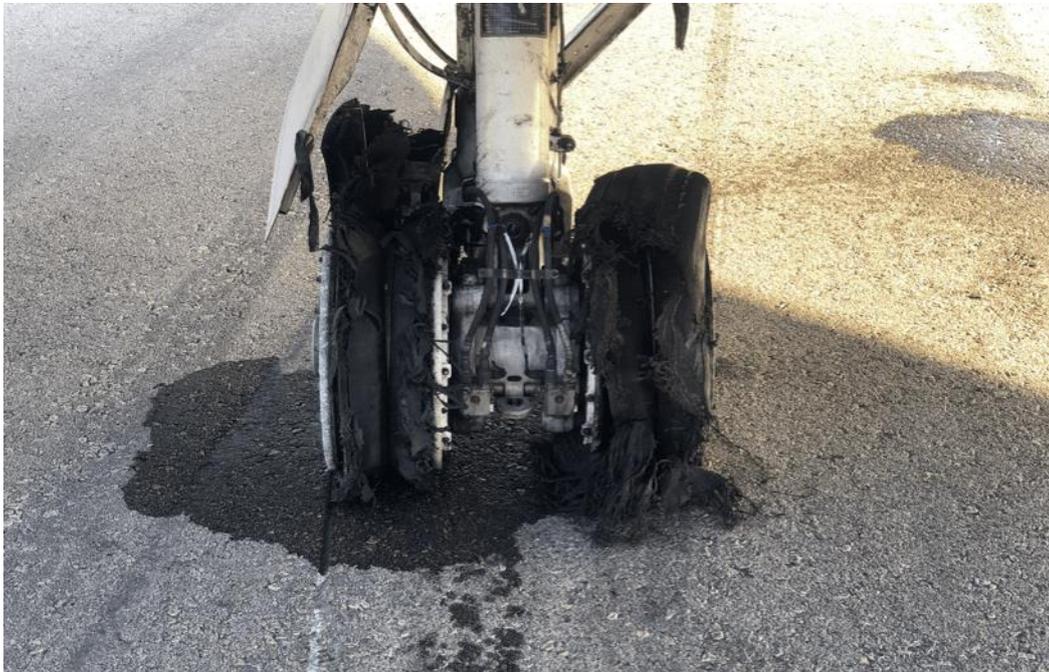
1. Hydraulic fluid level indicator of the Hydraulic System 1 Reservoir was at Position 1.
2. Hydraulic fluid spillage was observed underneath the left main landing gear.
3. A hydraulic brake hose coupling underneath the number 1 main landing gear was found loose and dripping hydraulic fluid intermittently. Upon tightening the connecting pipe, the leakage stopped.
4. The electrical connector on the Pressure Switch from the number 1 Engine Driven Pump was found loose. The electrical connector was tightened, tested and pressure indicated 3000 psi.

Figure 6: Spillage of hydraulic fluid observed underneath the left main landing gear

23. A loose coupling of a hydraulic brake hose underneath the number 1 main landing gear was observed with hydraulic fluid dripping intermittently.
