CIVIL AVIATION ACCIDENT REPORT
No. FMA/AIPB/394

**FINAL REPORT ON THE ACCIDENT TO THE
AERO CONTRACTORS COMPANY OF NIGERIA'S
AS-365-N2 DAUPHIN HELICOPTER REGISTERED 5N-BBS
AT AGIP OIL BASE, BRASS TERMINAL, BAYELSA STATE,
ON FRIDAY 3RD JANUARY 2003.**

FINAL REPORT ON THE ACCIDENT TO THE AERO CONTRACTOR COMPANY OF NIGERIA LIMITED'S AS-365-N2 HELICOPTER REGISTERED 5N-BBS AT BRASS OIL TERMINAL, BAYELSA STATE ON FRIDAY 3RD JANUARY 2003.

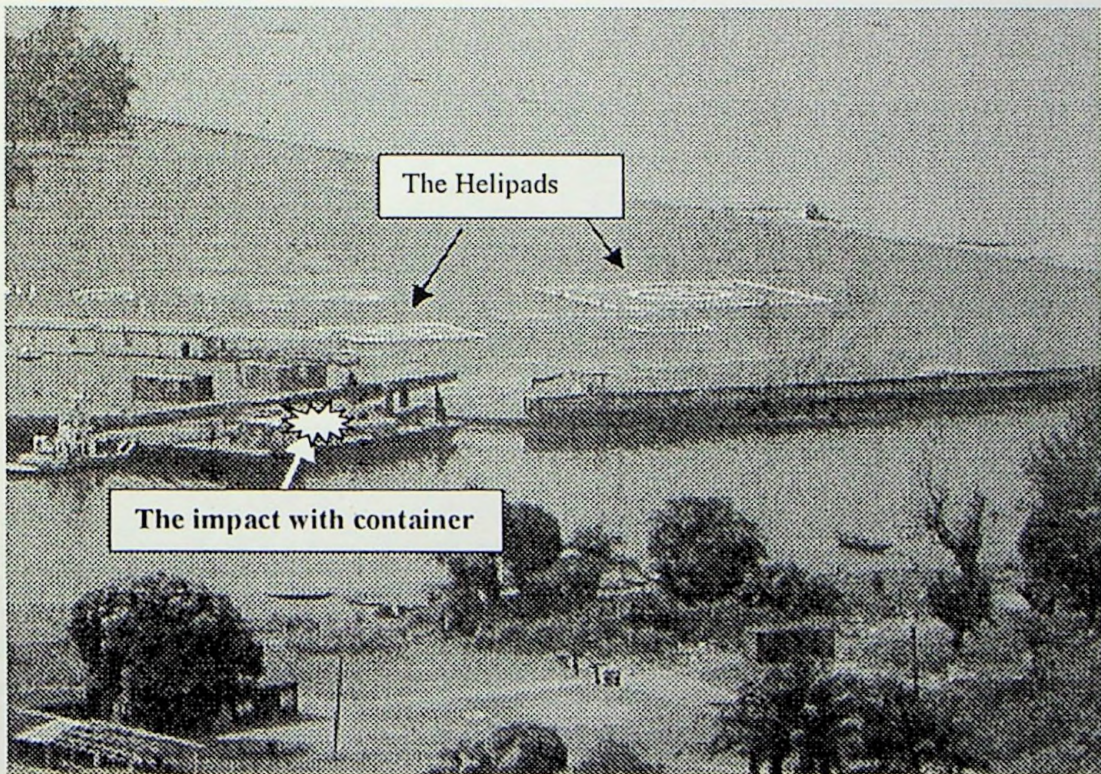
APPENDIX 5.2

Photograph showing the container on the barge in proximity to the helipads. The helicopter, obviously uncontrollable, strayed to the Barge and collided with the container.

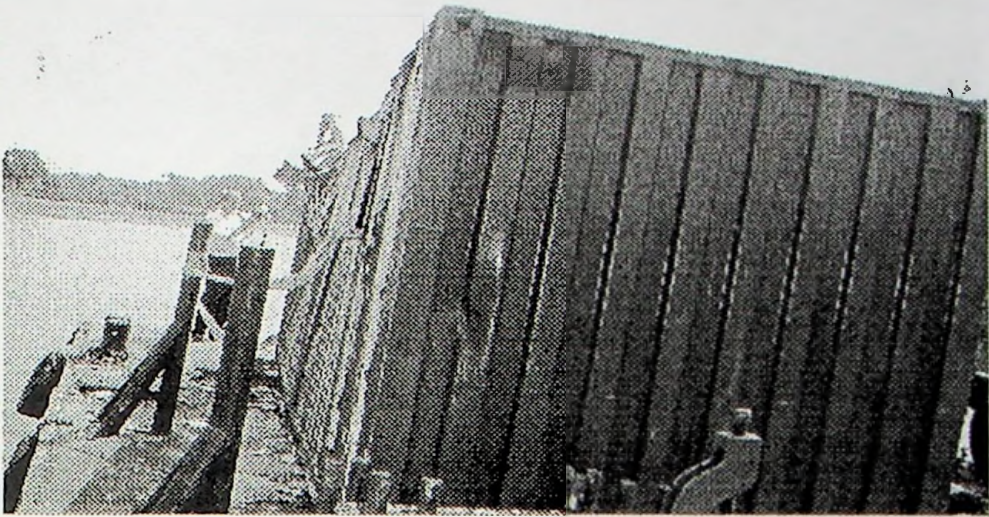
APPENDIX 5.3

Close-up photograph of the container.

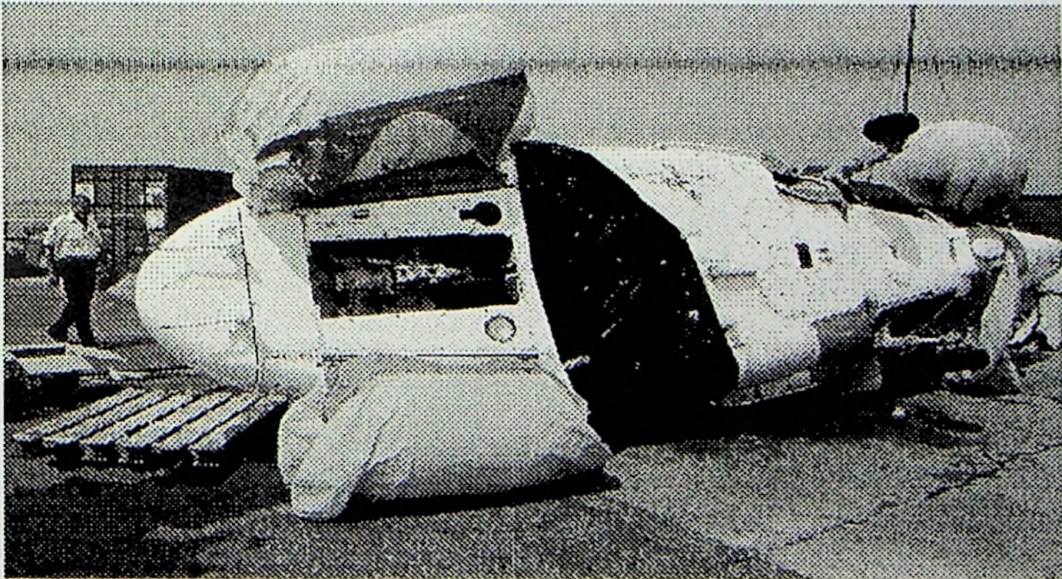
APPENDIX 5.4

5N-BBS after the wreckage was retrieved from the water showing 3 of the 4 emergency float bags remained still inflated after impact.

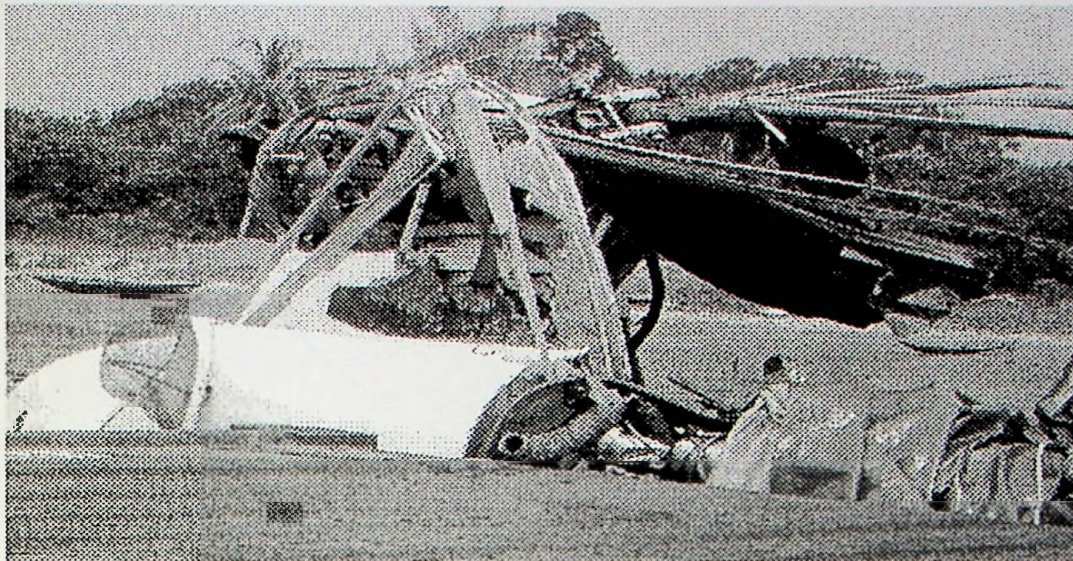
APPENDIX 5.5

The devastating destruction of the Main Rotor Blades portrays the closeness of the helicopter to the container on the barge.

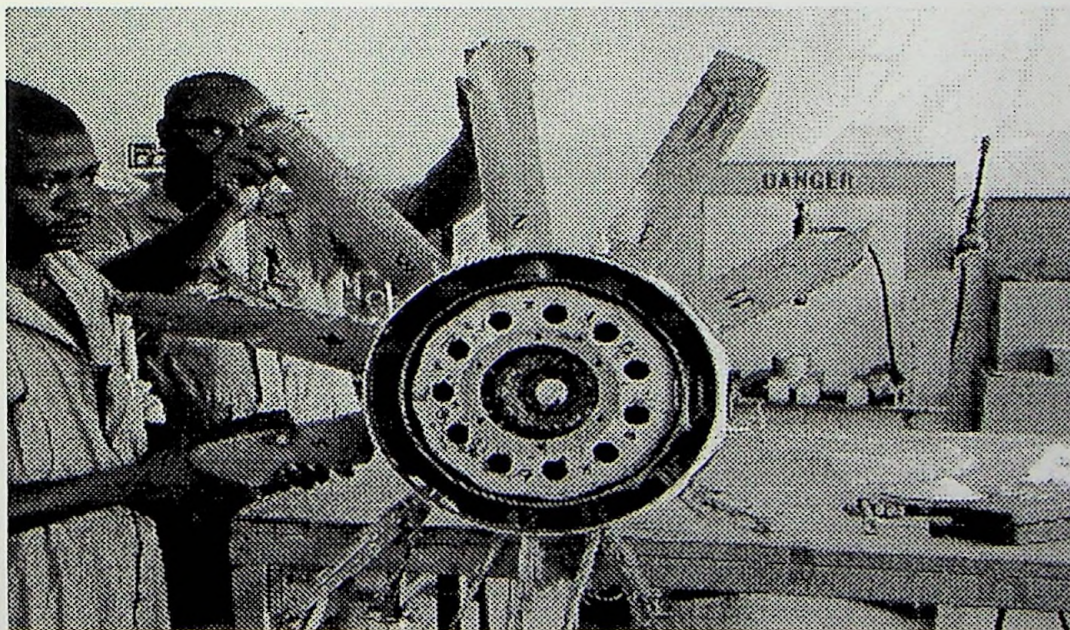
APPENDIX 5.6

The Tail Rotor Assembly Inspection After The Accident.

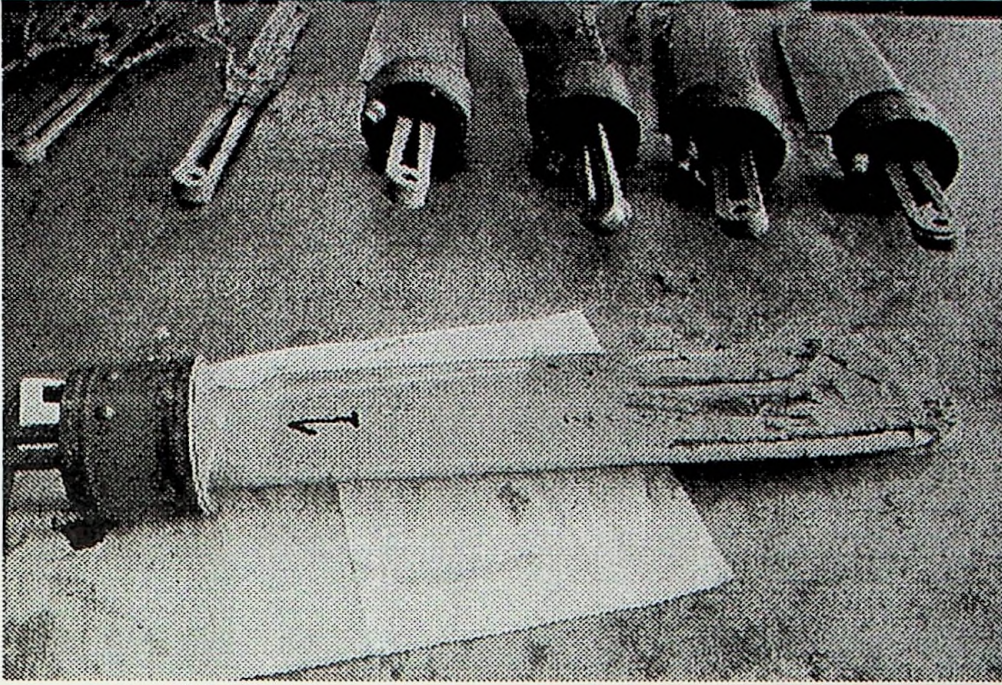
APPENDIX 5.7

Corresponding analysis were then performed on the blade number 35317 and the other blades of the AS 365 registered 5N-BBS (see the report on appendix 5.7 on page 36). The inspection analysis then concluded that the blade number 35317 presented a similar fatigue crack in the same area. This fatigue crack involved the rupture of the blade number 35317 then, this blade damaged the adjacent blade (number 36853), which also fractured. These fractures affected all other blades in the tail rotor assembly. It is to be noted that Eurocopter issued an Alert Bulletin No. 05.00.17 on April 16th 2003, to introduce a temporary operating time limit of 160 hours for certain blades P/N 365A112-0020-02 and to increase the maintenance intensity for the blades with these part numbers.

fatigue rupture of the Kevlar spar of a tail rotor blade was the cause of the failure. A corresponding analysis was then performed on the tail rotor blades of 5N-BBS and a similar crack was identified in the same area. This area is located between the Kevlar spar and the polyurethane material at a 90° angle of the tail rotor blade.

The Preliminary Individual Tail Rotor Blade Inspection On Site before shipment to the aircraft manufacturer in France.

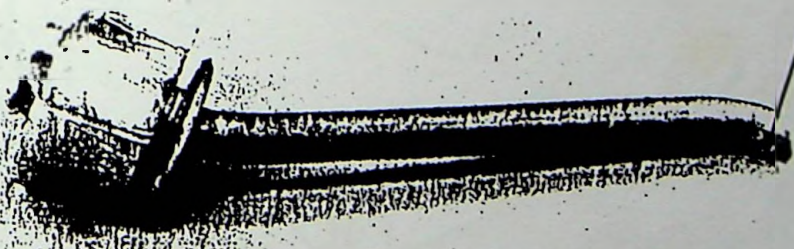
The damage found is consecutive to the accident.

Failure of
scissor link
pin

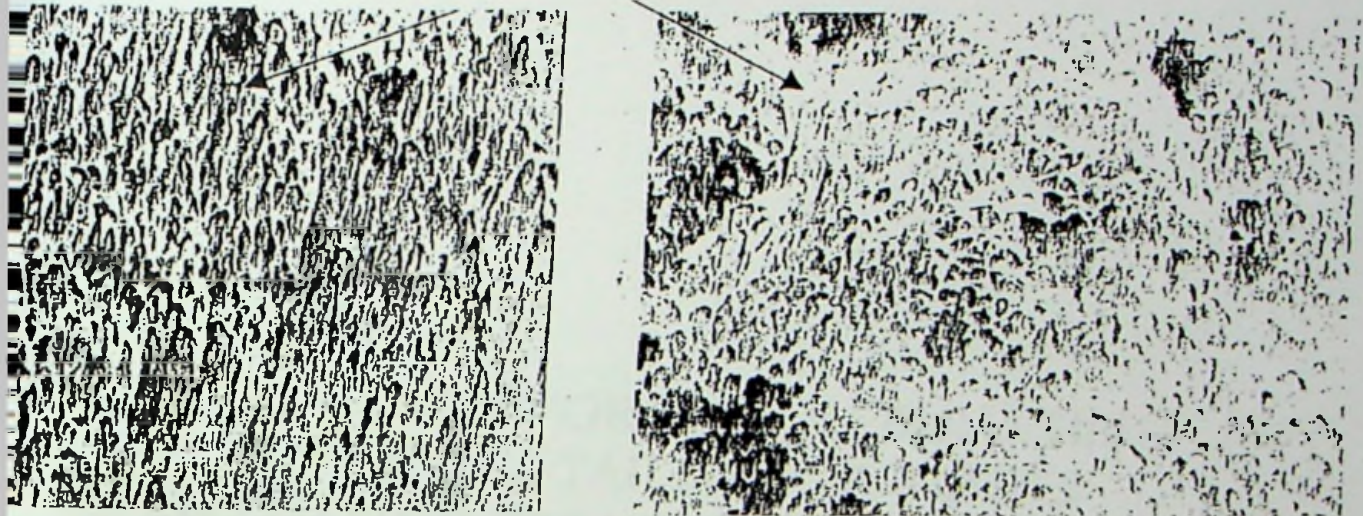
Scissor link pin

Metallurgical test performed on the rotating scissors' lower link bolt depicted that the fracture was a static failure meaning that the bolt fractured at the impact of main rotor blades with the container on the barge. No technical problems or deficiencies before impact. Please see the result of metallurgical test performed on the bolt and the spacer of the scissor link assembly. (Annex 5)

The failure of the scissor link pin is static.

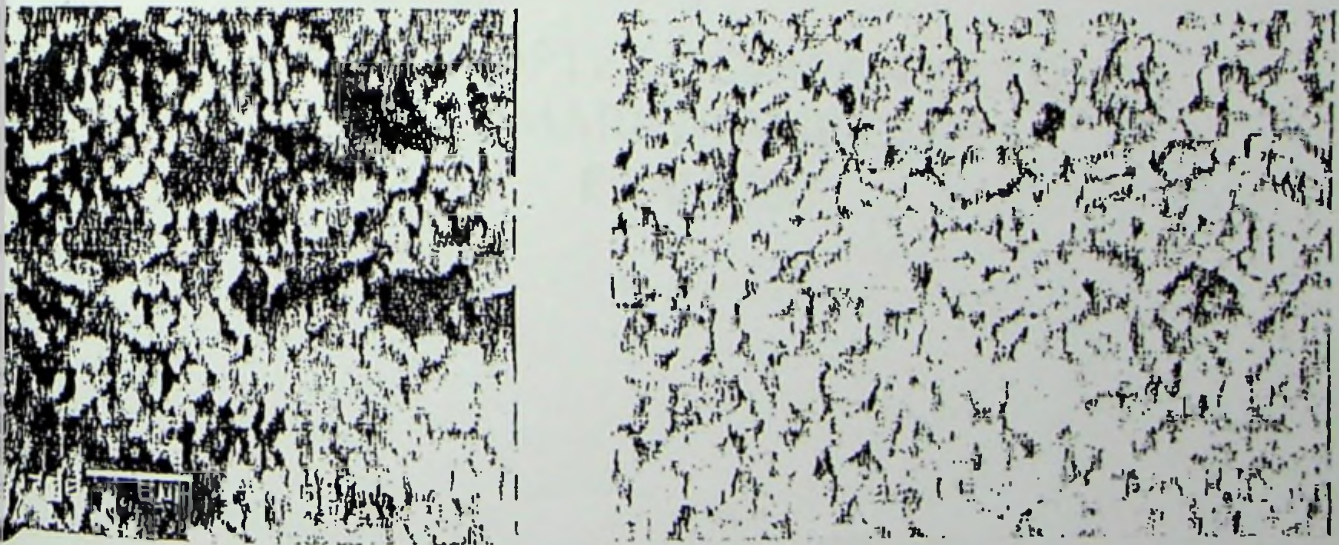
Spacer

Topographies of the spacer under
on.

Topographies of static failure induced on
the spacer in the laboratory.

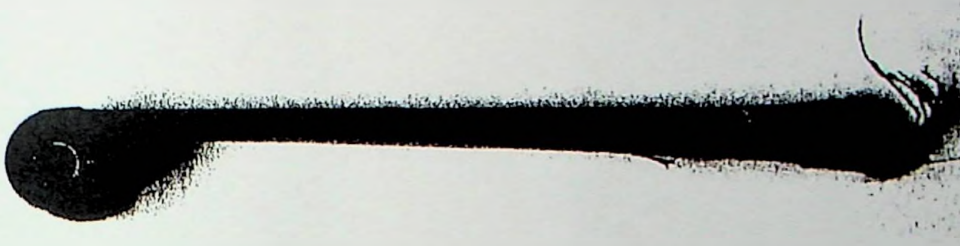
The spar strand on the leading edge side has disappeared.

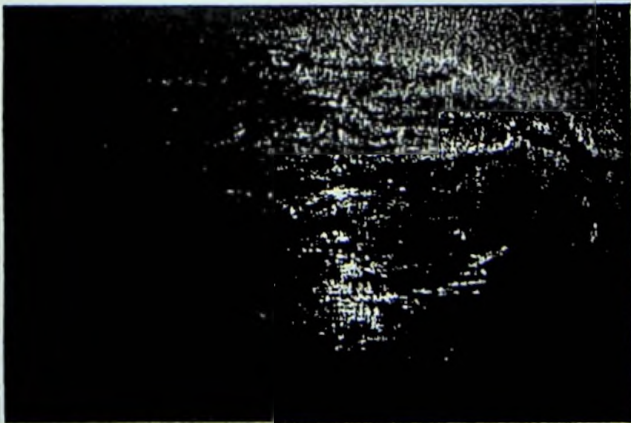
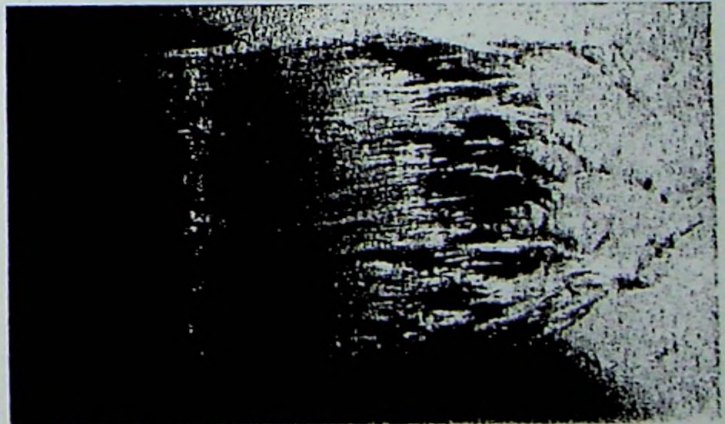
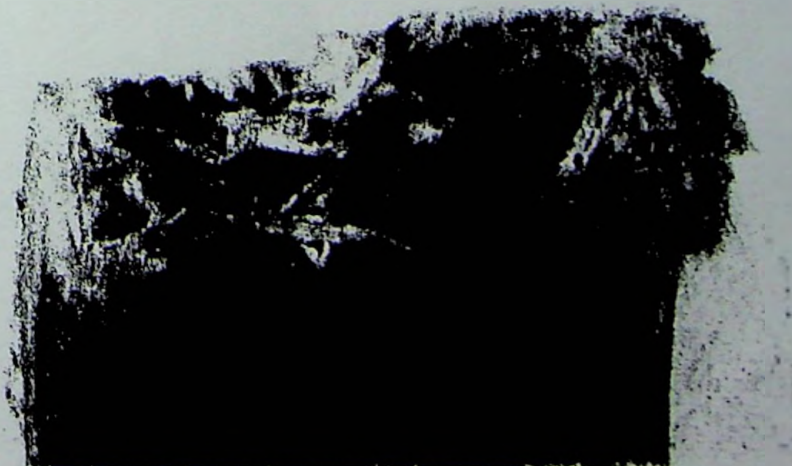
Failure at Bushing on Leading Edge Side

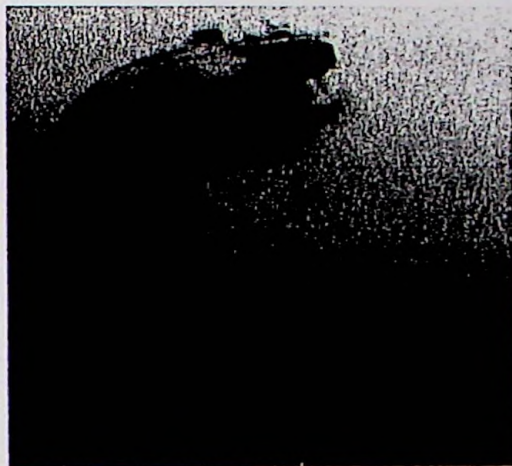
3.1 Failure of Tie Bar Assembly at Bushing

Dimension measured on a specimen tie bar assembly: 4.38 mm

Part of the tie bar has been delaminated.
