**PRELIMINARY REPORT ON SERIOUS INCIDENT INVOLVING A BOEING 737-500 AIRCRAFT WITH NATIONALITY AND REGISTRATION MARKS 5N-SYS OPERATED BY AZMAN AIR SERVICES LIMITED WHICH OCCURRED ON RUNWAY 18R, MURTALA MUHAMMED INTERNATIONAL AIRPORT, LAGOS; NIGERIA ON THE 16TH OF FEBRUARY, 2021**

<b>Registered owner and operator:</b>	Azman Air Services Limited
<b>Aircraft type and model:</b>	B737-500
<b>Manufacturer:</b>	Boeing Aircraft Company, USA
<b>Year of manufacture:</b>	1997
<b>Nationality and registration marks:</b>	5N-SYS
<b>Serial number:</b>	28565
<b>Location:</b>	Runway 18R, Murtala Muhammed International Airport, Ikeja, Lagos.
<b>Date and time:</b>	16th February, 2021 at about 17:55 h ( <i>All times in this report are local times UTC+1 unless otherwise stated</i> )

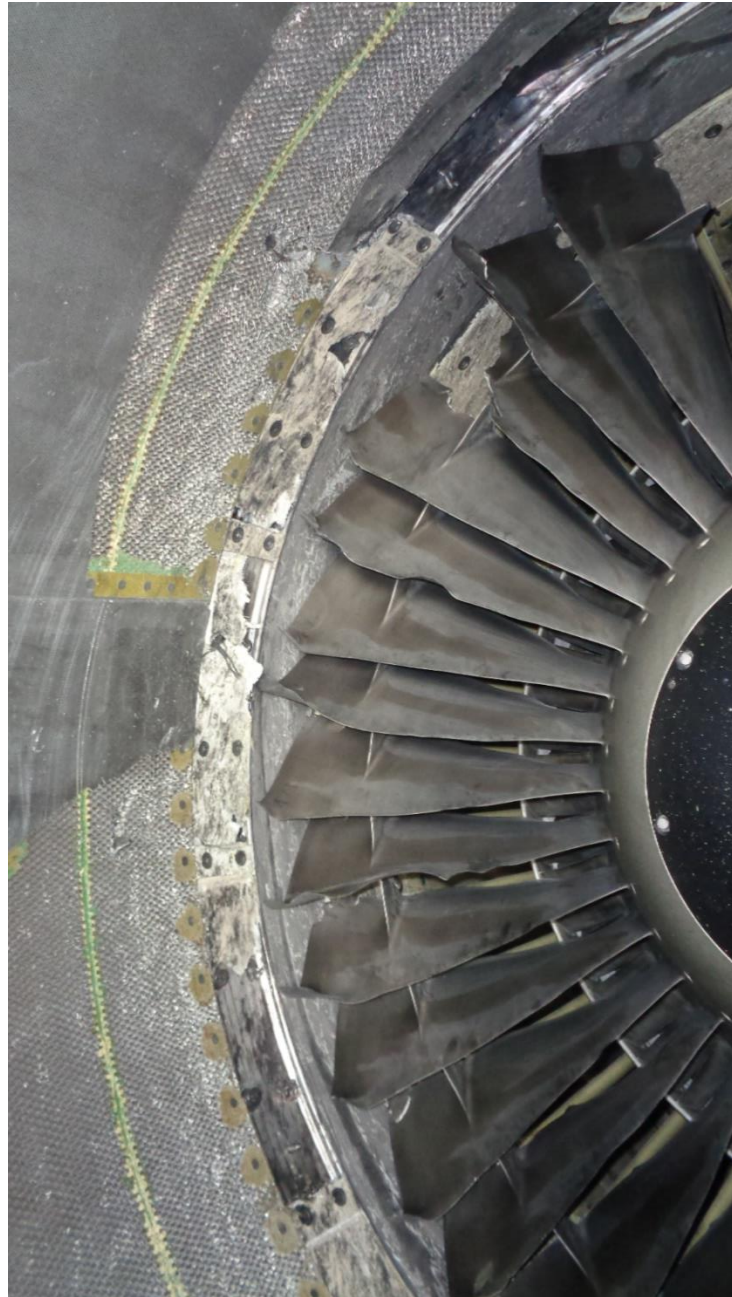
The aircraft remained on the active runway. No. 1, 2, 3 & 4 main landing gear tyres were found burst. The tyre threads were heavily worn revealing multiple layers of the canvass. Debris from the tyres were ingested into No. 1 engine and the left rear side of the fuselage.

**Figure 2: Damaged fan blades of number 1 engine caused by ingestion of debris from the burst tyre**

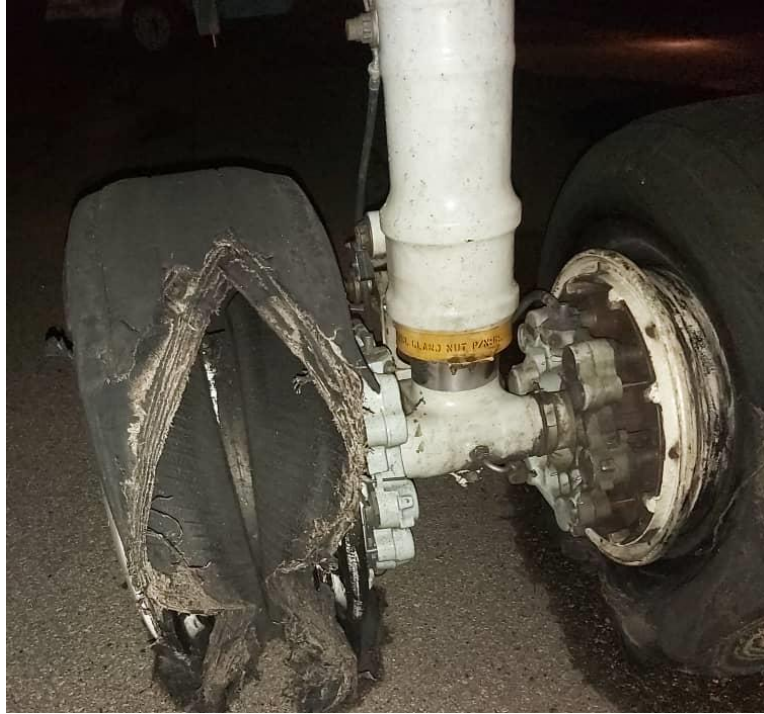
**Figure 3: Damaged number 1 & 2 main wheel tyres**

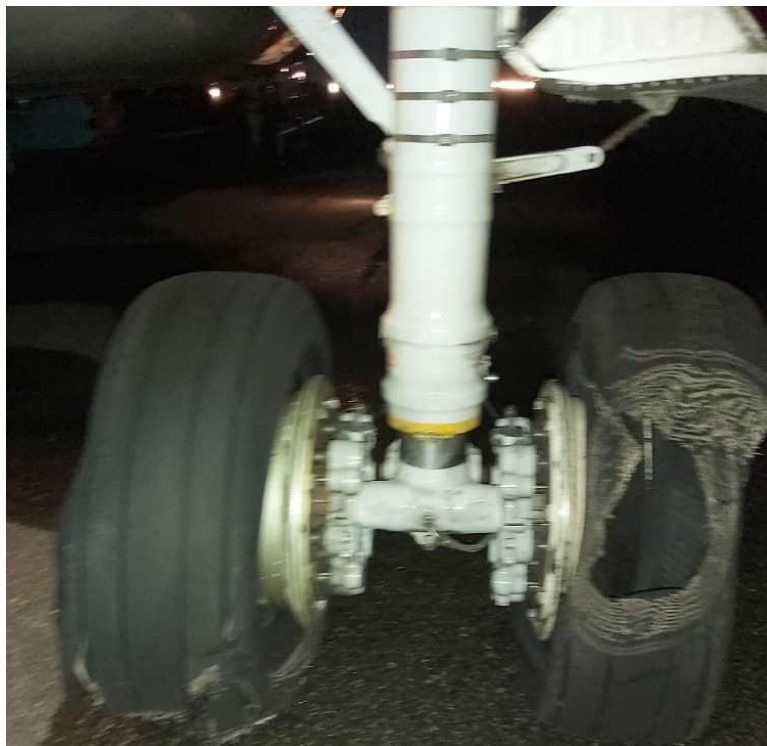
**Figure 4: Rear view of damaged number 3 & 4 main wheel tyres**

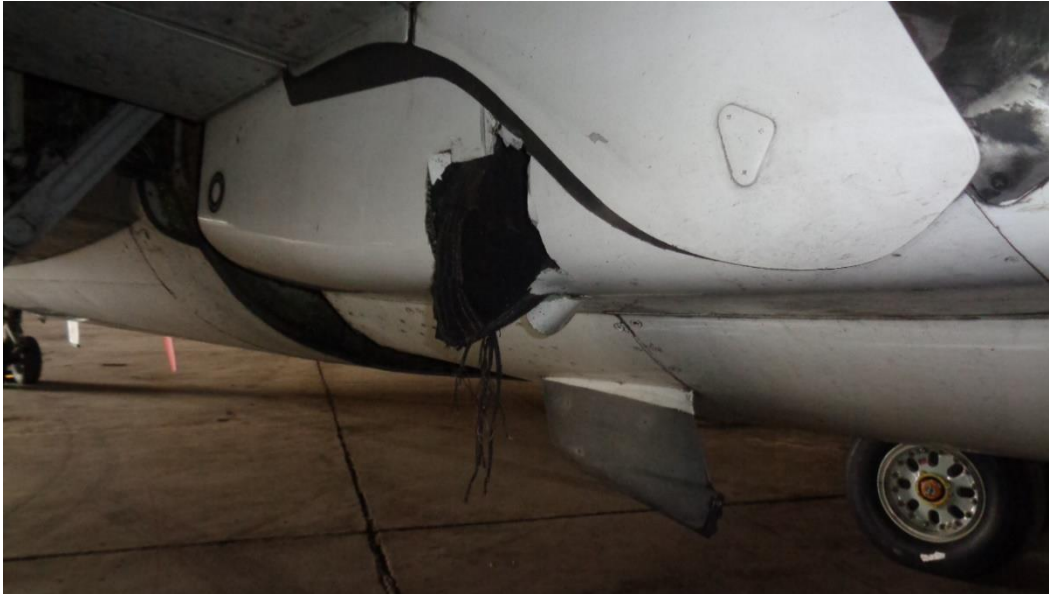
**Figure 5: A damaged section of the fuselage due tire debris**
