AIRCRAFT ACCIDENT REPORT

AIRPEACE/2019/06/22/F

**Report on the Serious Incident involving a B737-500
aircraft operated by Air Peace Limited with nationality
and registration marks 5N-BRN which occurred at Port
Harcourt Airport, Omagwa, Rivers State
On 22nd June, 2019**

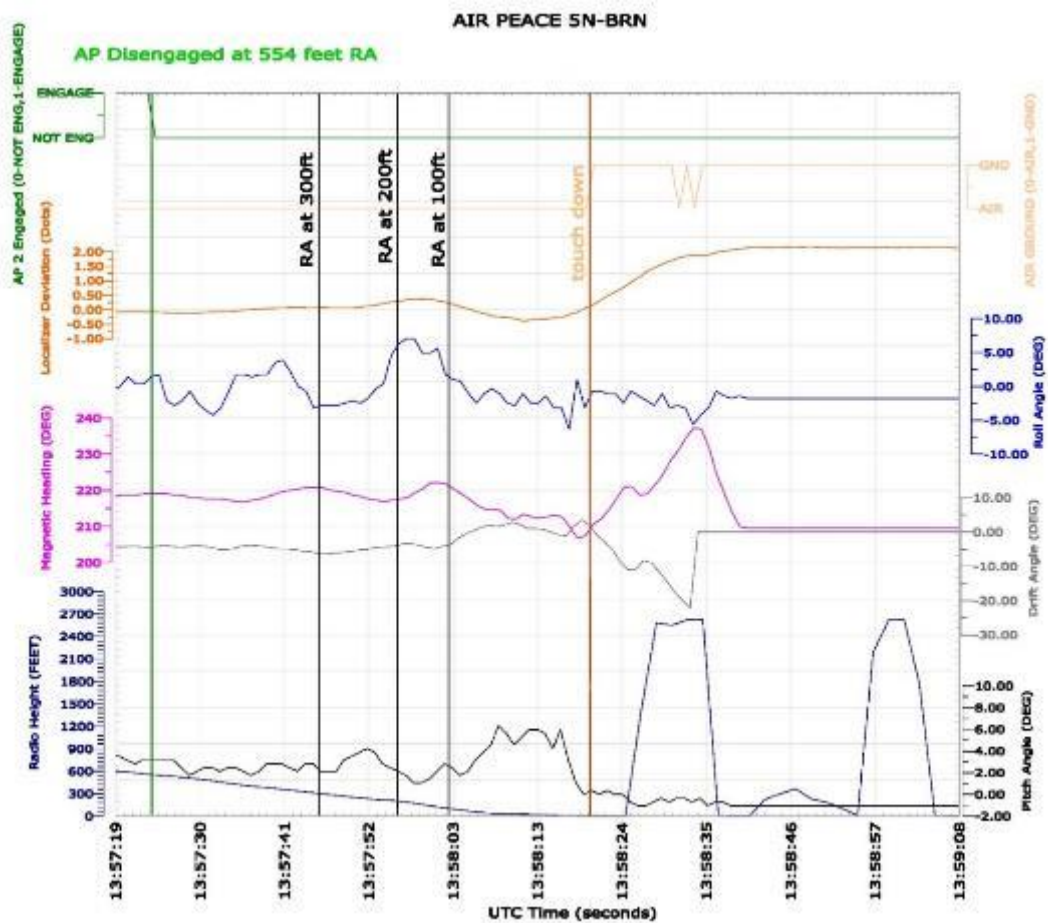
Figure 8: Final approach and landing

From the FDR and CVR evidence available to the bureau, the operation of the flight was normal and stabilized until about 30 feet to touchdown. At this height, there was a positive drift angle of about 6 degrees and a negative rudder input of about 7 degrees. This shows that the aircraft was drifting to the right and the PF corrected for the drift with rudder input to the left. Also, at 30 ft RadAlt height, the throttles on both engines were retarded to idle which caused the aircraft to lose momentum for better

From the FDR plot at touchdown, with a possible cross wind factor from the right at 100°/12 knots involved, the aircraft started drifting to the left of the runway. The rudder input at this point was zero and increased to the right on the landing roll to 4 degrees and further to 7 degrees. This could be as a result of the flight crew realizing that the aircraft had drifted and touched down left of the runway centreline and tried to correct for this. This is corroborated by the magnetic heading of 212 degrees. During the landing roll, the magnetic heading started increasing to the right then suddenly started decreasing.

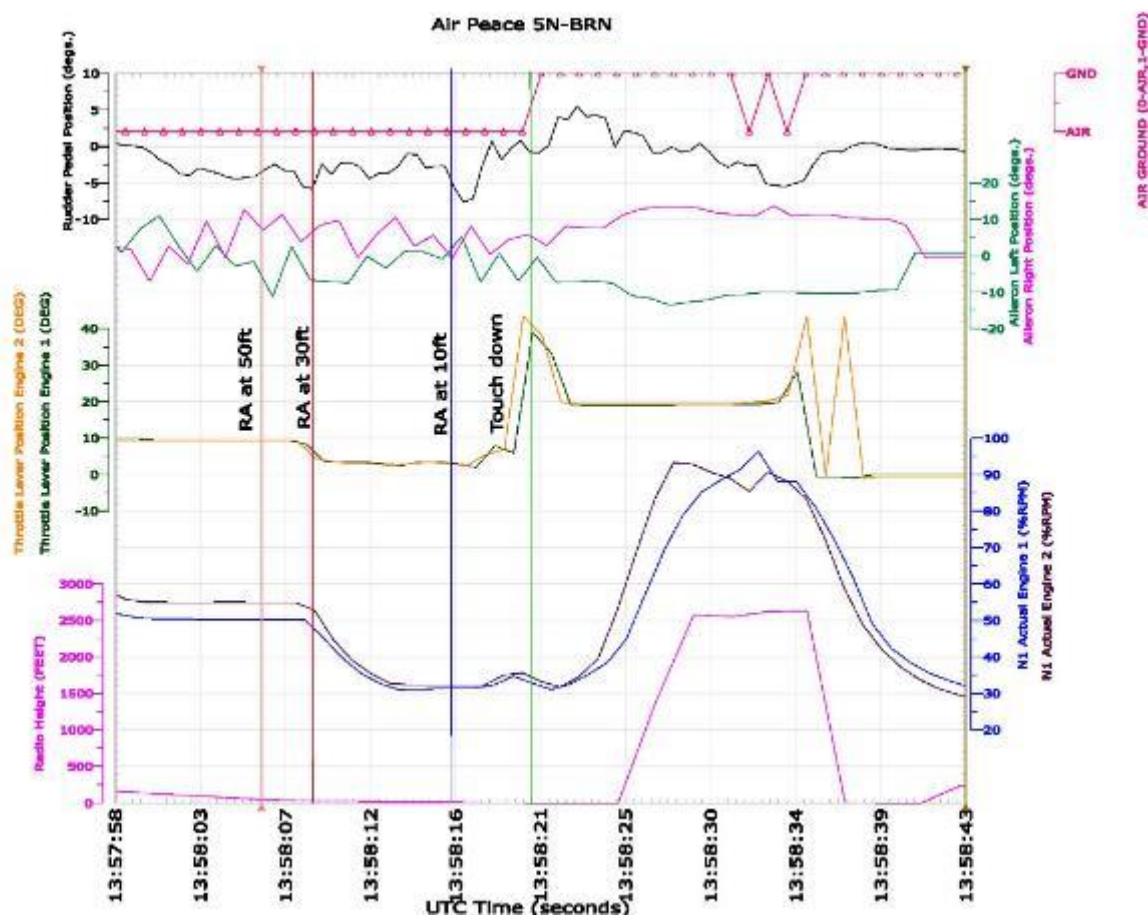
Figure 9: Final approach and landing

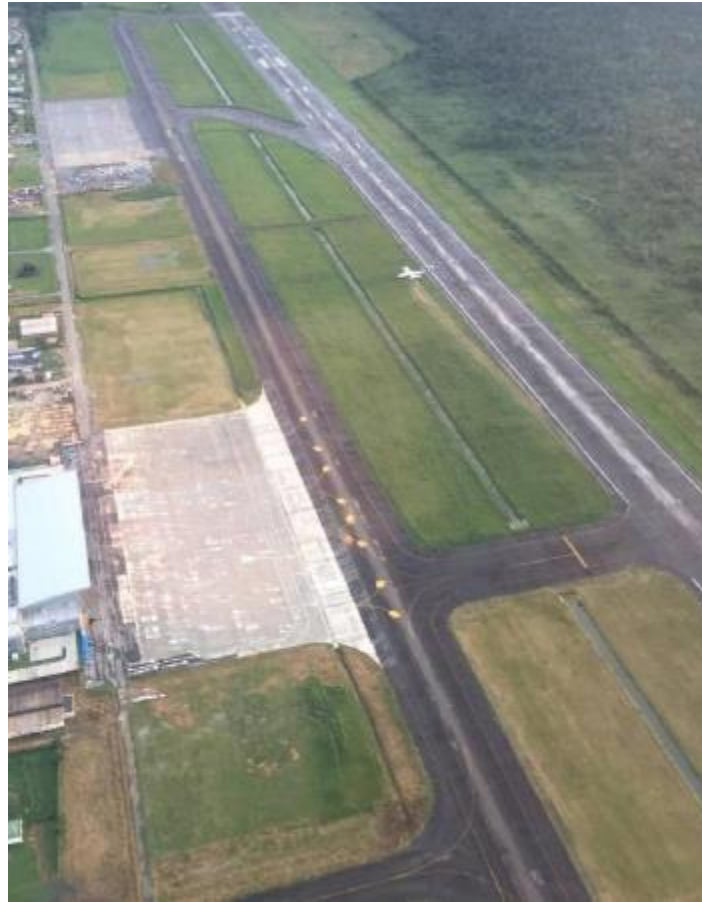
The aircraft touched down and veered off the runway, left of the centreline into the grass verge at about 1,260 m from the threshold. It continued its movement on the grass and stopped parallel to the runway at about 1,620 m from the threshold with the right wing-tip at the edge of the runway shoulder at approximately 37 m from the runway centreline and came to a stop with the wheels stuck in the mud.

Figure 10: Aerial view of the aircraft at its final position

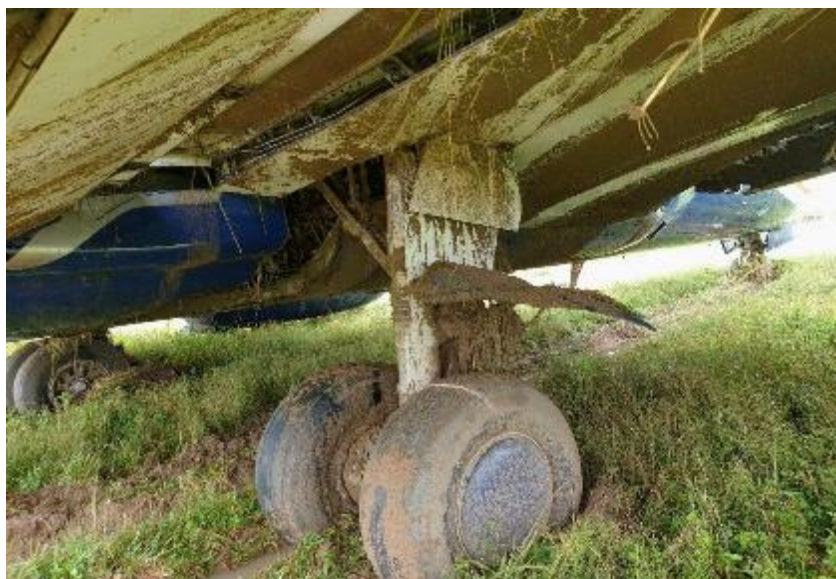
It continued its movement on the grass and stopped parallel to the runway at about 1,620 m from the threshold with the right wing-tip at the edge of the runway shoulder at approximately 37 m from the runway centreline and came to a stop with the wheels stuck in the mud.

Figure 11: The aircraft wheels stuck in mud

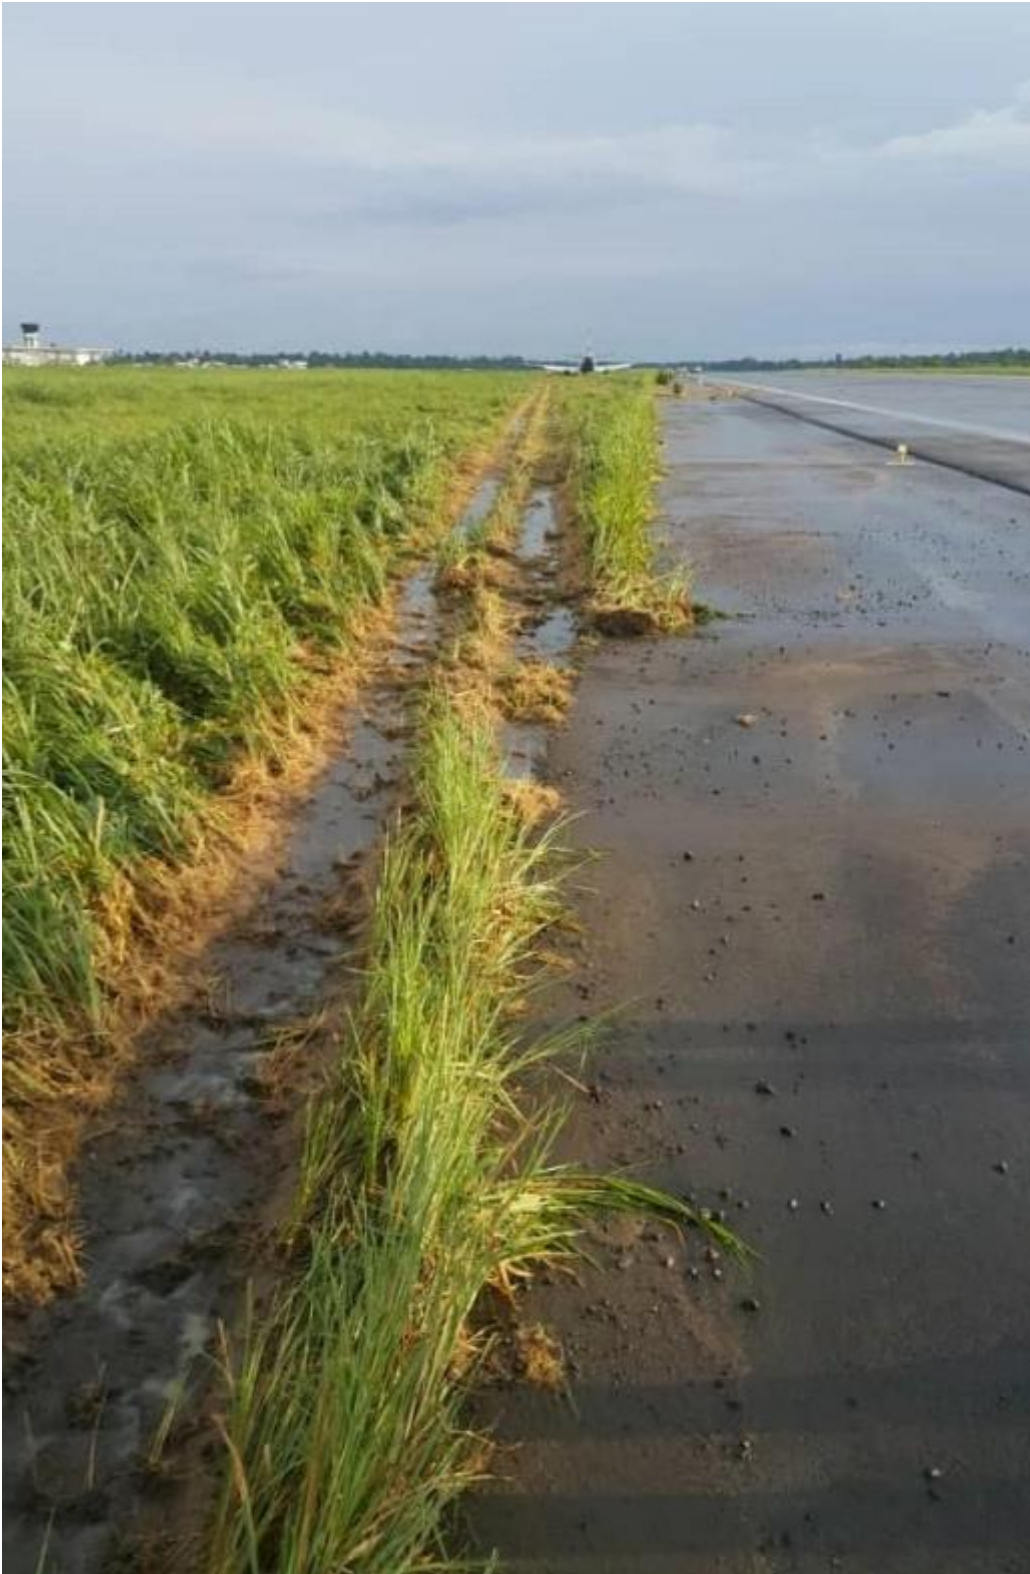
Landing clearance was given to the crew and the aircraft touched down on runway 21 and subsequently veered off the runway, left of the centreline into the grass verge at about 1,260 m from the threshold.

Figure 12: Tracks of the main wheels leading into the grass verge

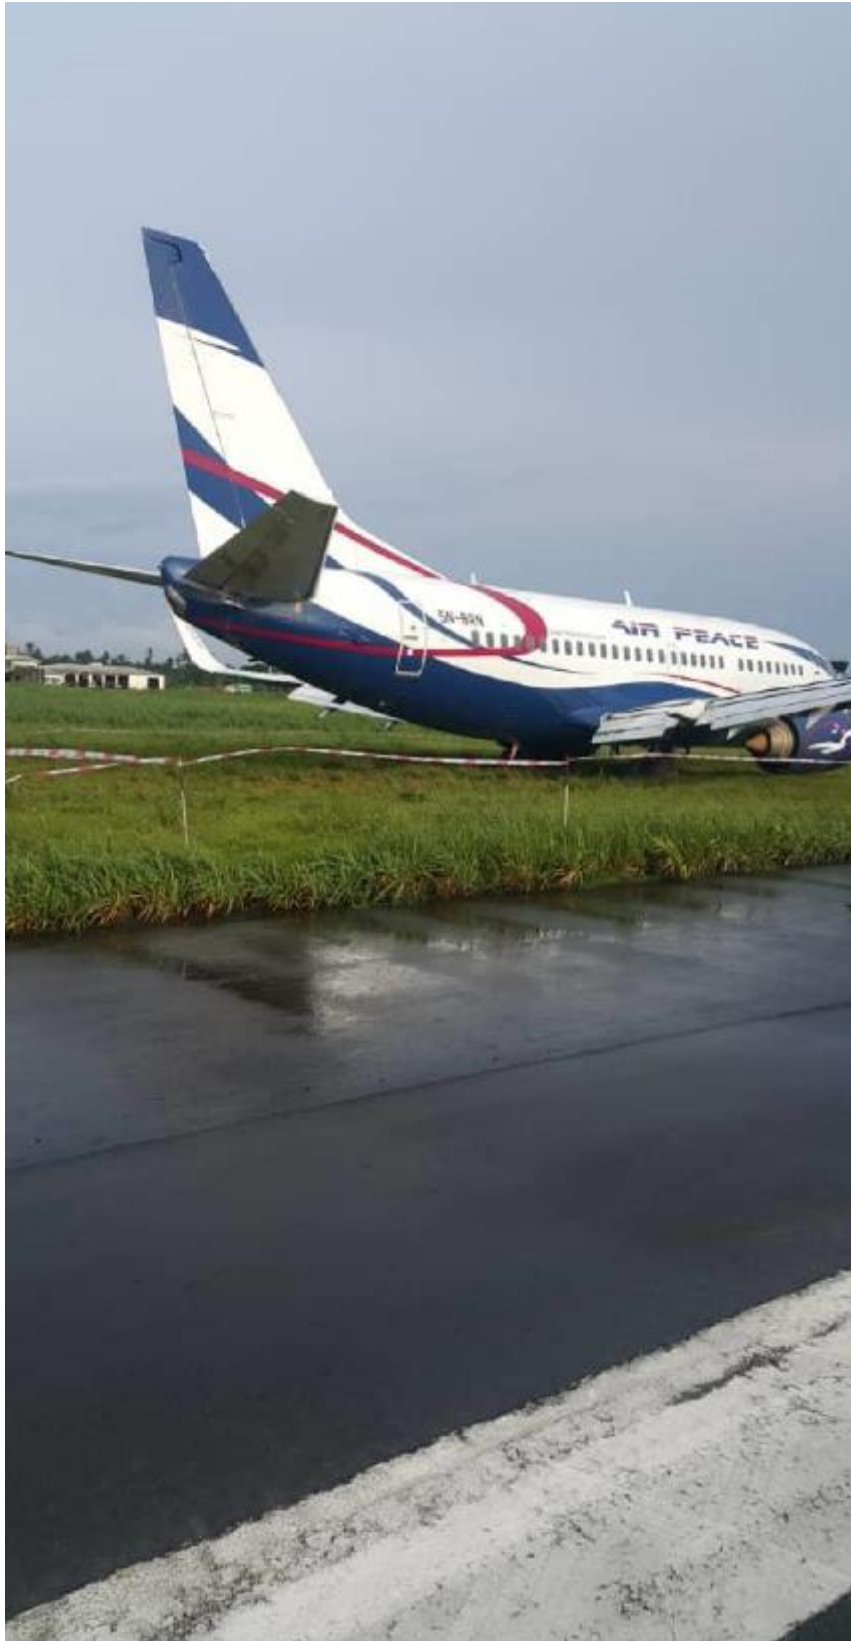
Figure 13: The aircraft at its final position

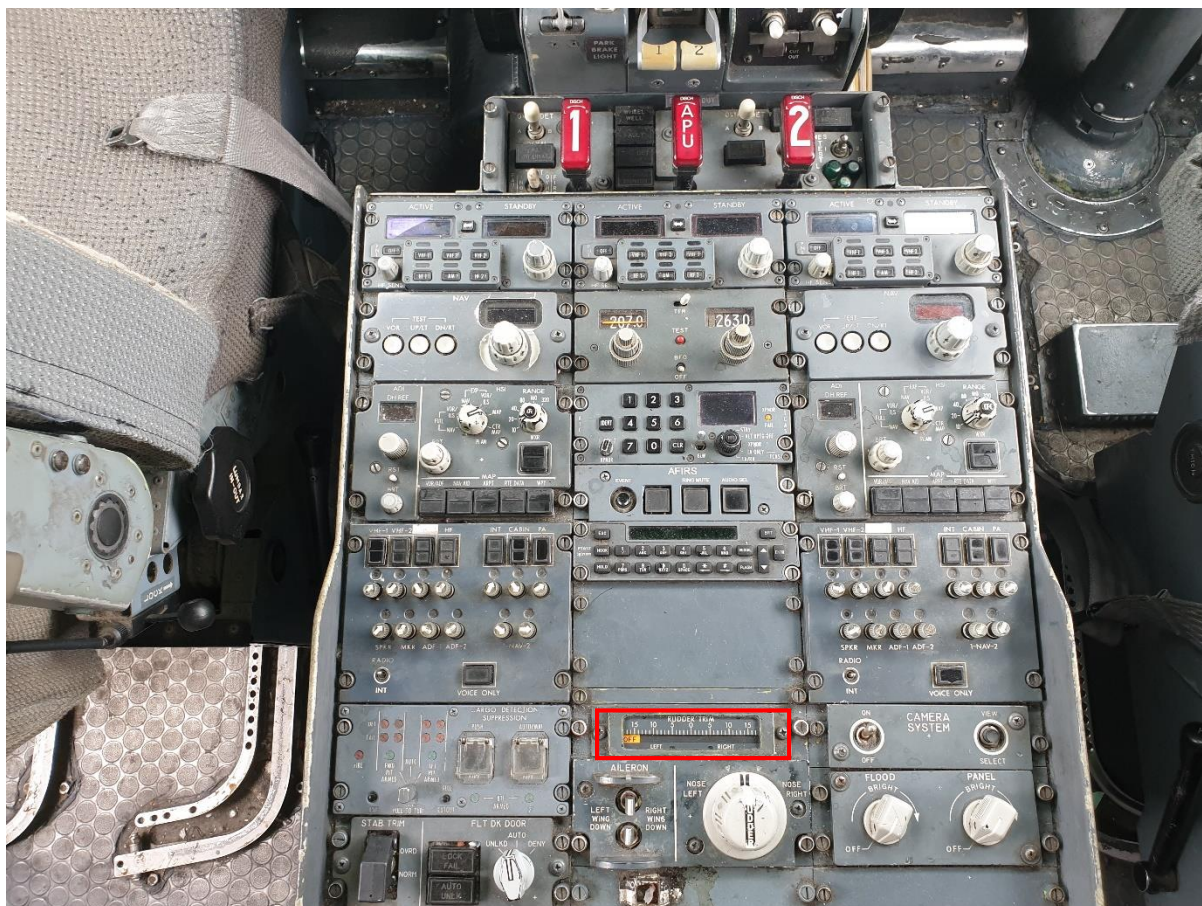
Figure 14: Highlighted photo of rudder trim panel on the pedestal
