AIRCRAFT ACCIDENT REPORT

ASSOC/2011/07/10/F

Accident Investigation Bureau

**Report on the Serious Incident involving HS-125-700A
aircraft operated by Associated Aviation Limited with
nationality and registration marks 5N-BEX which
occurred at Benin Airport, Edo state, Nigeria
On 10th July, 2011**

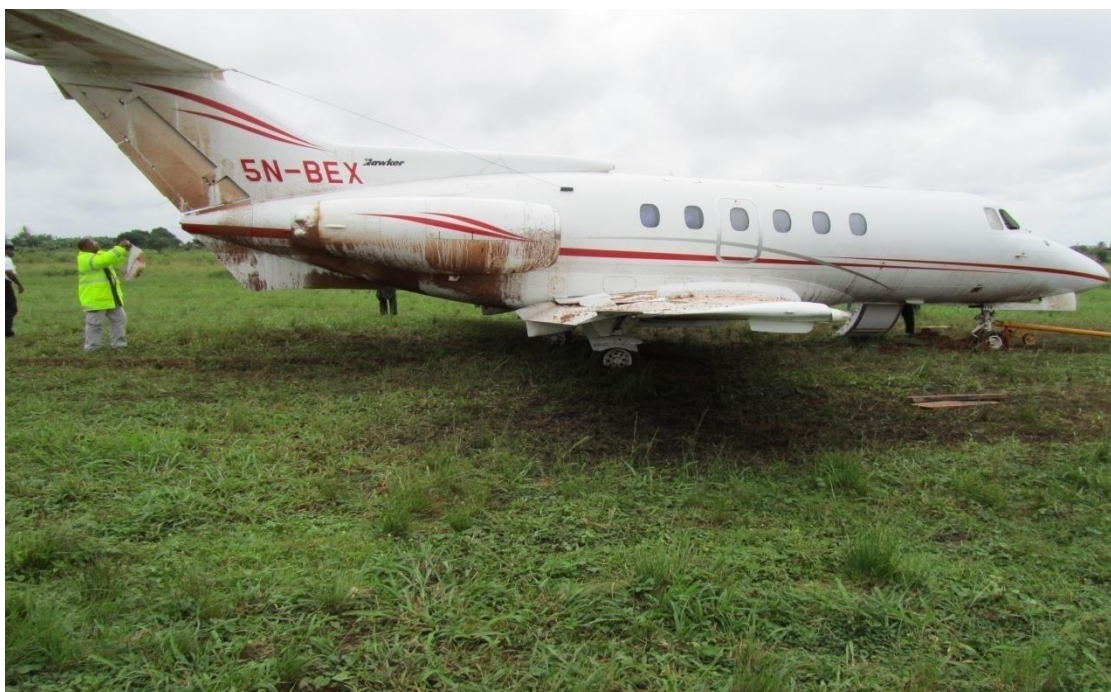
Figure 1: The aircraft at its final position

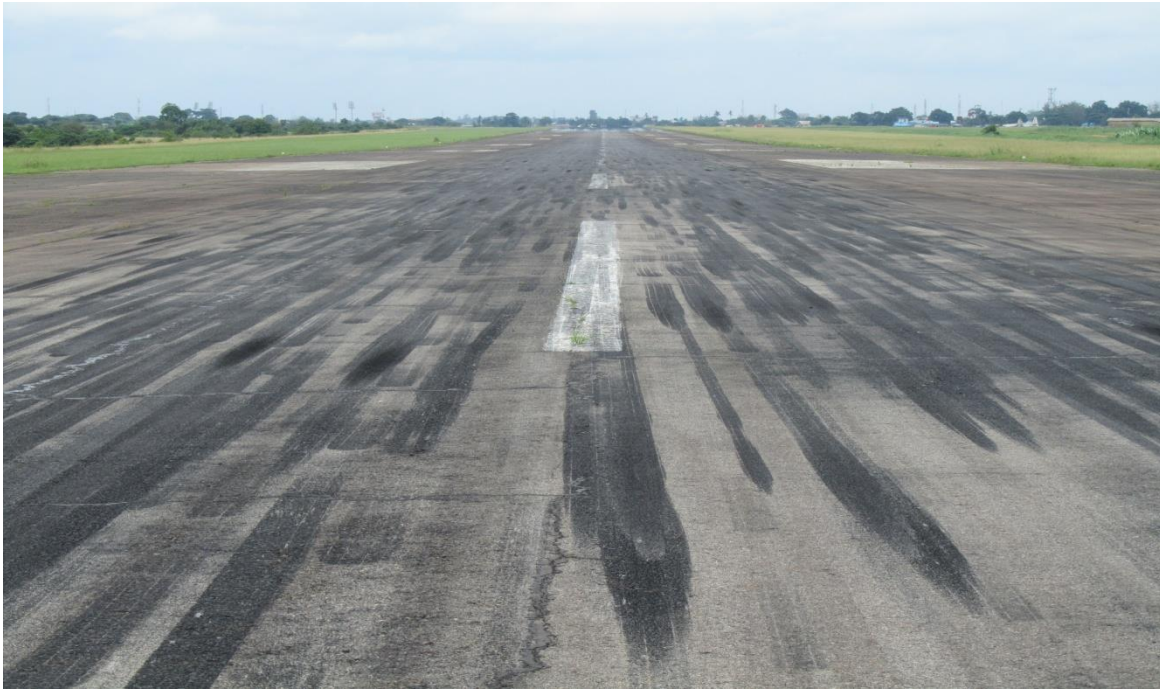
Figure 2: Rubberized touchdown zone of runway 05

The singular responsibility of installation and maintenance of the airport facilities rests with FAAN. During the investigation it was discovered that almost all the approach lights, runway edge lights and the ILS had been left unattended to and the runway surface left to deteriorate to an unsafe condition.

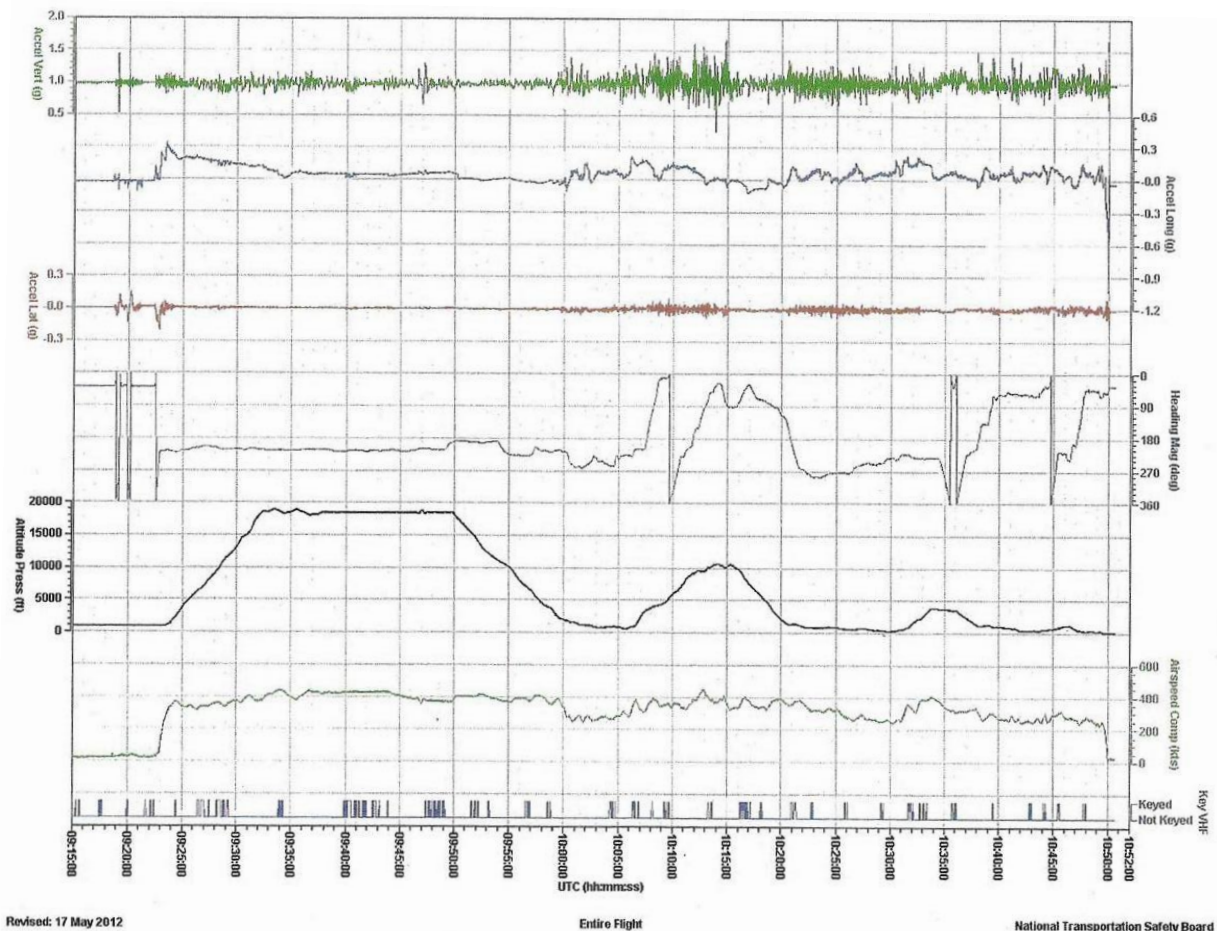
Figure 3: Plot of the entire flight from 09.15.00 to 10.50.38

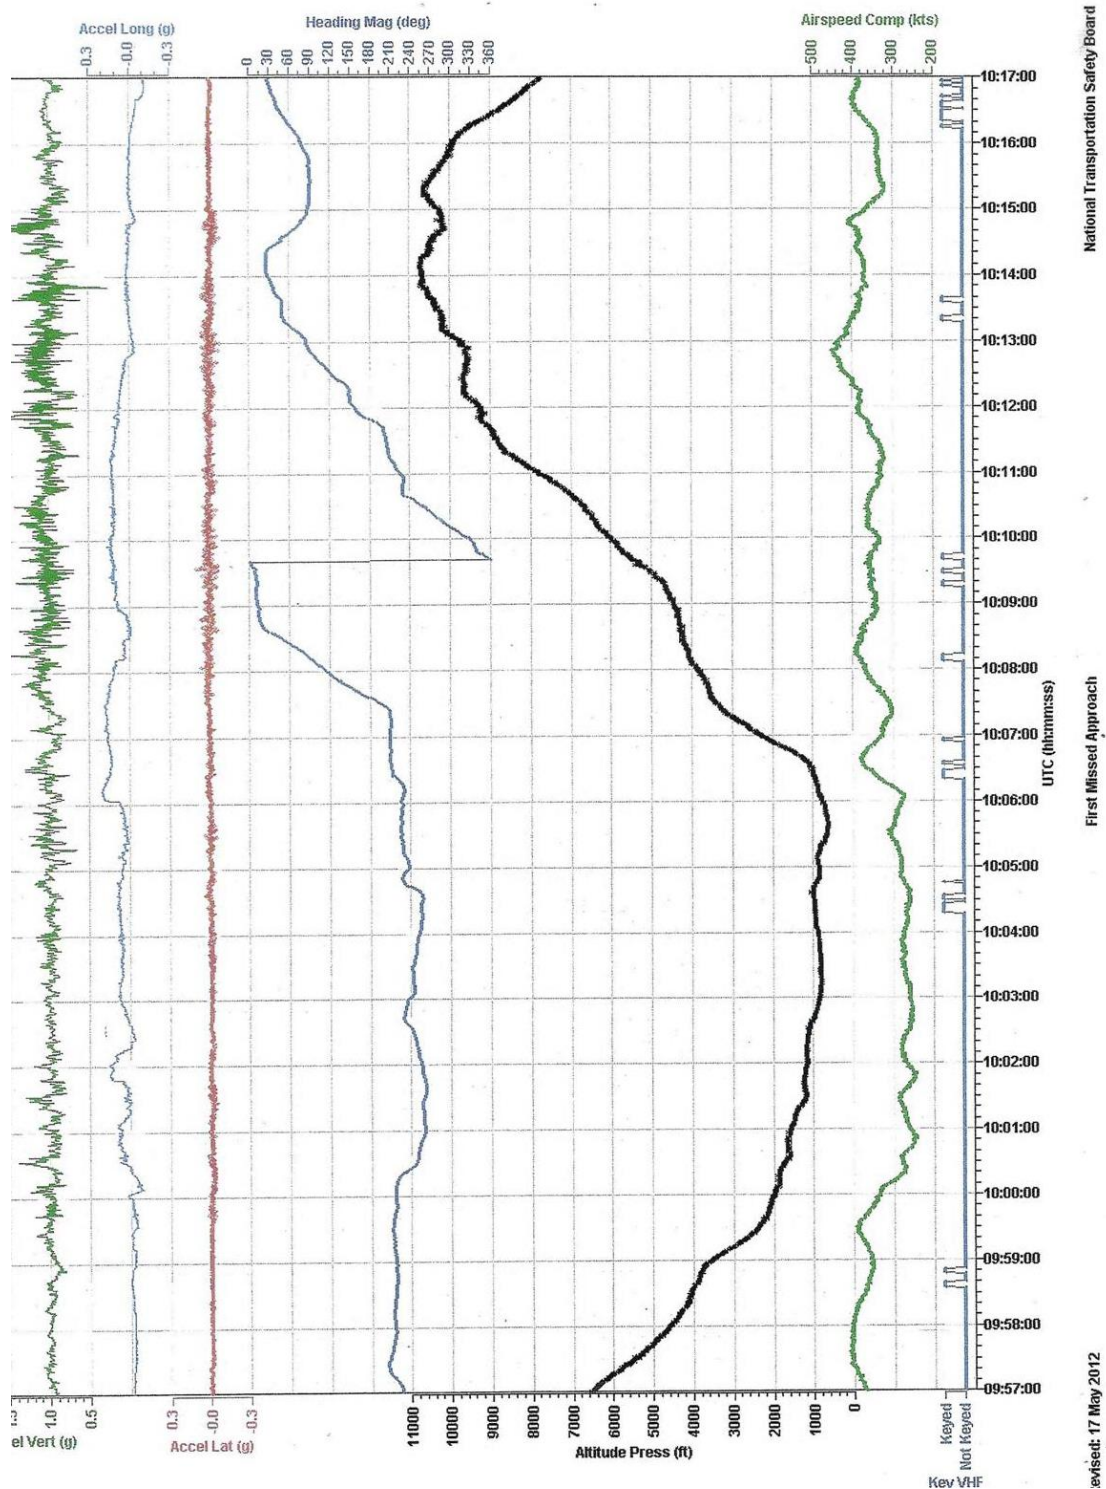
Figure 4: Plot of the first missed approach from 09.57.00 to 10.17.00

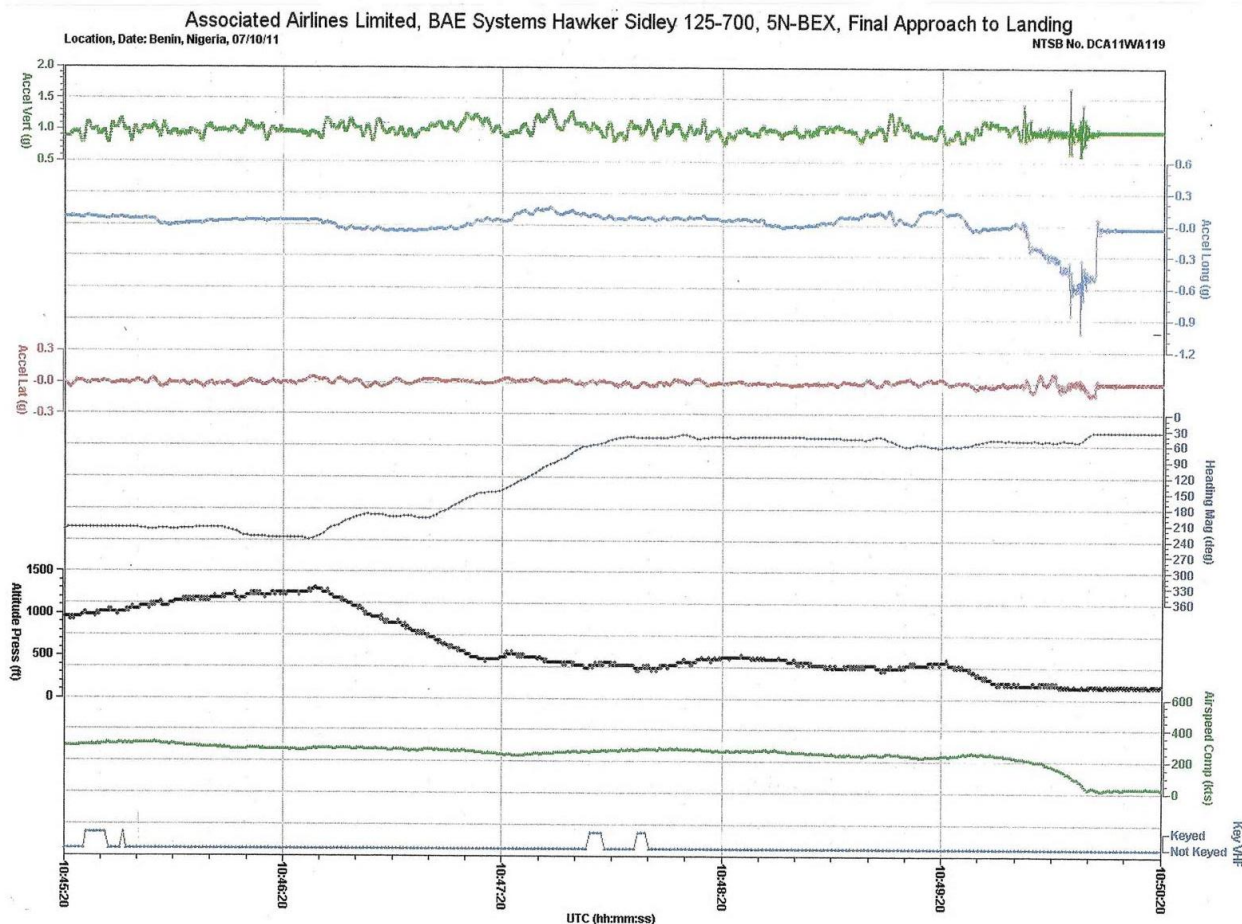
At 10.47.42, the recorded pressure altitude was 395 feet, and the computed airspeed was 212 kt with a magnetic heading of 45 degrees. This coincides with the time the aircraft crossed the threshold.

At 10.49.42, the acceleration data was consistent with touchdown, the computed airspeed was 212 kt and the magnetic heading was 51 degrees according to the FDR plot. The V_{ref} computed by the crew was 122 kt which represented about 90 kt below the computed airspeed provided by the FDR.

Figure 5: Plot of the final approach to landing from 10.45.20 to 10.50.20

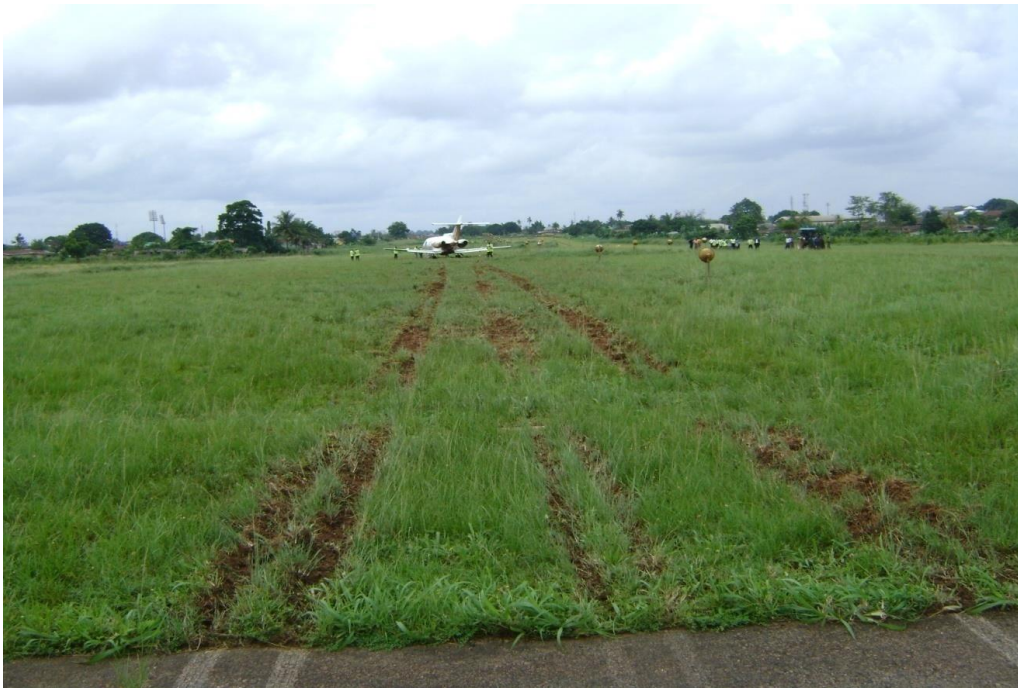
The aircraft was intact as it came to rest at about 450 ft from the threshold of Runway 23. There was no wreckage trail. The terrain surrounding the incident site was contaminated with aviation fuel that leaked from the right-wing tank. Grass and mud were found in the engine air intakes and the APU nacelle. Both rear wheels were embedded in the muddy field. The damage to the aircraft was as a result of impact forces with the approach light mountings and cables.

Figure 6: Final position of aircraft 450 ft from the edge of runway 23

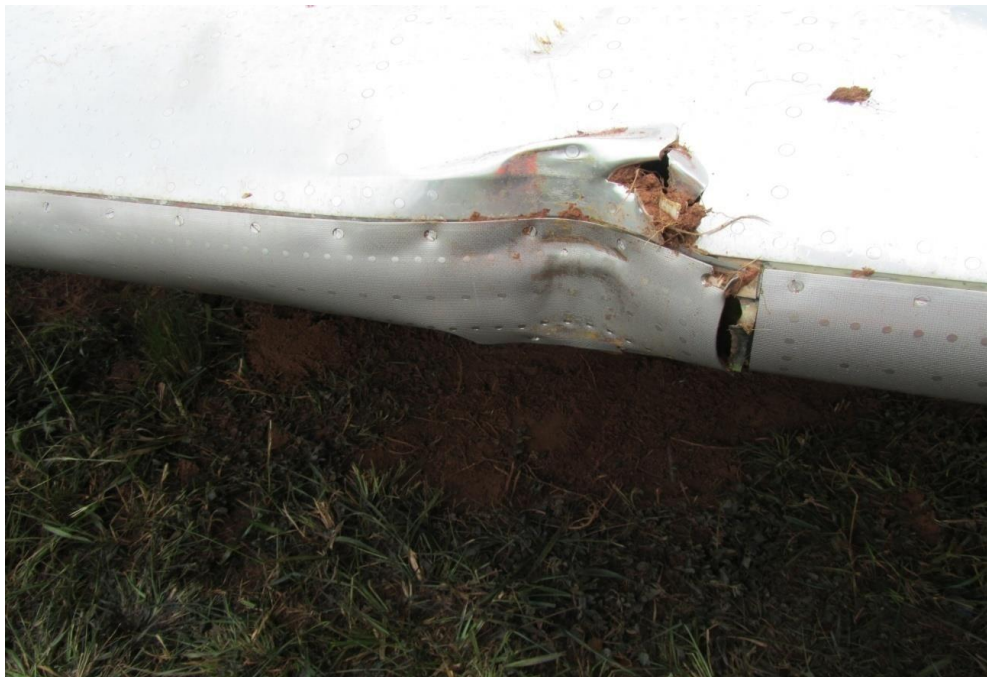
Figure 7: Right-wing leading edge damage

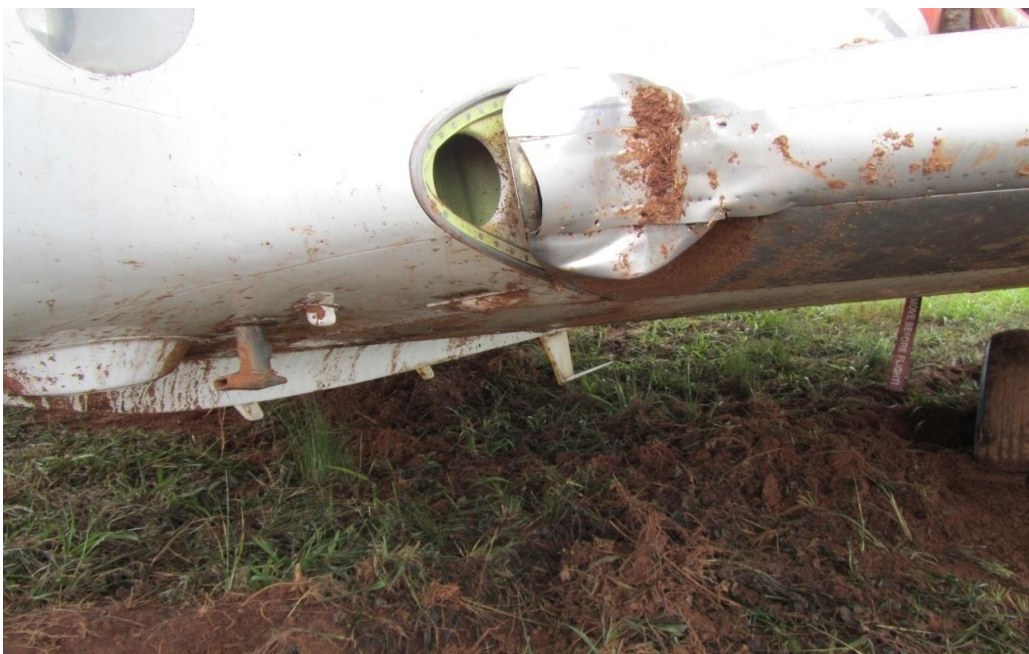
Figure 8: Damage to the right-wing leading edge at the wing root

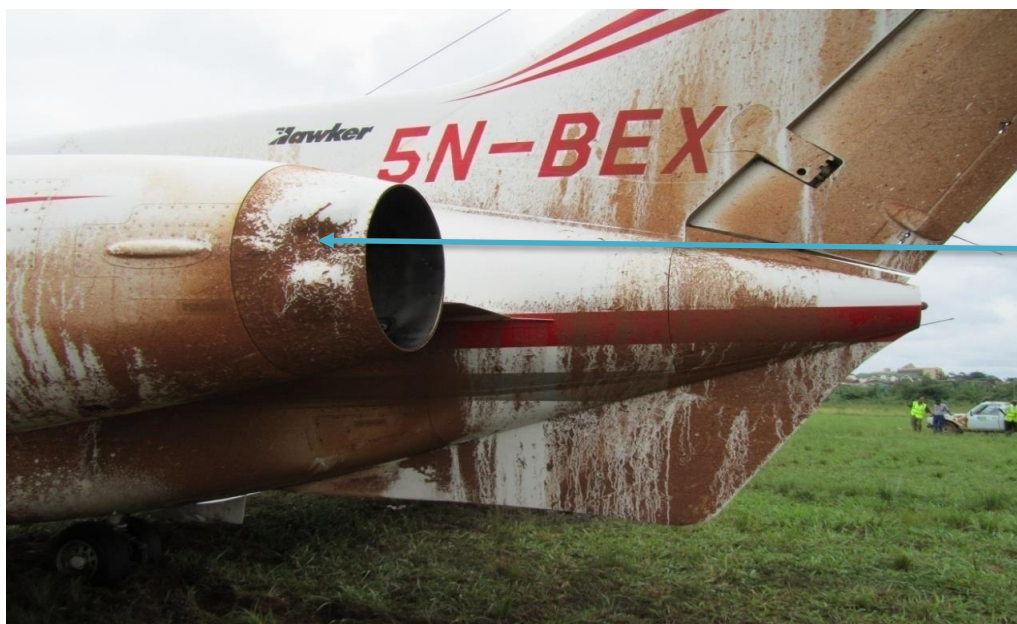
Figure 9: Dent of the No. 1 engine exhaust with mud splatter on the empennage of the aircraft

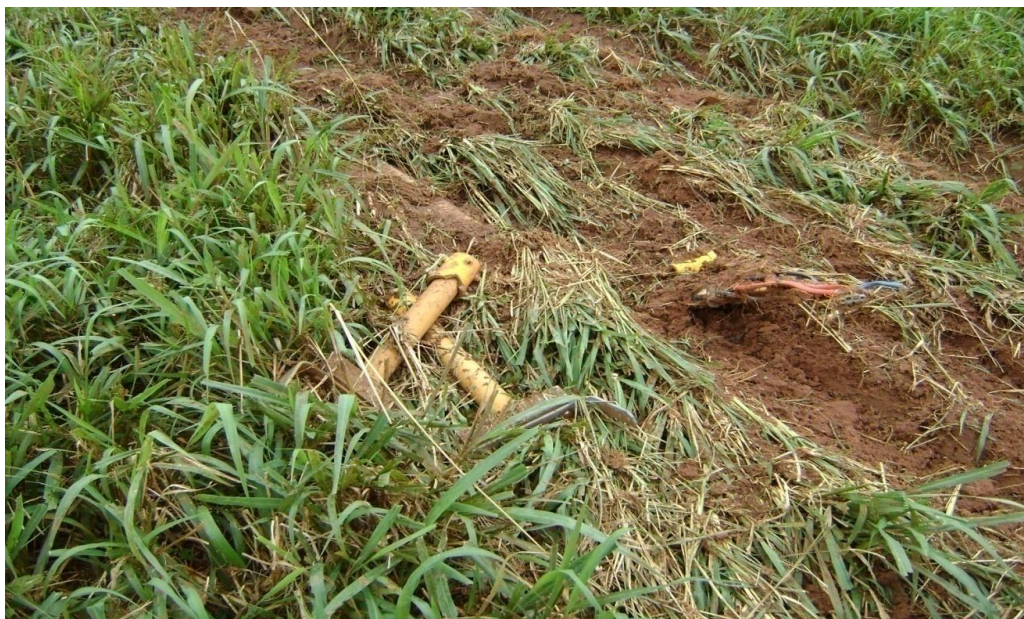
Three approach light assemblies were destroyed and the attached electrical armored cables pulled out and damaged. There was fuel leakage from the right fuel tank that contaminated the grass area.

Figure 10: Damage to the approach lights of runway 23

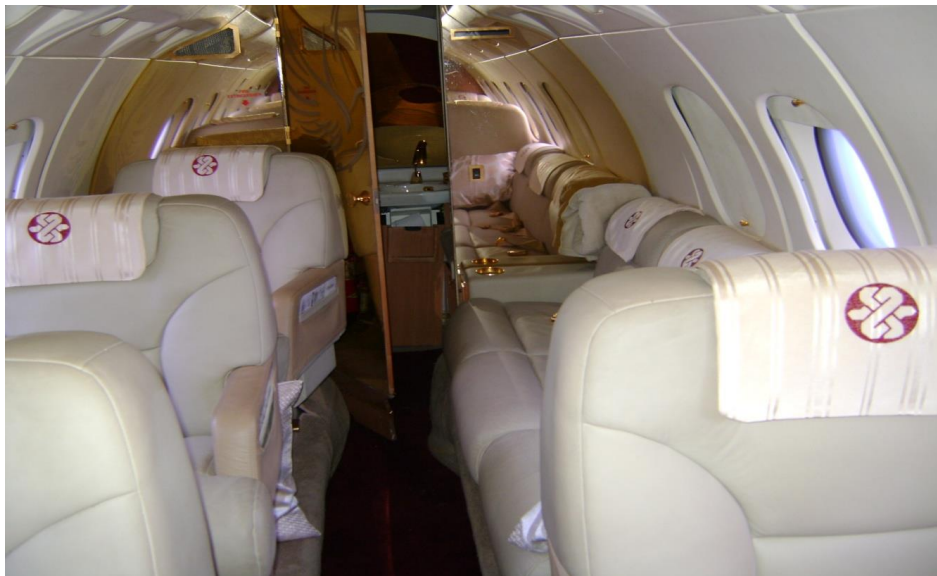
The aircraft remained intact when it came to a complete stop without failure of any structures in the cabin such as seats, seat belts and overhead bins. There was thus, sufficient liveable volume. The Airport Rescue and Fire Fighting Service personnel arrived the site within 5 minutes of the incident according to the ATC and some interviewed witnesses. The Emergency Locator Transmitter Centre in Abuja confirmed that the incident activated an emergency signal.

Figure 11: The passenger cabin section of the aircraft after the incident

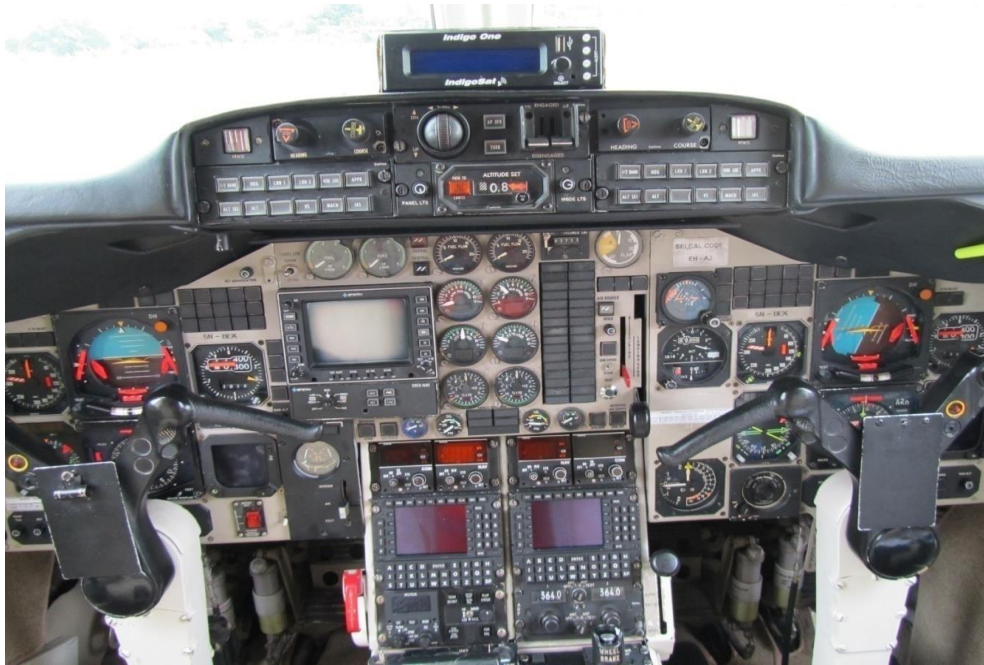
Figure 12: A cross-section of the cockpit instrument panel
