AIRCRAFT ACCIDENT REPORT

**Report on the Serious Incident involving an Airbus
330-343 aircraft operated by Turkish Airlines Inc. with
nationality and registration marks TC-LOL which
occurred at Port Harcourt Intl. Airport, Omagwa,
Rivers State, Nigeria
On 31st December 2019**

Aircraft accident report number: TURKISH/2019/12/31/F

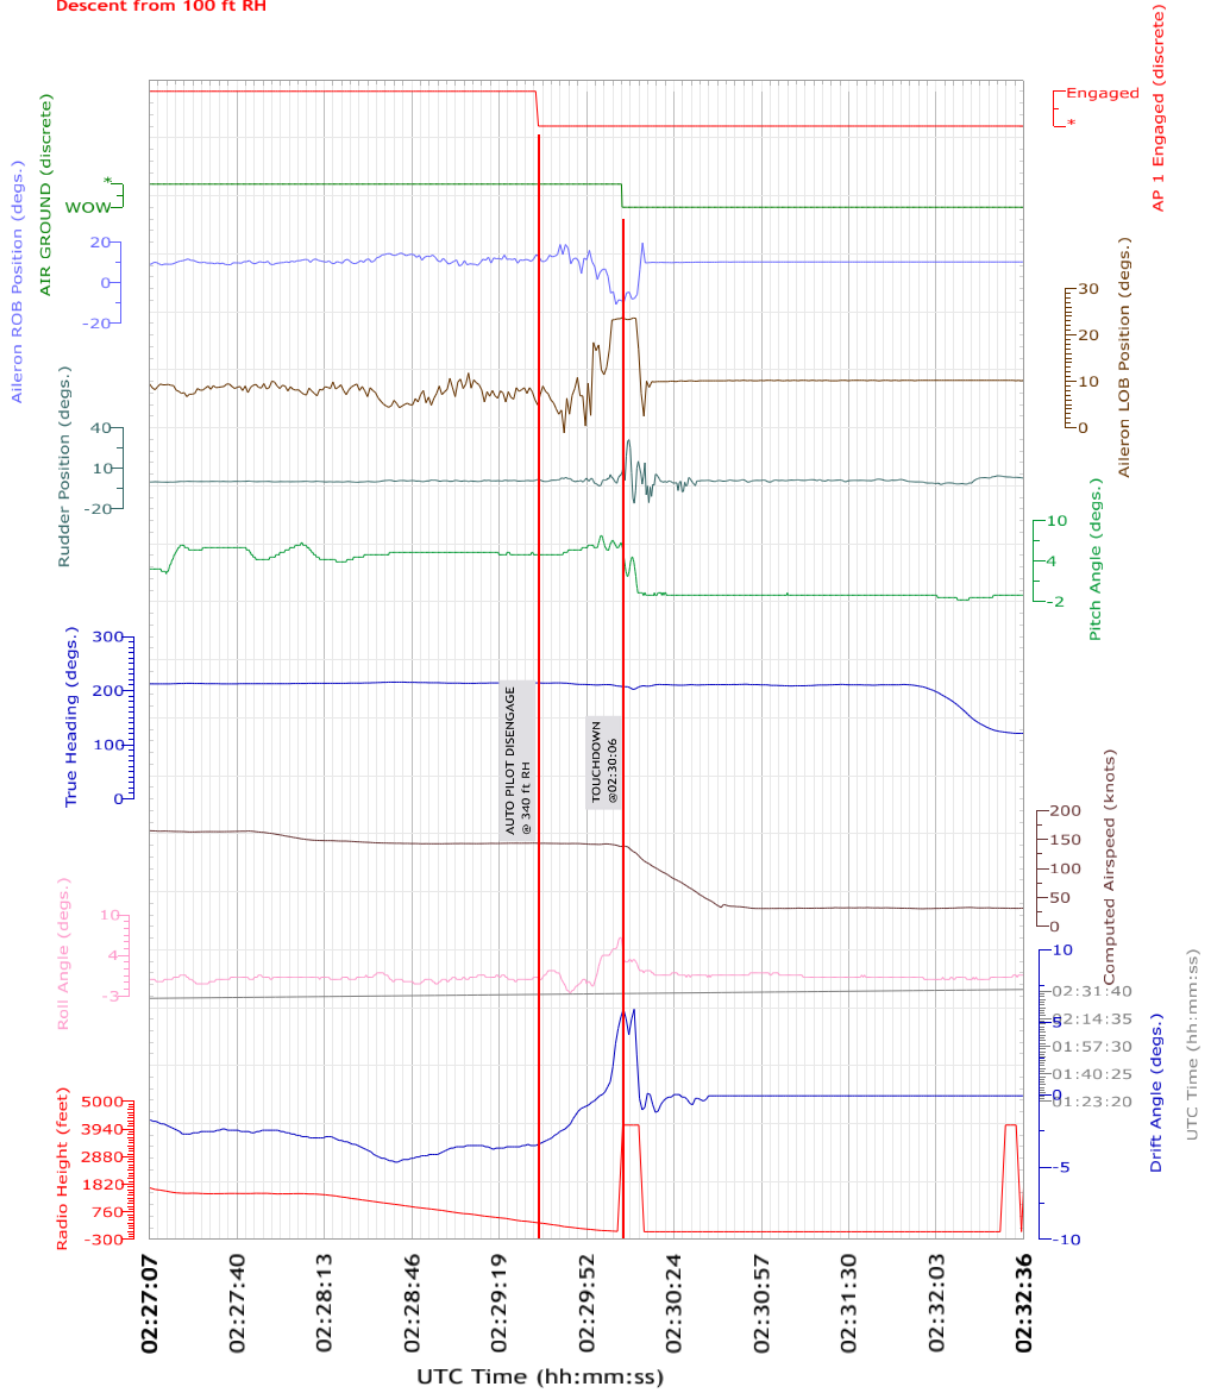
Figure 2: FDR data plot

AUTO PILOT was disengaged at 324 ft Radio Height.

WOW: Aircraft touched down at 02:30: UTC with a VERTICAL SPEED of 540 fpm, COMPUTED AIRSPEED of 138 knots, 6° PITCH, ROLL ANGLE was 7°.

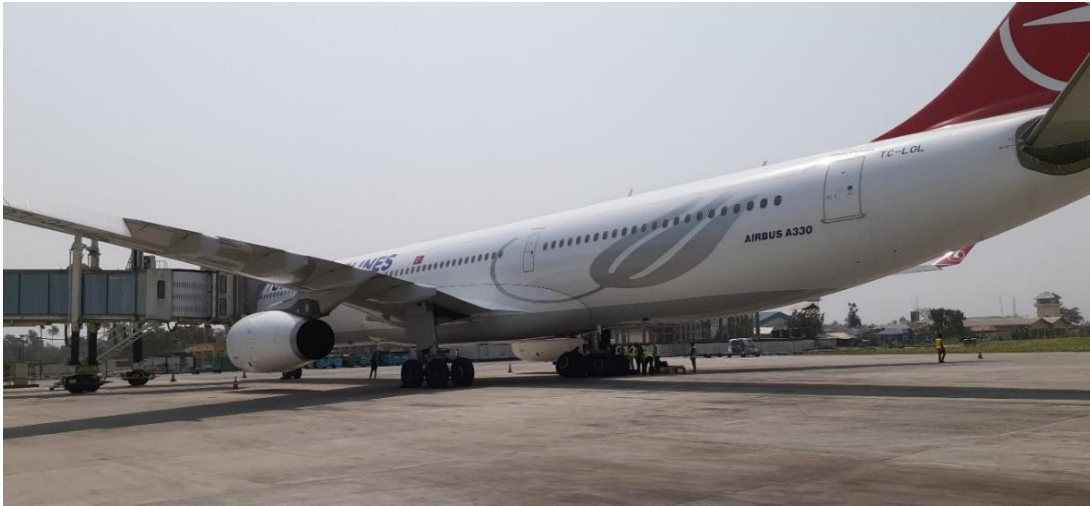
Figure 5: Photo of the aircraft parked at the apron after the occurrence

The aircraft was slightly damaged.

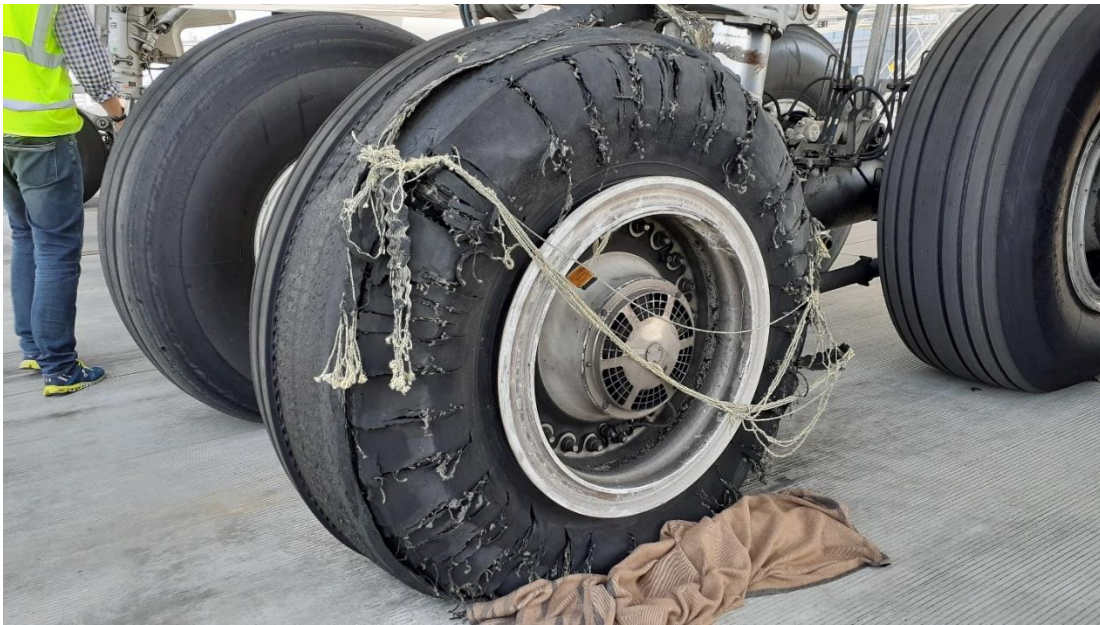
Figure 6: Photo of the No. 8 main wheel tyre

Nos. 3 and 7 main wheel tyres were scuffed. No. 8 Main wheel tyre was found deflated with shredded plies. The right inboard flap was dented on its lower surface. A dent was observed to the internal fan cowl of engine No. 2. Debris from the tyres was found on the runway.

At this time, the aircraft was then out of the runway with the right main landing gear on the right shoulder of the runway. During the lateral runway excursion, three runway edge lights were impacted and damaged. These runway edge lights have metal components which must have cut through the No. 8 main wheel which deflated the tyre.

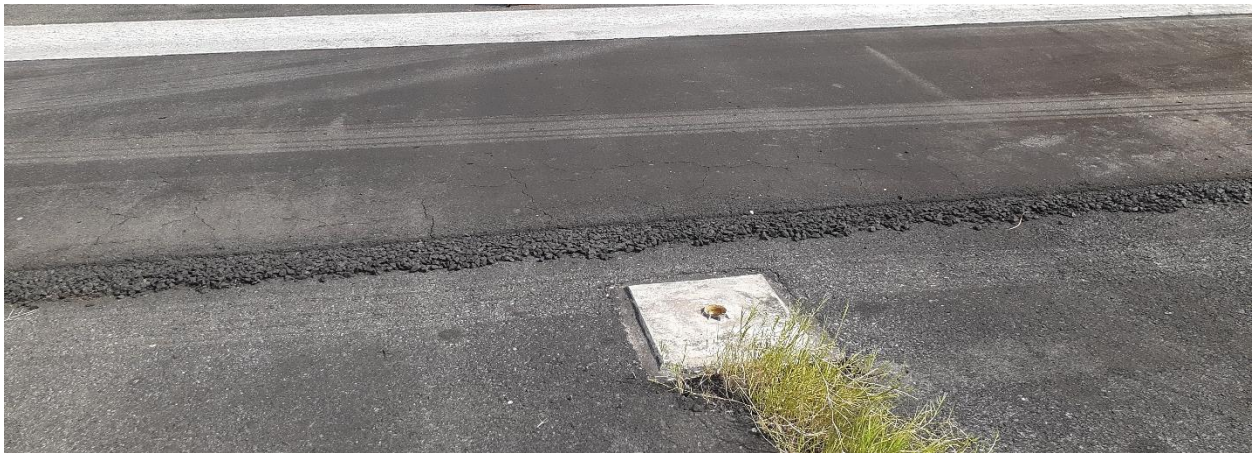
Figure 9: Photo of one of the damaged runway edge lights

Three runway edge lights were damaged.

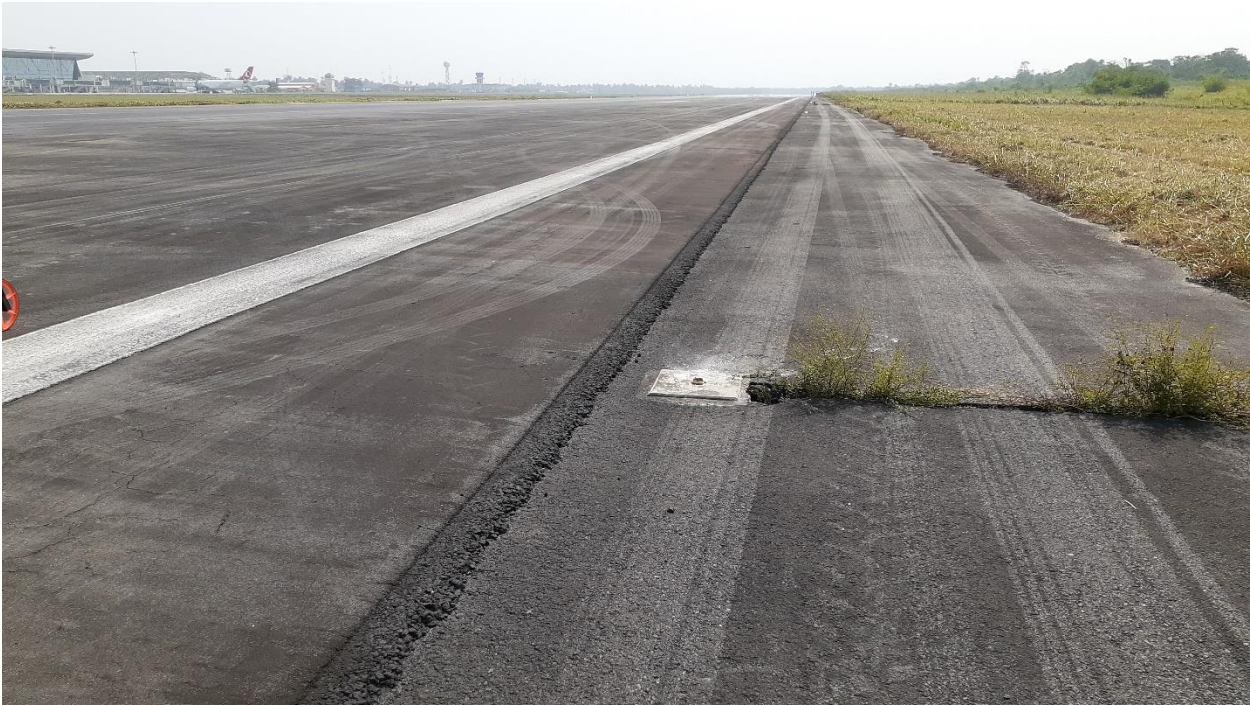
Figure 10: A photo of the tyre marks from the right main wheel tyres on the runway shoulder

Aircraft tyre marks found on the runway showed that the aircraft touched down right of the runway centreline, at about 612 m from the threshold. The right main wheel crossed the runway edge line onto the runway shoulder at about 27 m from the touchdown point, impacted and damaged three runway edge lights, and returned to the runway at a distance of about 1,037 m, from the threshold.

The tyre marks further indicated that the aircraft returned to the runway centreline at about 1,478 m from the threshold.
