AIB BULLETIN

NAF-CBN/2020/06/15-003

Accident Investigation Bureau

Bulletin on the ground collision incident involving a Central Bank of Nigeria (CBN) truck with registration number AKD 765 FK and Nigeria Air Force (NAF) Bell 412 helicopter with nationality and registration marks NAF 600 which occurred at the General Aviation Terminal (GAT) apron of Nnamdi Azikiwe International Airport, Abuja on 15th June, 2020.

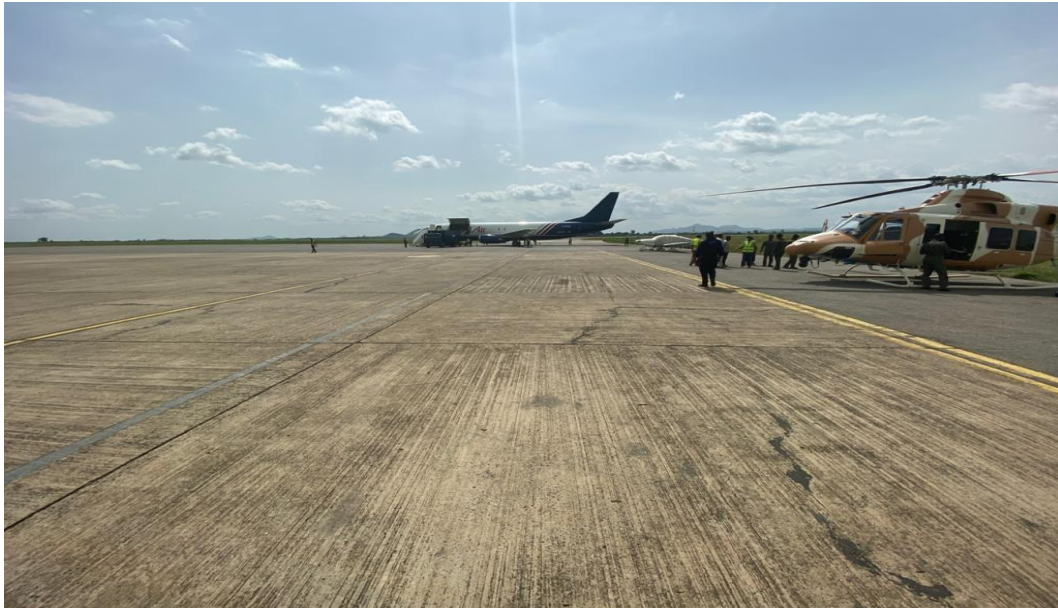
Figure 1: The relative positions of the NAF 600 and 5N-RKT

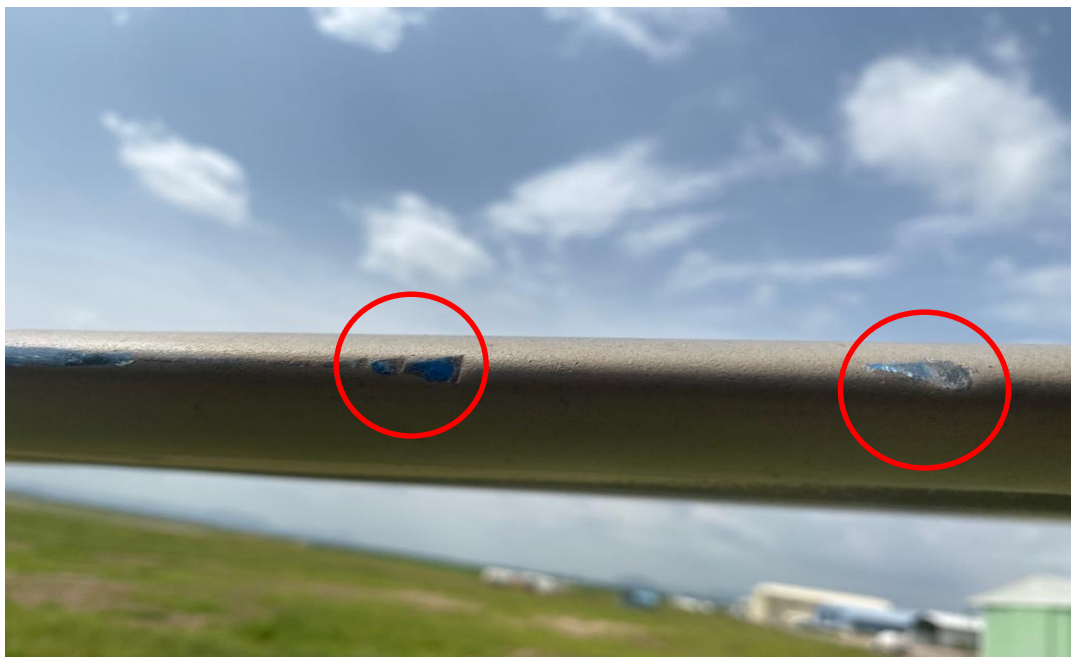
- i) Two nicks on the leading edge of one of the main rotor blades
- ii) Dent and cut on the truck trail container

According to the NAF 600 Co-pilot, he was on board the helicopter preparing the flight plan for the next mission, when he heard a bang; he looked up and saw the main rotor blades of NAF 600 helicopter rotating and the CBN truck moving away. Upon inspection, he noticed that the main rotor blades rotated to approximately 120° sweep angle in a clockwise direction (viewed from the cockpit). He further stated that he noticed two marks (dent and cut) on the leading edge of one of the main rotor blades.

Figure 2: Strike marks on the Helicopter Main rotor blade

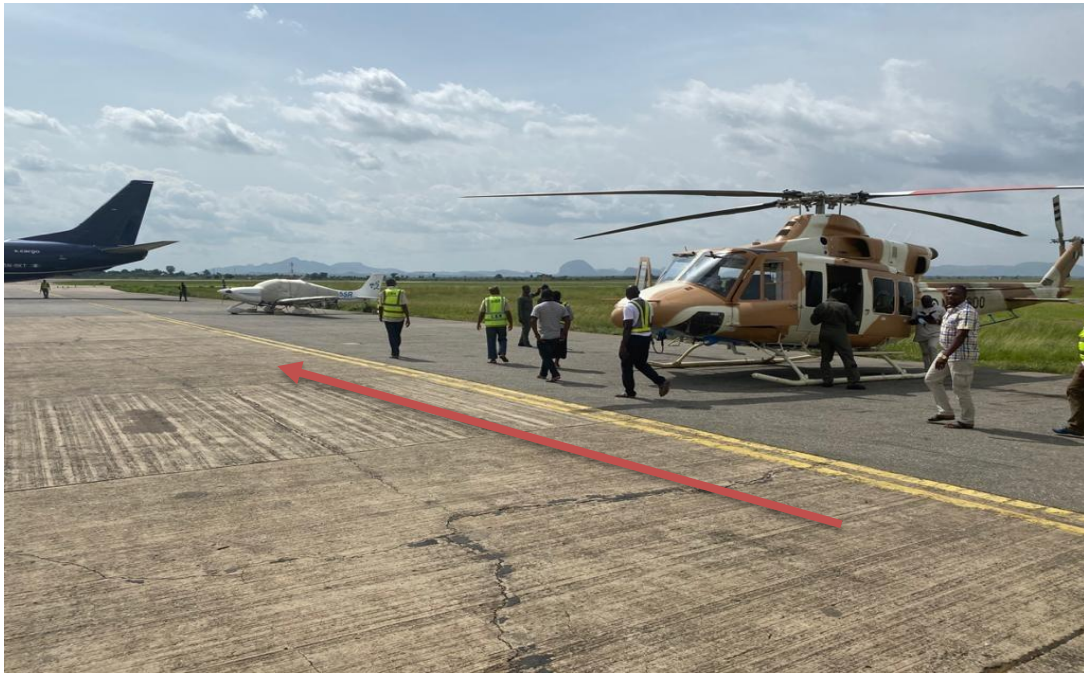
Figure 3: NAF600 on the ramp

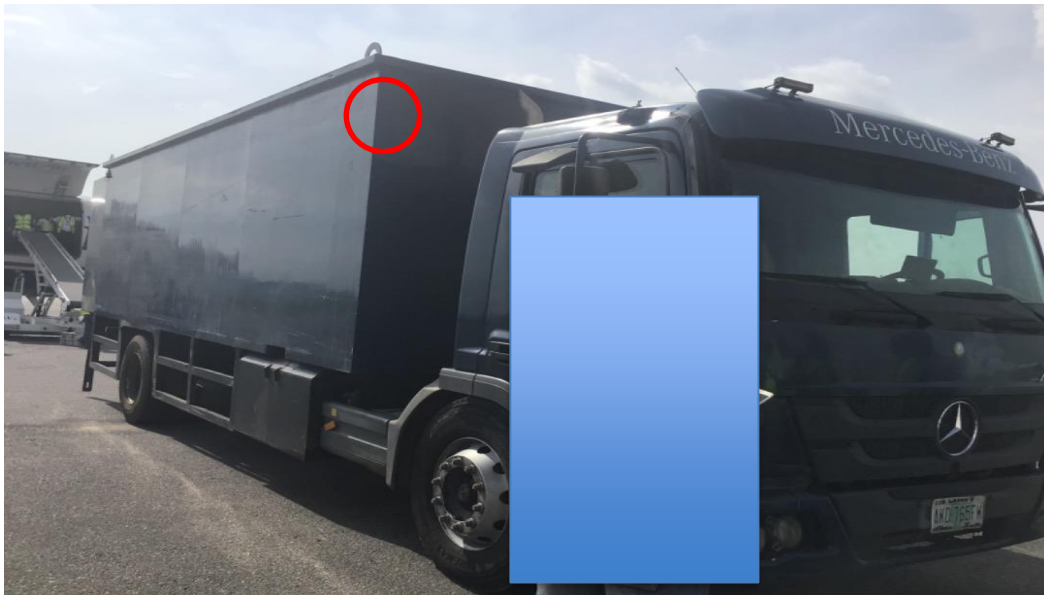
Figure 4: Side view of the CBN truck indicating the strike mark

The driver's misjudgment of the clearance between the truck and the helicopter main rotor blades.

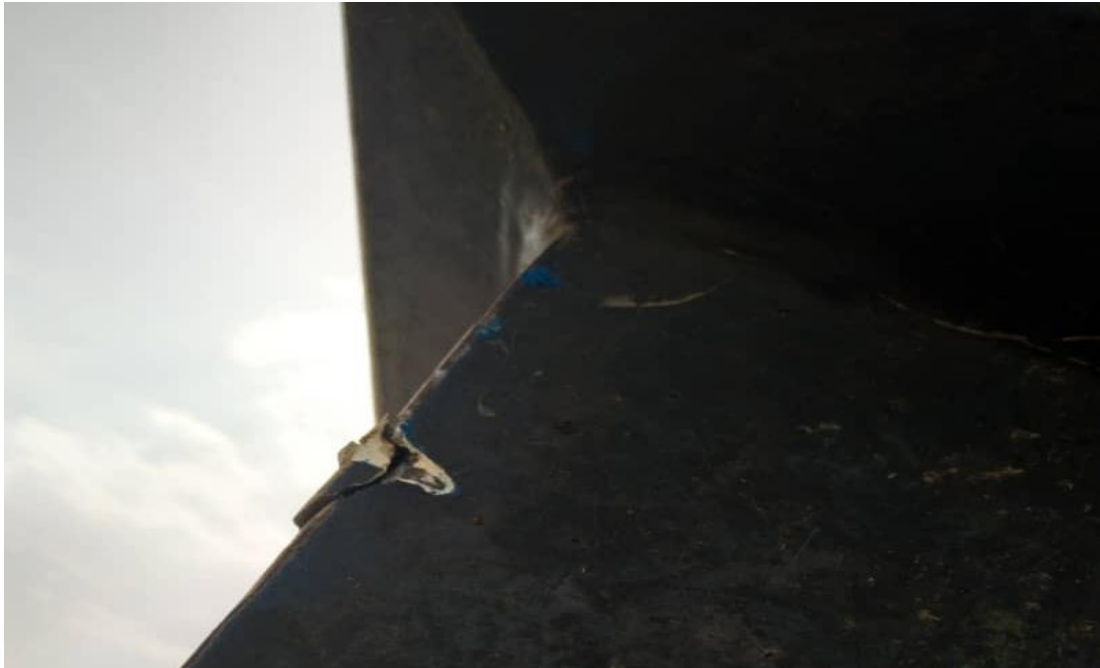
Figure 5: The point impact on the CBN truck

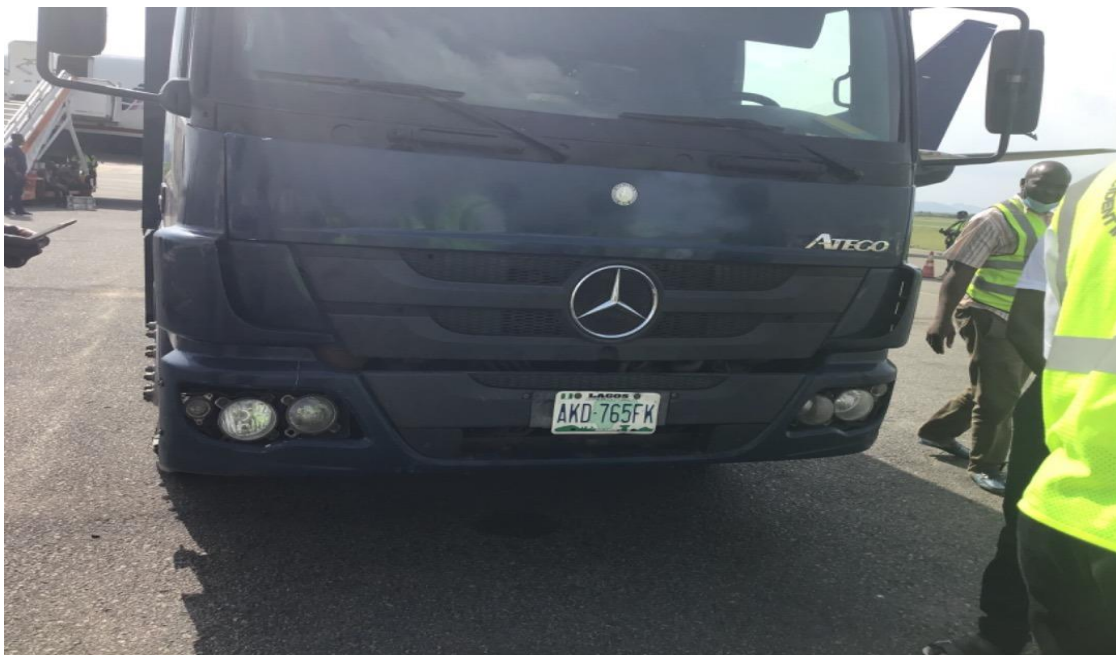
Figure 6: The front view of the CBN truck showing no apron access

Federal Airports Authority of Nigeria (FAAN) is responsible for training and approving any person driving on the airside. Such persons are trained to recognize surface markings and how to drive on the airside for safe operations. After successful completion of the drivers training course, the drivers are issued Airside Drivers' Permit and Apron Access Card. However, the CBN drivers had not undergone training on the driving techniques and rules of the airside. Also, neither the drivers nor the vehicles have the airside drivers and vehicles permit and apron access cards respectively.

Central Bank of Nigeria (CBN) should ensure that all CBN operated vehicles, equipment and personnel assigned to operate within or drive vehicles or access all Nigerian Airports are provided with appropriate Apron permit and access cards for identification and proper operational control at the airside of all Nigerian airports.
