# AIRCRAFT ACCIDENT REPORT

SEA/2018/10/04/F

**Final Report on the Accident involving Air Tractor AT-401B aircraft with nationality and registration marks 5N-BTV, operated by Skypower Express Airways Nigeria Limited, which occurred at Rukubi village 90 NM South-East of Abuja; Nigeria on 4th October, 2018.**

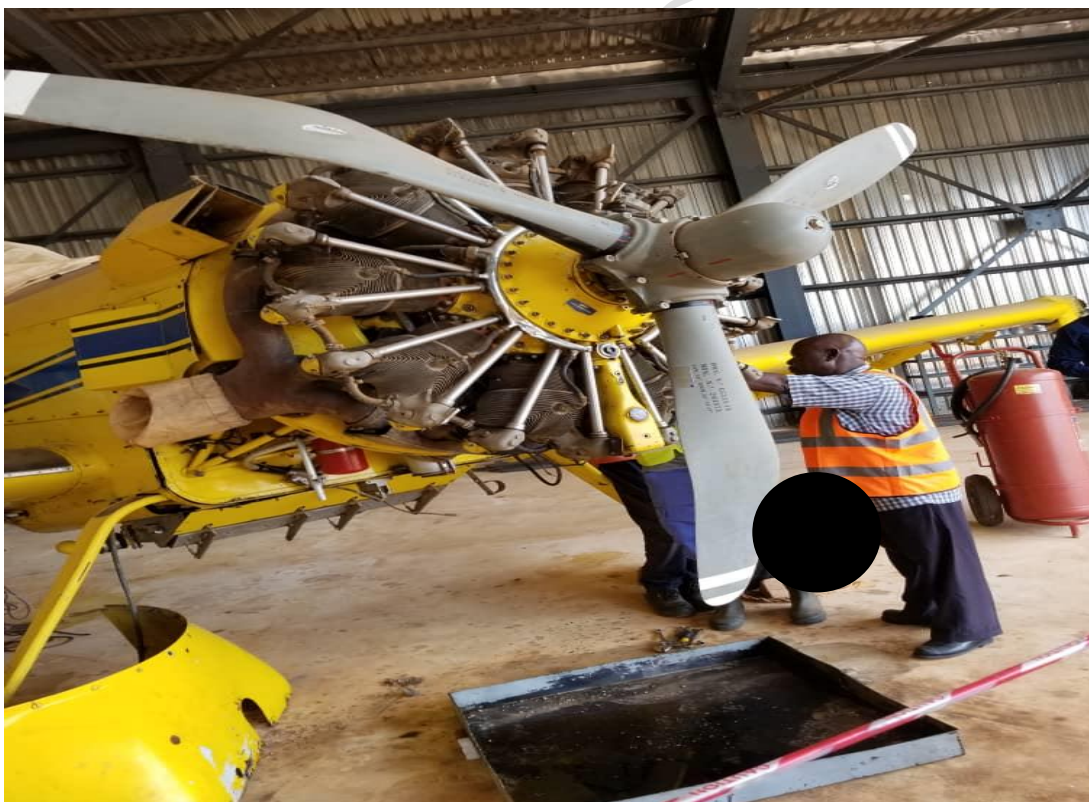
**Figure 3:** Propeller blade after the incident

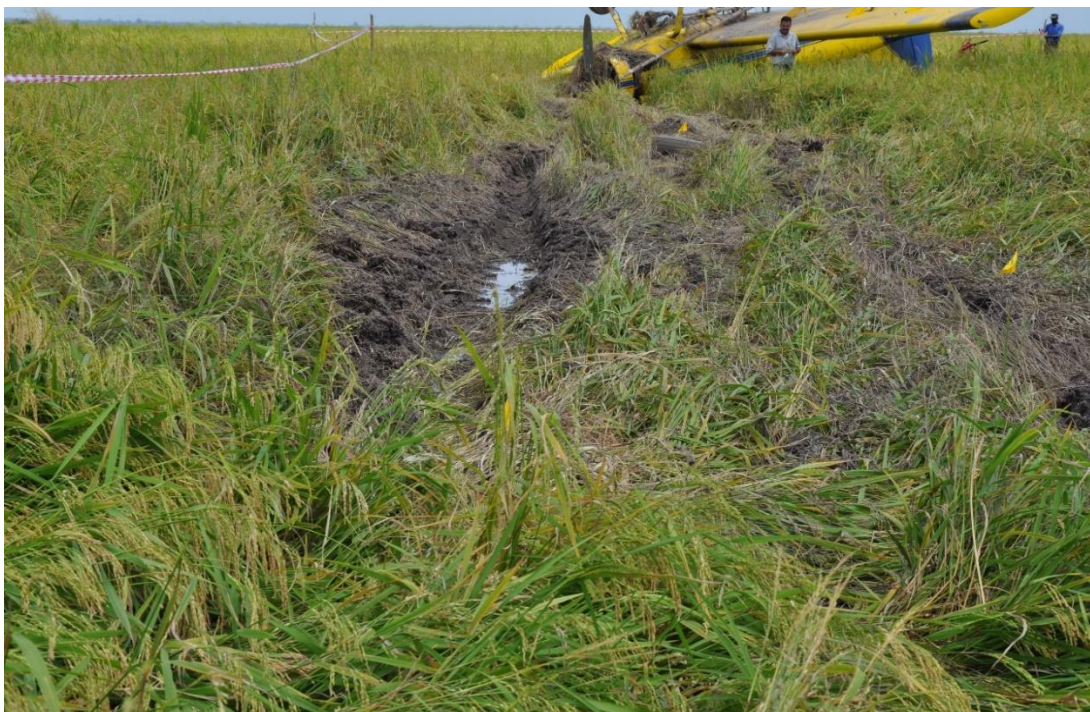
**Figure 4:** Propeller Blade Slash Marks

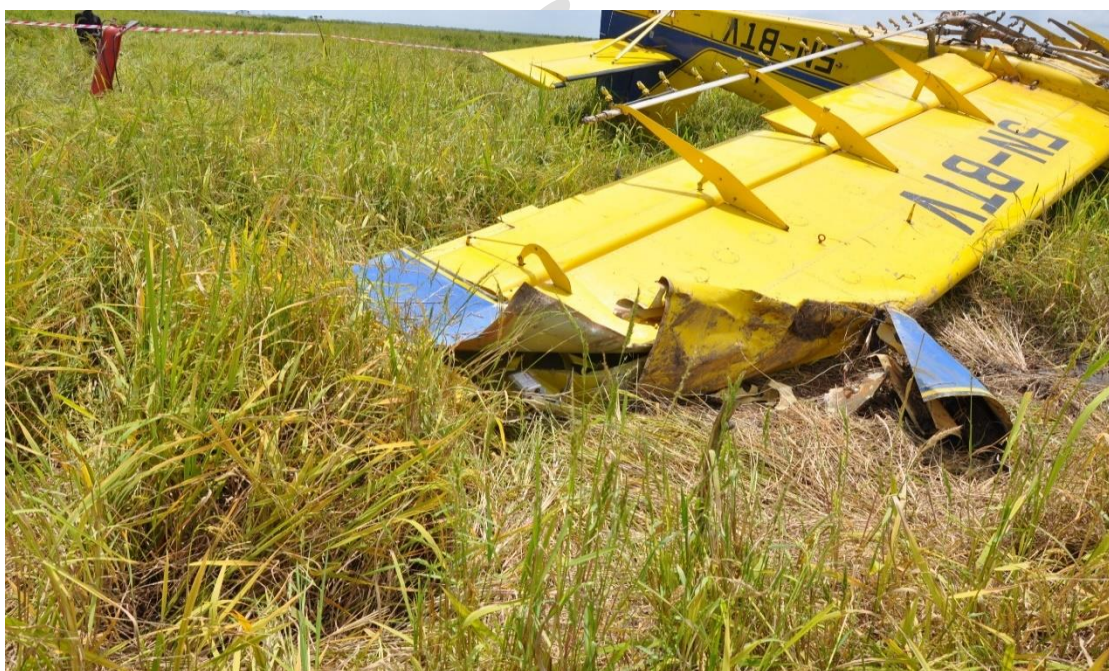
**Figure 5:** Damaged Left Wing Tip Leading Edge

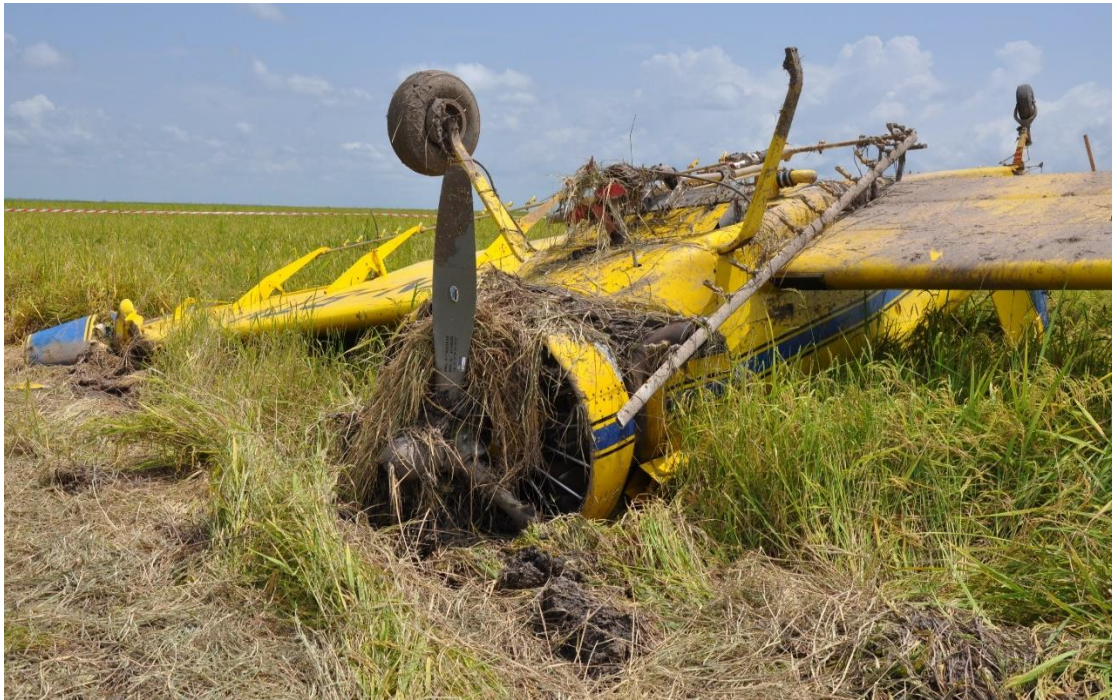
The aircraft impacted the ground in a marshy undulating rice farm designated as N803, 3.5 km to the airstrip, with the right main landing gear first, followed by the left main landing gear at about three meters from the point of first impact. The right main landing wheel broke off from its attachment seven meters from the point of impact and was found 24 meters from the first point of impact. A detached section of the spray boom was also located eight meters from the first point of impact. One of the propeller blades remained intact while the remaining two were bent rearwards. The left wing tip leading edge impacted the ground causing substantial damage to the wing. The aircraft flipped over, 38m from the first point of impact and remained generally intact. See Appendix 1: Olam Ondorie Nucleus Rice Farm.

**Figure 6:** The inverted aircraft at its final position

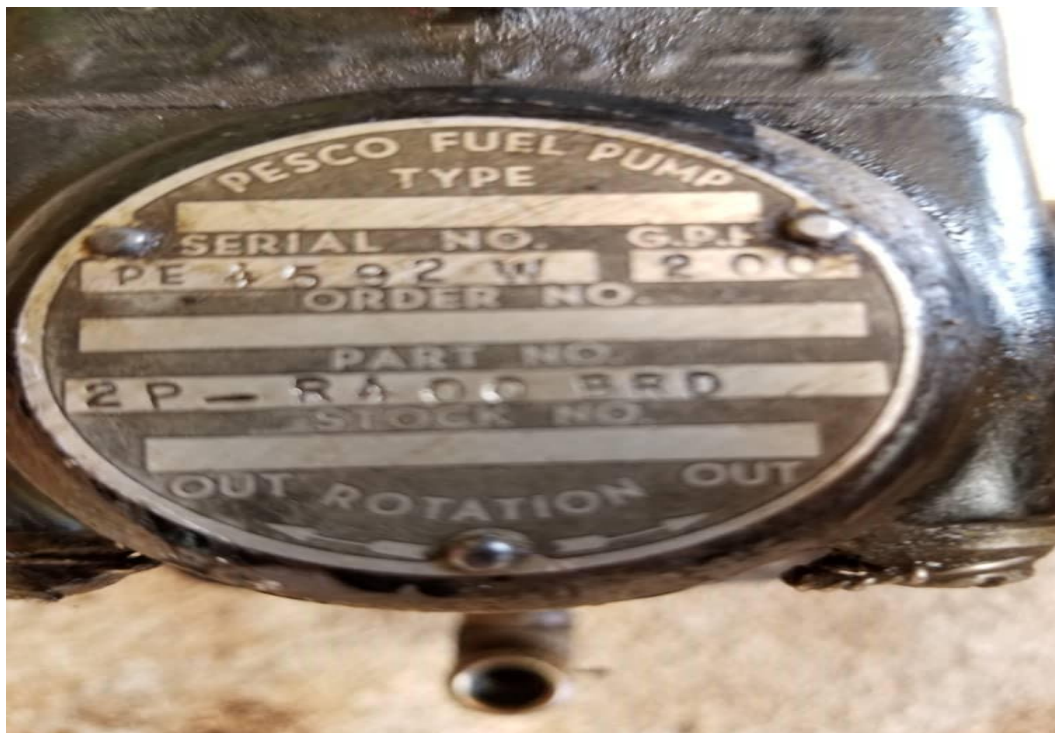
**Figure 7:** Fuel pump

Post-crash inspection of the engine was conducted by an authorised engineer in the presence of the investigating team. The accessories, bolts, wirelocks were found in place. The inlet and outlet lines of the fuel system were intact. The carburettor filters were removed, checked and found to be clean and dry. Also, the engine-driven fuel pump was removed and inspected. In an attempt to rotate the fuel pump shaft, it was found to be stiff.

During the post-crash inspection, the engine driven fuel pump was removed and inspected. In an attempt to rotate the fuel pump shaft, it was found to be stiff. This stiffness might have prevented the fuel pump from supplying sufficient fuel into the carburetor, starving the engine of fuel and resulting in loss of power. At the time of this investigation, further engine examination is yet to be conducted to ascertain the actual cause of the engine failure.

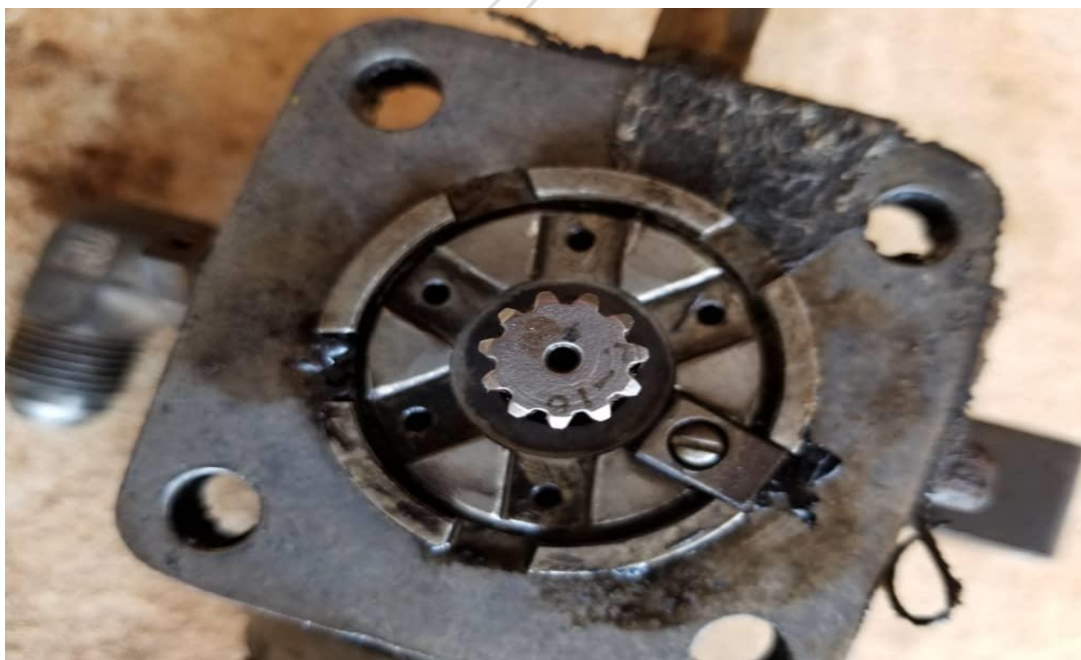
**Figure 8:** Fuel pump showing the spline and drive shaft
