Preliminary Report on the Serious Incident involving Embraer 145LR aircraft with nationality and registration marks 5N-BWW operated by United Nigeria Airlines Limited which occurred at about 4,000 feet climbing out of Nnamdi Azikiwe International Airport, Abuja Nigeria on 17th November, 2021.

Registered owner:	Private Airlines Services Limited
Operator:	United Nigeria Airlines Company Limited
Aircraft type and model:	EMB-145LR
Manufacturer:	Yabora Industria Aeronautica S.A
Year of manufacture:	2002
Nationality and registration marks:	5N-BWW
Serial number:	145553
Location:	About 4,000 feet climbing out of Nnamdi Azikiwe International Airport, Abuja
Date and Time:	17th November, 2021 at about 08:43 h <i>(All times in this report are local time, equivalent to UTC+1 unless otherwise stated)</i>

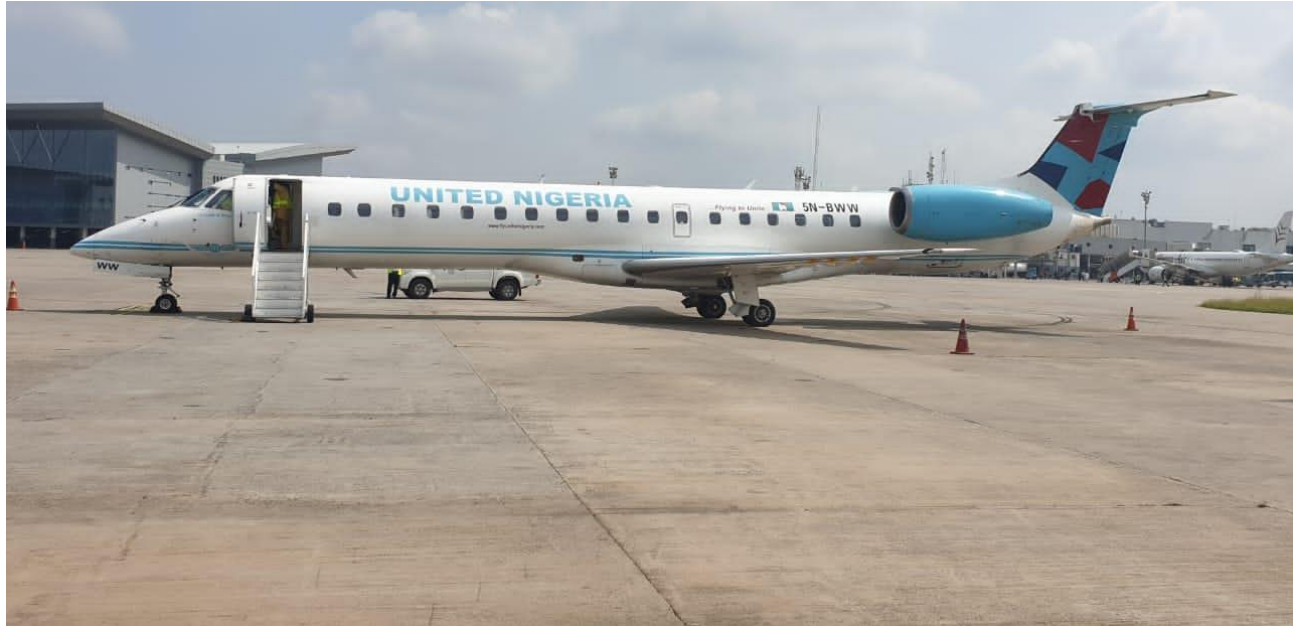
Figure 1: The aircraft parked at Apron of Nnamdi Azikiwe International Airport after the incidence
