**Preliminary Report on the Serious Incident involving Embraer 145LR aircraft with nationality and registration marks 5N-BWW operated by United Nigeria Airlines Limited which occurred at about 4,000 feet climbing out of Nnamdi Azikiwe International Airport, Abuja Nigeria on 17th November, 2021.**

<b>Registered owner:</b>	Private Airlines Services Limited
<b>Operator:</b>	United Nigeria Airlines Company Limited
<b>Aircraft type and model:</b>	EMB-145LR
<b>Manufacturer:</b>	Yabora Industria Aeronautica S.A
<b>Year of manufacture:</b>	2002
<b>Nationality and registration marks:</b>	5N-BWW
<b>Serial number:</b>	145553
<b>Location:</b>	About 4,000 feet climbing out of Nnamdi Azikiwe International Airport, Abuja
<b>Date and Time:</b>	17th November, 2021 at about 08:43 h <i>(All times in this report are local time, equivalent to UTC+1 unless otherwise stated)</i>

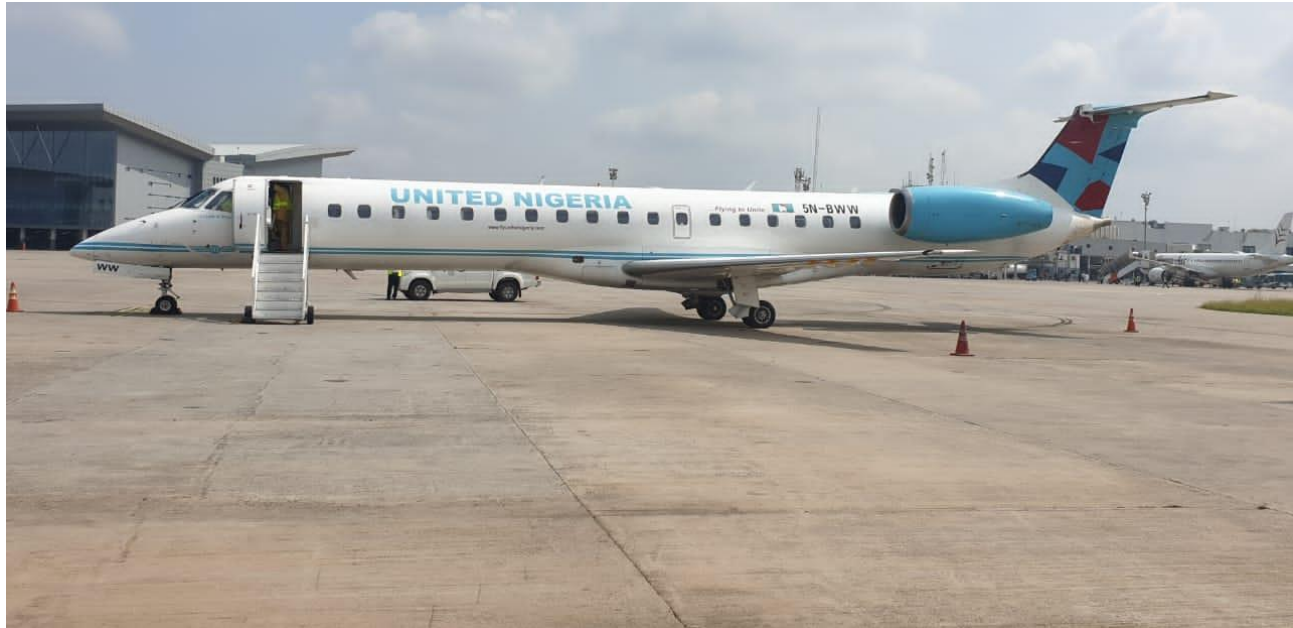
**Figure 1:** The aircraft parked at Apron of Nnamdi Azikiwe International Airport after the incidence
