Preliminary Report on the serious incident involving a Boeing 737-300 aircraft owned and operated by Air Peace Limited with nationality and registration marks 5N-BUQ which occurred After Take-Off from Sam Mbakwe Airport, Owerri Enroute Lagos on 22nd November, 2021

| Nationality and registration marks: | 5N-BUQ |
| Date and time: | 22nd November, 2021 at about 17:57 h |

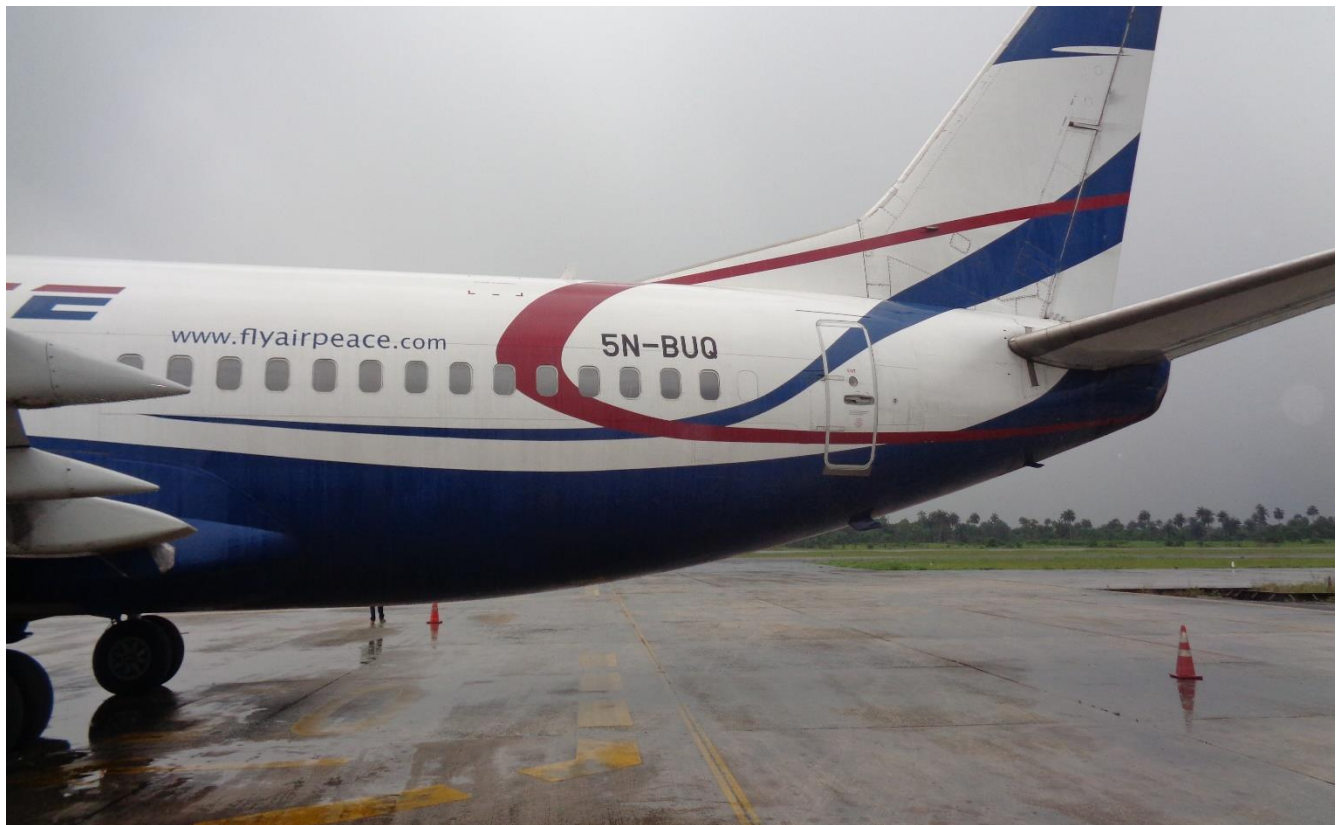
Photo showing the aircraft on ground Port Harcourt airport after the occurrence.
