AIRCRAFT ACCIDENT REPORT

MAL/2019/09/07/F

**Final Report on the serious incident involving a Boeing
747-400 aircraft with nationality and registration
marks 5N-DBK operated by Max Air Limited which
occurred at Minna Airport; Nigeria on 7th
September, 2019**

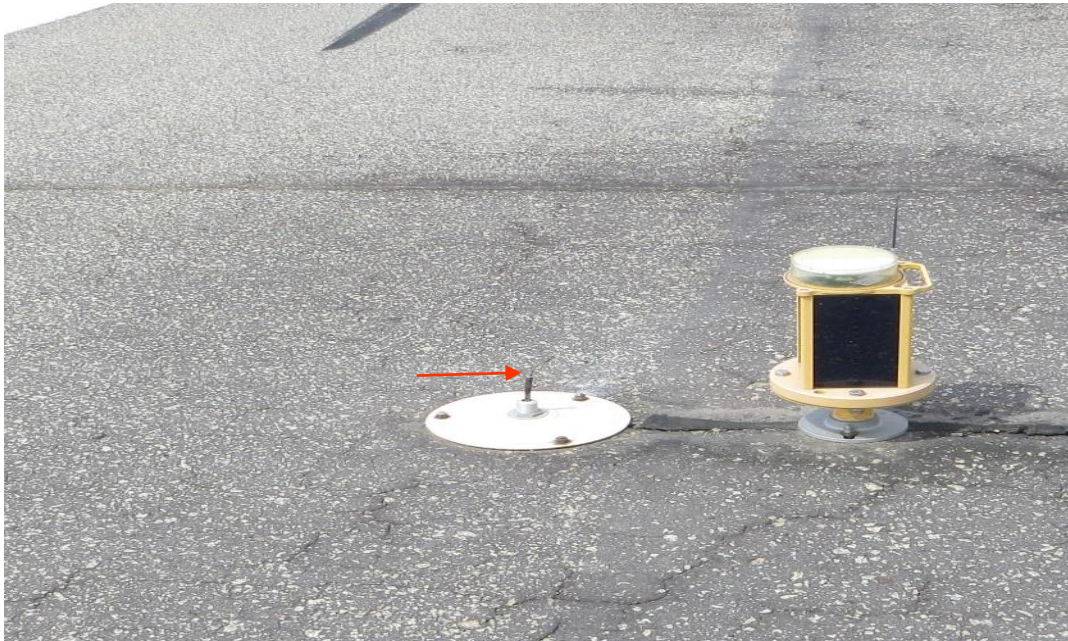
One runway edge light was damaged.

Figure 2: Damaged runway edge light

13. One runway edge light was damaged.
14. There was evidence of bird strike at the edge of the lower part of the radome.
15. Minna Airport does not have an approved Aerodrome Manual.

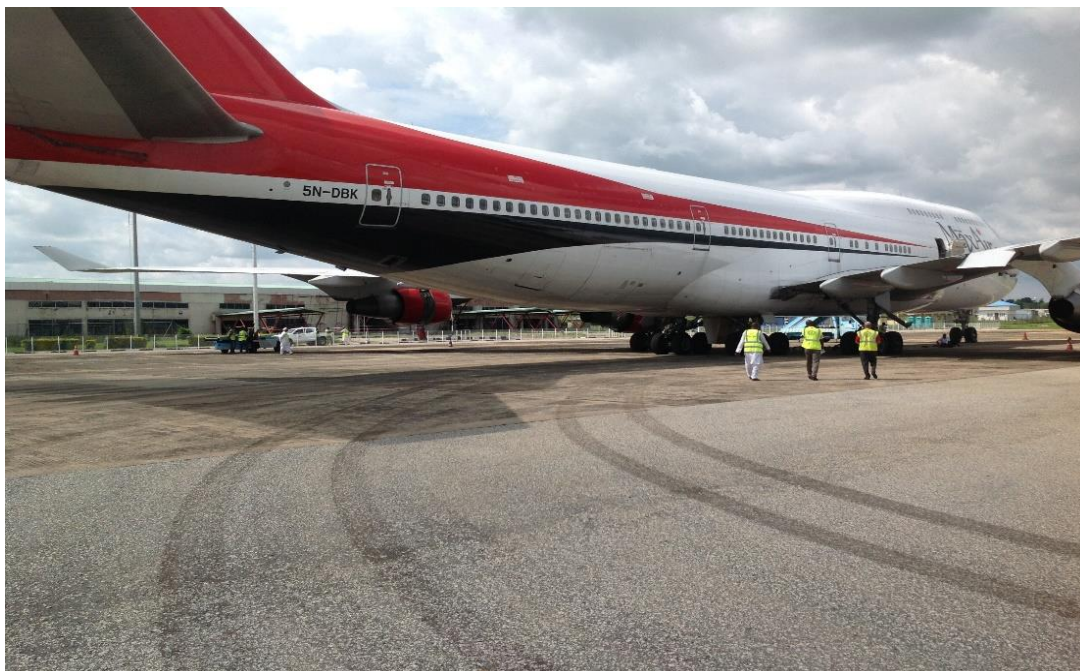
Figure 3: 5N-DBK parked at the Apron after the incident

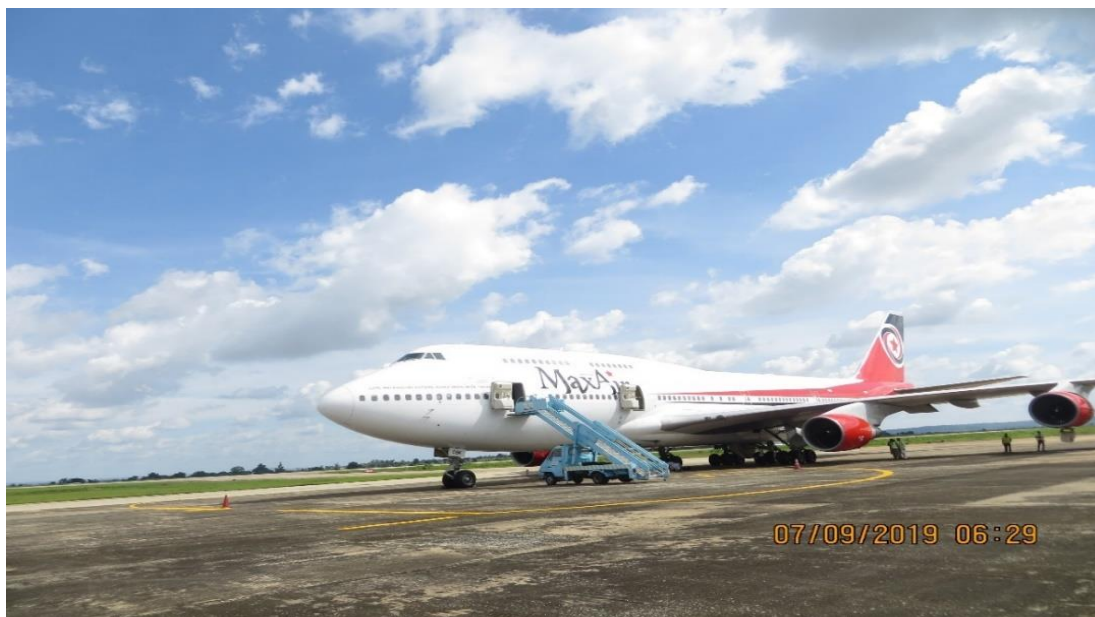
Figure 4: The aircraft after disembarkation

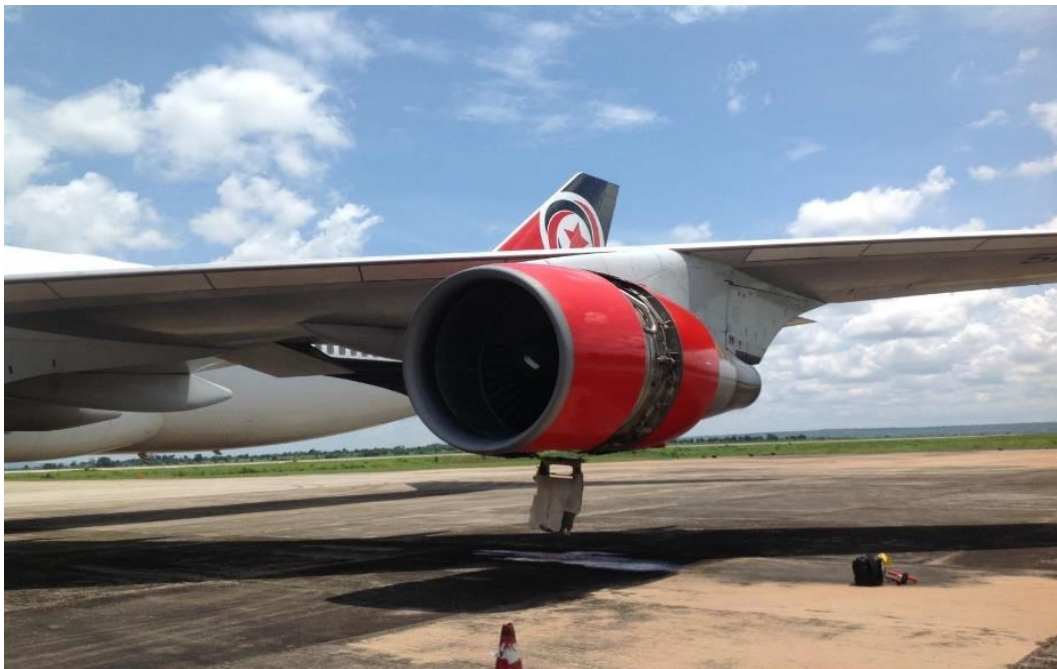
Physical examination of the aircraft revealed that the lower surface of the nacelle was abraded, thereby releasing the cowl latches resulting in the fan cowls being blown-off the engine.

1. Damage to the lower intake of number one engine
2. Damage to fan cowl (left and right) on number one engine
3. Damage to thrust reverser cowl on number one engine
4. Torn fairing on the left wing
5. Damage to transfer tube between angle gear box and main gear box
6. Evidence of bird strike on the lower part of the radome

Figure 11: Damaged cowling of engine number one

11. The aircraft was steered to the centre line after touchdown.
12. The aircraft sustained damage to the number one engine, its fan and reverser cowlings.

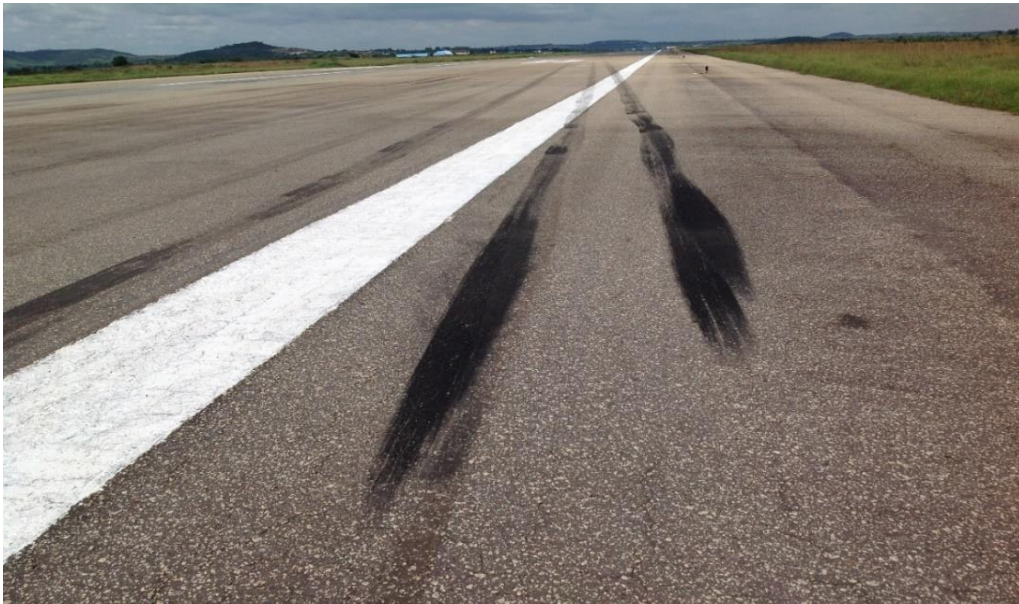
The aircraft crossed the threshold right of the centerline in a left bank, the left main wheels touched down, the number one engine nacelle impacted the runway on the center line, 203 m from the threshold, and was dragged on the runway along the center line for approximately 44 m as the aircraft was steered to the center line.

Figure 12: Tyre marks indicating the touchdown point

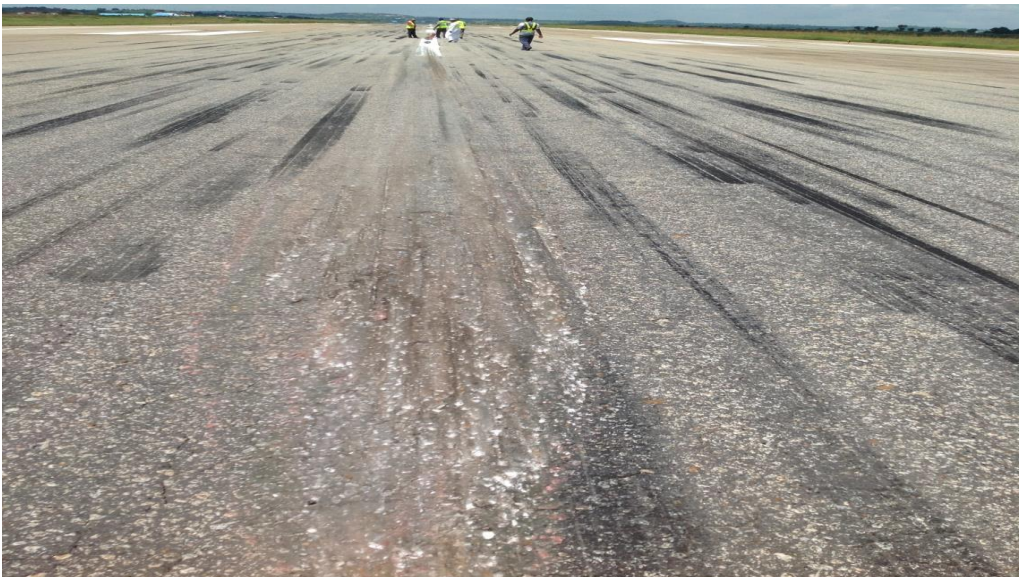
Figure 13: Number one engine nacelle impact point on the runway

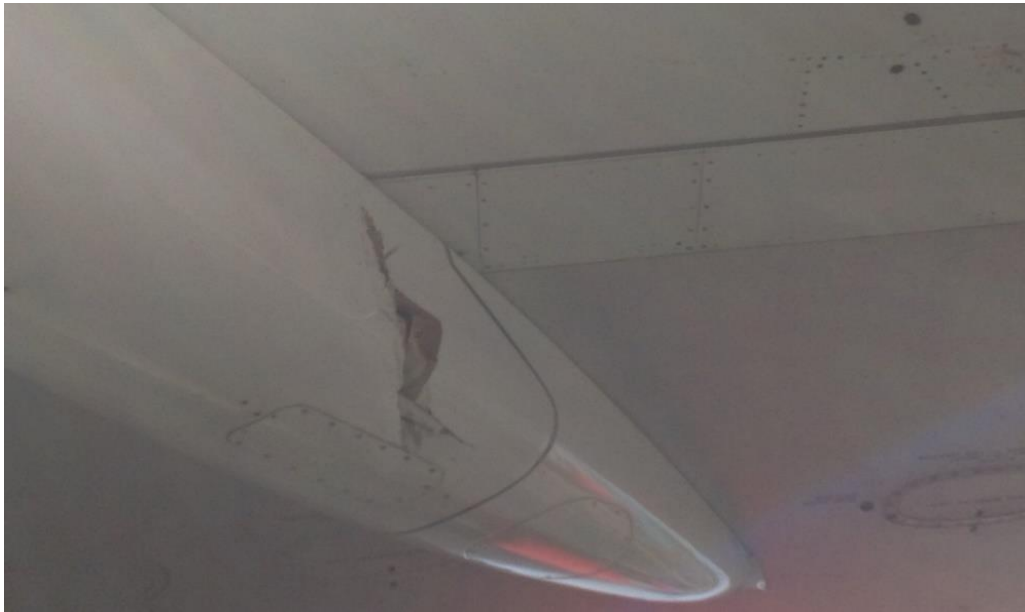
Figure 14: Torn flap fairing on the left wing

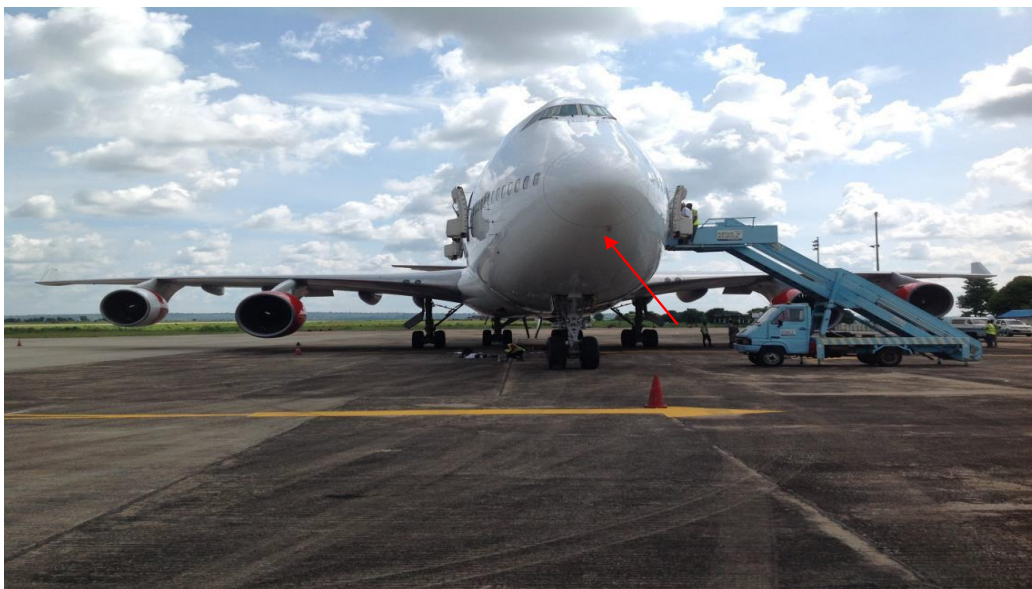
Figure 15: Evidence of bird strike on the lower radome
