Preliminary Report on the Ground Collision Incident involving an EMB-135BJ aircraft Registered 5N-BXK Operated by Max Air Limited and a Parked ATR 42 Aircraft Registered NAF 930 Operated by Nigerian Air Force which occurred on the Apron of the General Aviation Terminal of Nnamdi Azikiwe International Airport Abuja; Nigeria on 26th April, 2022.

Registered owner:	Max Air Limited
Operator:	Max Air Limited
Aircraft type and model:	EMB 135 BJ
Manufacturer:	EMBRAER
Year of manufacture:	2009
Nationality and registration marks:	5N-BXK
Serial number:	14501086
Location:	General Aviation Terminal (GAT) Nnamdi Azikiwe International Airport, Abuja (DNAA)
Date and time:	26 th April, 2022 at 09:08 h

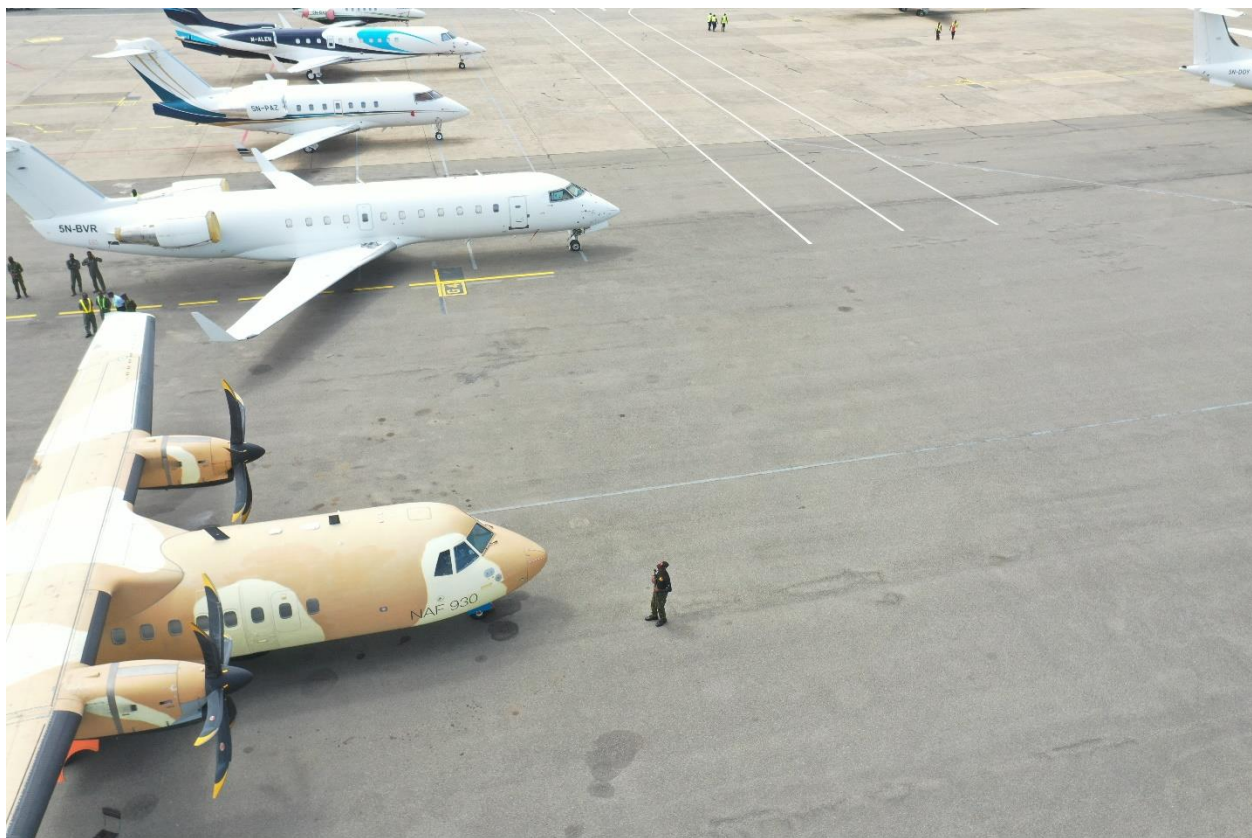
² NAF930 arrived GAT Apron at about 08:30 h was marshalled by NAF personnel to park at an unmarked position at the edge of the active Apron. At the time of the incident there was no person on board the ATR42.

Figure 1: NAF ATR 42 Parked at unmarked spot beyond Active Apron Boundary Line

- the GAT Apron, its right wing extended beyond the active apron edge line and its Tail Section protruded into the Apron Taxi Lane in use by 5N-BXK.
12. The military personnel that provided marshalling services to ATR 42 NAF930 prior to the occurrence did not have any formal training on aircraft marshalling.

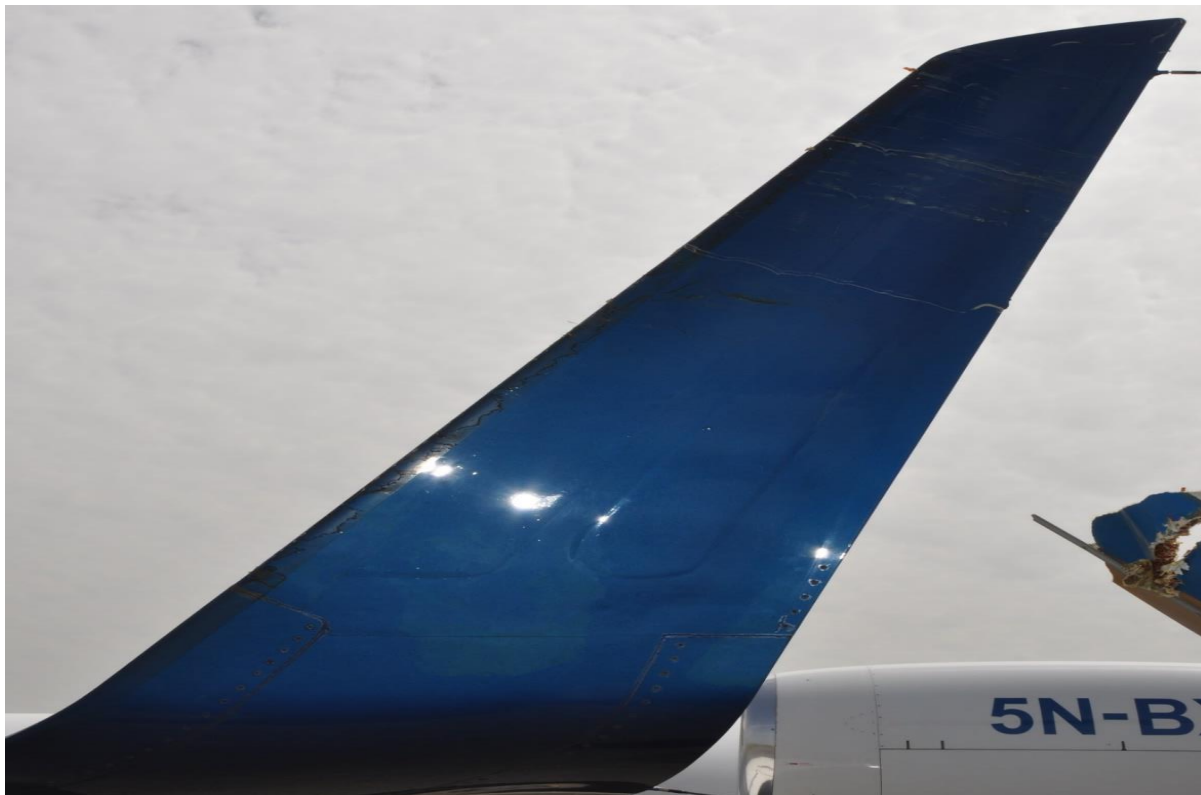
Post occurrence inspection of 5N-BXK showed that there was an abrasion on the left Winglet and a Static Discharge Wick was missing.

An abrasion on the left Winglet and a broken Static Discharge Wick.

Figure 1: 5N-BXK Winglet abrasion and the broken discharge wick position

- 1) Performed detailed visual inspection (DET) in affected regions (winglet area) and surroundings in accordance with (IAW) Aircraft maintenance manual (AMM) 57-52-00 Part II and EMBRAER case number [EEJ-0442047]. No major damage or abnormality, found only abrasions, abrasion cleaned, and new winglet leading edge erosion tape installed.
- 2) Performed DET in the wing-to-fuselage fairings IAW AMM 57-52-00 Part II and EMBRAER case number [0442047]. No damage or abnormality on fairings and seals.
- 3) Missing static dischargers recovered, inspected and found satisfactory. Static dischargers reinstalled IAW AMM 23-60-01-04 Part II.

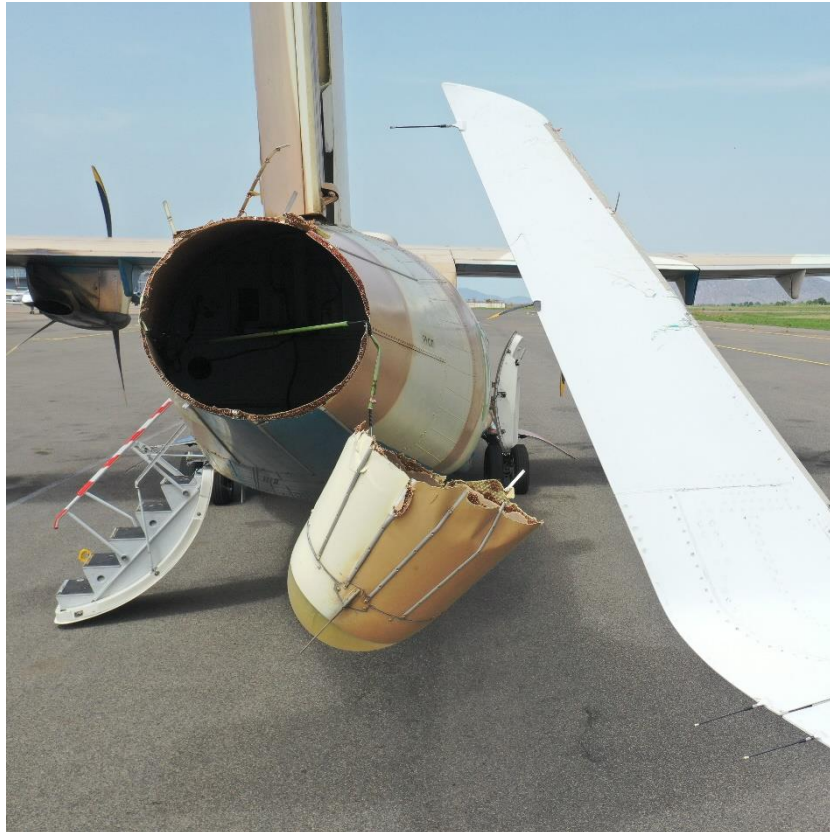
At 09:08:29 h, as the PF commenced left turn to exit the Apron, the left winglet of 5N-BXK struck the Tail Cone of the parked ATR42 aircraft.

The Tail Cone of the parked ATR 42 (NAF 930) sheared off.

Figure 2: Sheared off section of the Tail cone of the parked ATR 42 (NAF930)

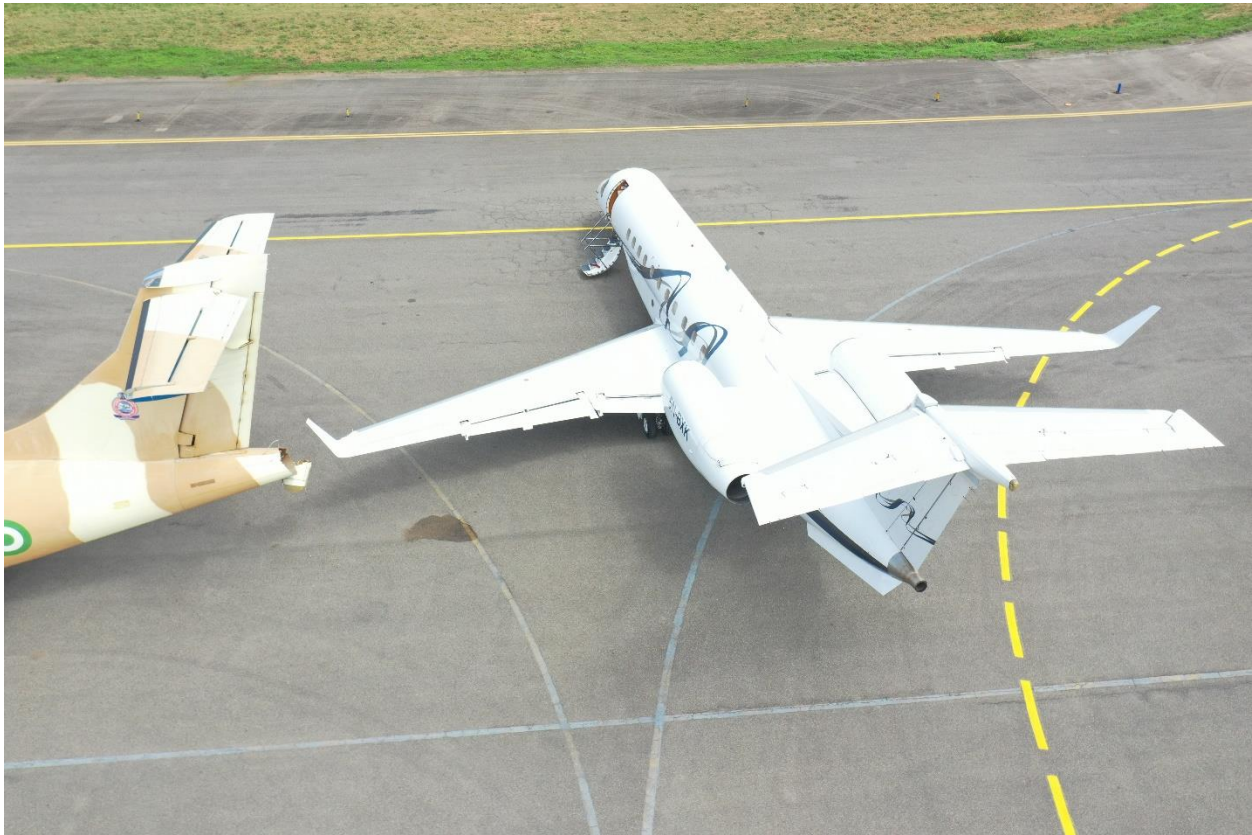
Figure 3: Post occurrence aerial view of 5N-BXK and NAF ATR 42 (NAF930)

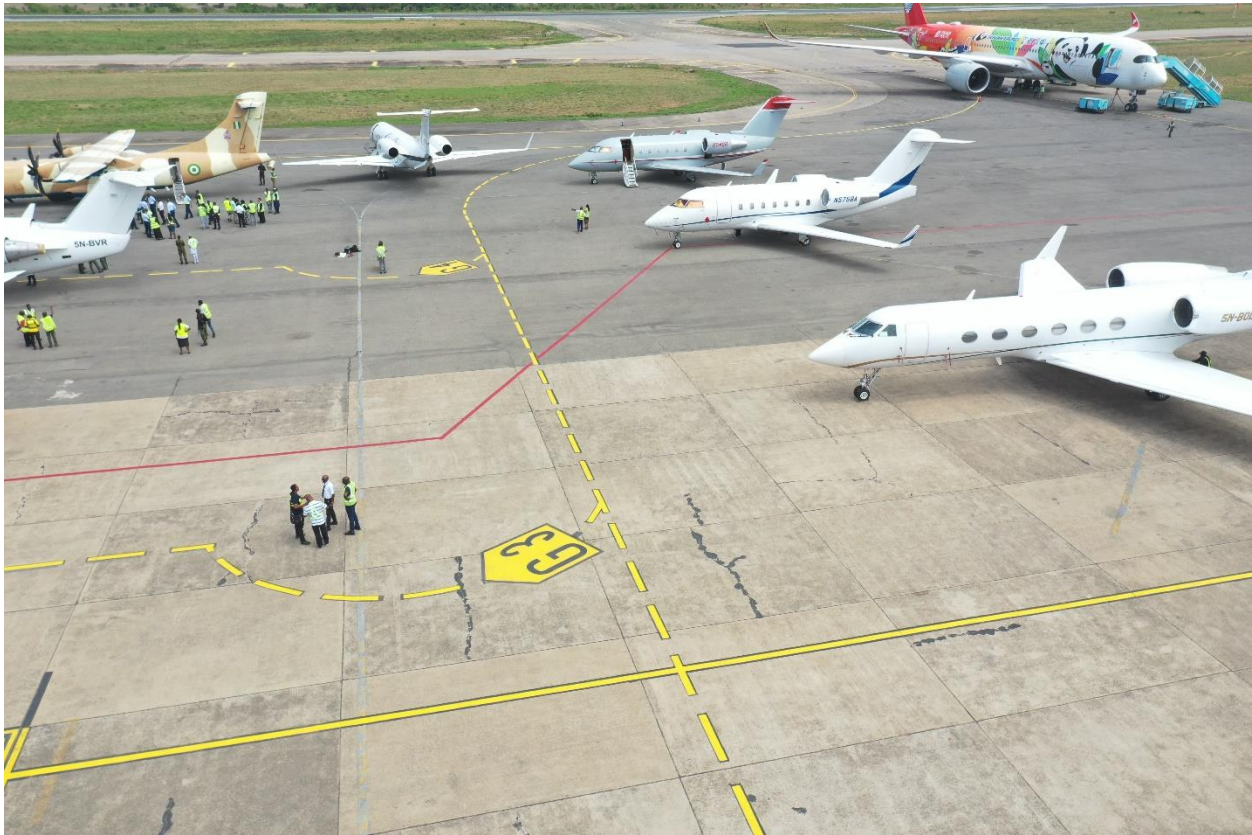
aware that the ATR 42 NAF930 Tail Section protruded into the Apron Taxi Lane used by 5N-BXK.

Figure 4: NAF ATR 42 parked at unmarked spot with its Tail Section protruding into the Apron Taxi Lane. Other aircraft parked at unmarked spots on the GAT Apron right side of 5N-BXK

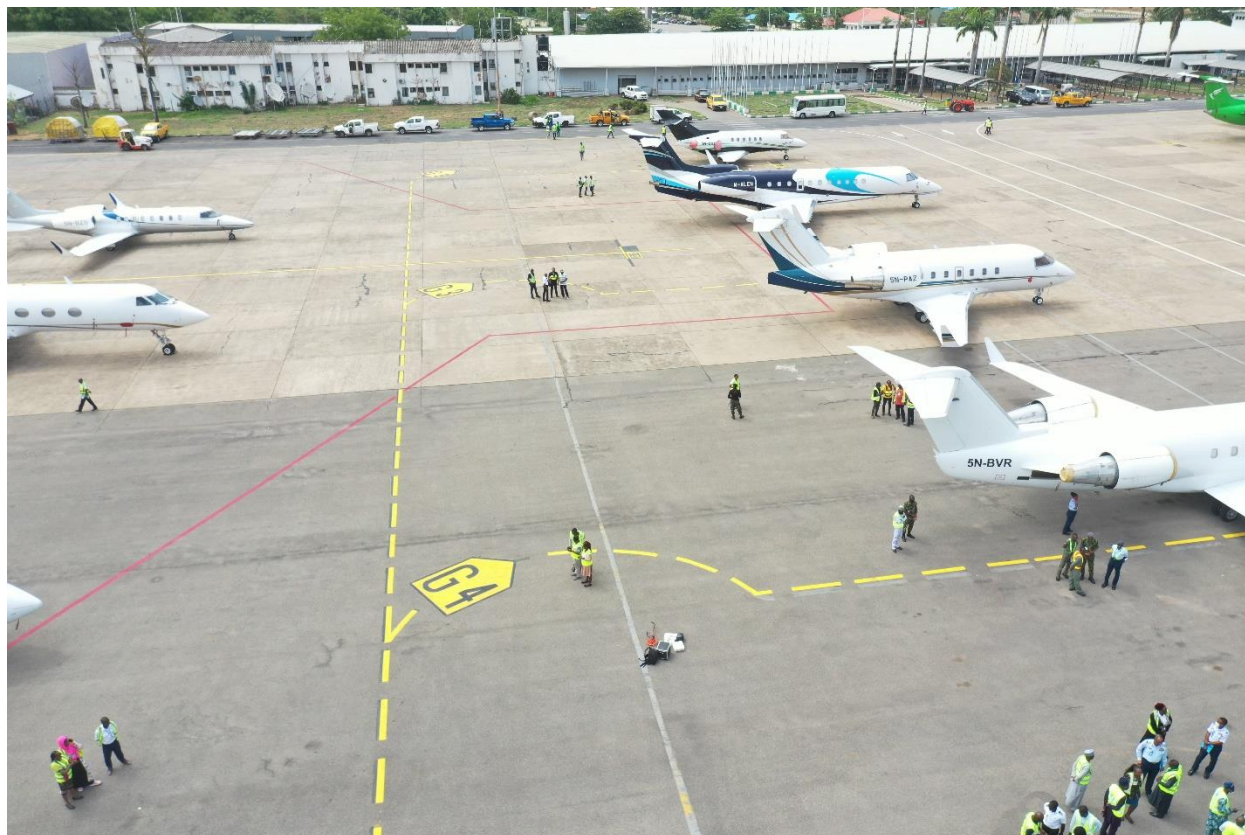
Figure 5: Aerial view of aircraft parked at marked positions and at unmarked spots on both sides of the GAT Apron Taxi Lane of the congested GAT Apron

13. At 09:07:08 h, 5N-BXK commenced taxi from an unmarked parking spot at a Bay on the GAT Apron to the Holding Point RWY 22.
 14. The GAT Apron was congested with several aircraft parked on both sides of the Apron Taxi Lane at the time 5N-BXK was taxiing out.
