# AIRCRAFT ACCIDENT REPORT

OLA/2014/11/29/F

**Draft Final Report on the serious incident involving ATR 72 aircraft with nationality and registration marks 5N-BPG owned and operated by Overland Airways Limited which occurred at Ilorin International Airport, Nigeria on 29th November, 2014.**

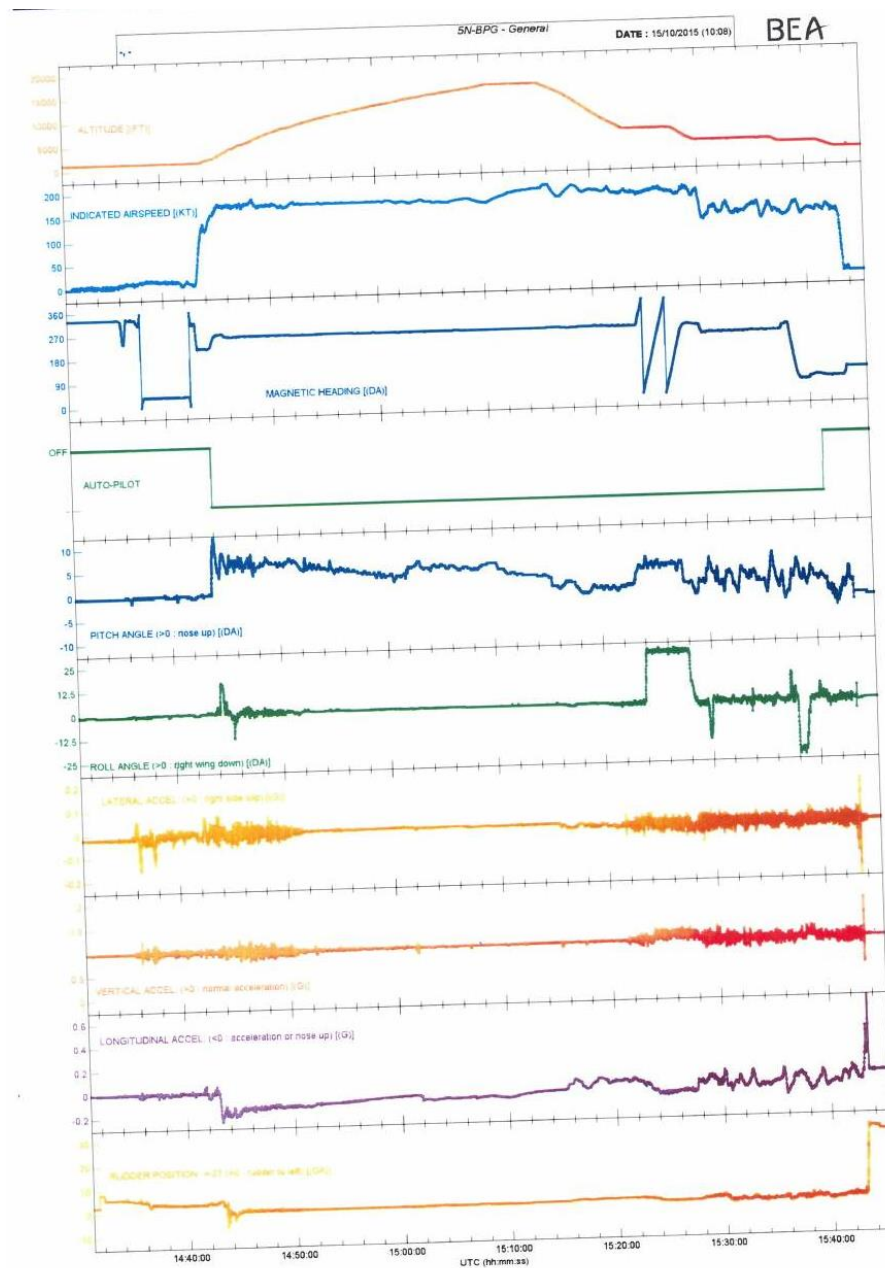
Figure 4: FDR plot 1

UTC(FDR PLOTS)	FDR PARAMETERS	BEA COMMENTS
15 h 43 min 02s	Radio-height stabilized. Longitudinal acceleration to increase. Magnetic heading is 51°	Flare and touchdown. The aircraft was well aligned with the runway 05.
15 h 43 min 05s	Rudder position started to increase.	The crew started to give pedal order to turn to the left.
15 h 43 min 12s	Magnetic heading started to increase.	Aircraft started to veer to the right when air speed passed below 70kt. As the air speed was decreasing to a low value, the crew probably lost lateral aero dynamical control of the aircraft.
15 h 43 min 18s	Maximum rudder position is reached. Heading continued to increase.	The crew applied maximum pedal order to the left but the aircraft continued to turn to the right.
15 h 43 min 23s	Strong peaks in vertical, longitudinal and lateral acceleration. Air speed was 12 kt.	Aircraft veered off the runway at low speed.
15 h 43 min 28s	Longitudinal acceleration stabilized close to 0 g	Aircraft stopped

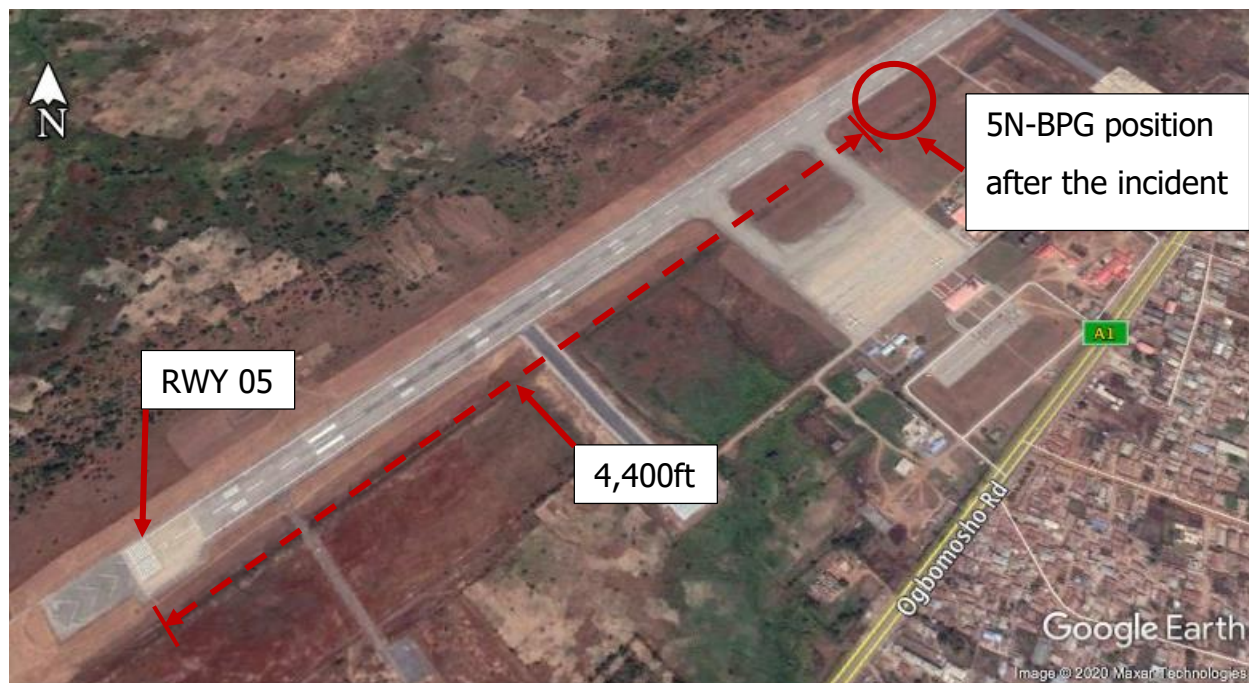
**Figure 6:** Aircraft position after the incident

Post occurrence inspection of the wreckage by the AIB investigators found that the aircraft Nose Landing Gear collapsed, the Flap Lever was at 30° position, the Power Levers were at FLIGHT IDLE position and the Condition Levers were at MIN RPM position.

12. The aircraft veered right of the runway centerline and exited, hit a ridge and the nose gear collapsed.
13. The engines were shut down by pulling the ENG FIRE handles as the condition levers were jammed.
14. The Flap Lever was found at 30° position and the flaps extended, the Power Levers were at FLIGHT IDLE position and the Condition Levers were at MIN RPM position.
15. The crew and passengers were evacuated uninjured.

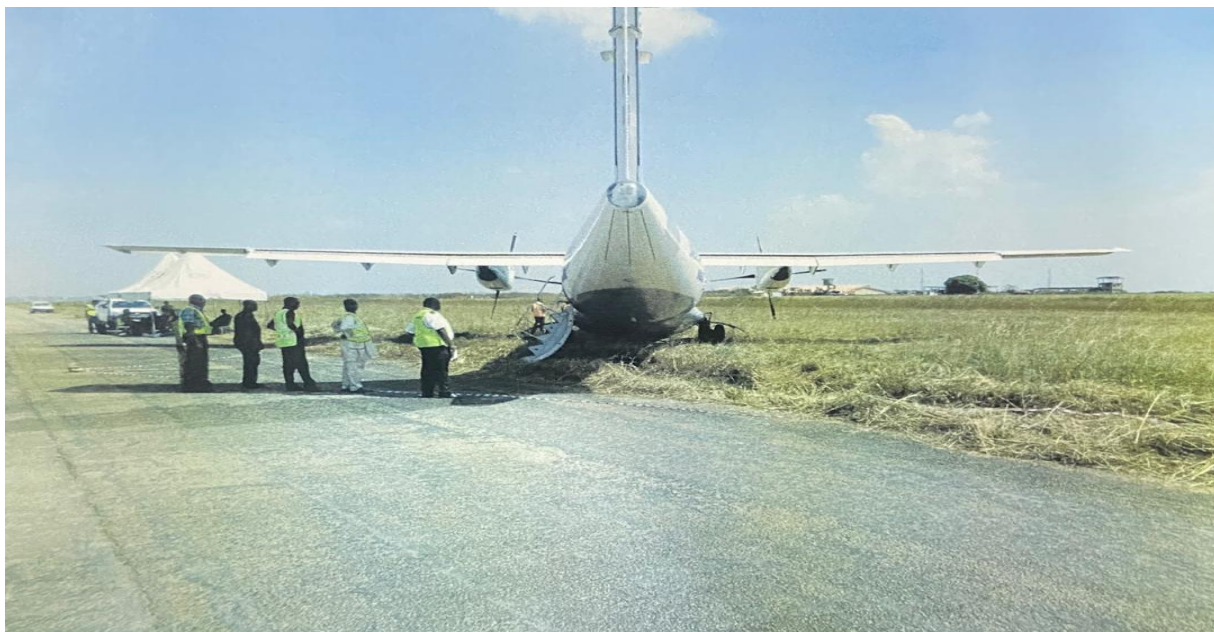
**Figure 7:** 5N-BPG on the grass verge

At 16:43:23 h, OLA1186 veered off the runway at low speed into the grass verge, hit a trench and its nose gear collapsed. The aircraft came to a stop at a distance of 4,400 ft from RWY 05 threshold, 40 ft from the edge of RWY 05 with its tail 12 ft from the runway shoulder. The engines were shut down by pulling the ENG FIRE handles as the condition levers were jammed. The ARFFS responded appropriately.
