# AIRCRAFT ACCIDENT REPORT NPF/2012/03/14/F

Accident Investigation Bureau

Report on the accident involving Bell 427 Helicopter belonging to the Nigeria Police Force, registration 5N-POL which occurred at Kabong, Jos South L.G.A Plateau State on the 14<sup>th</sup> of March, 2012

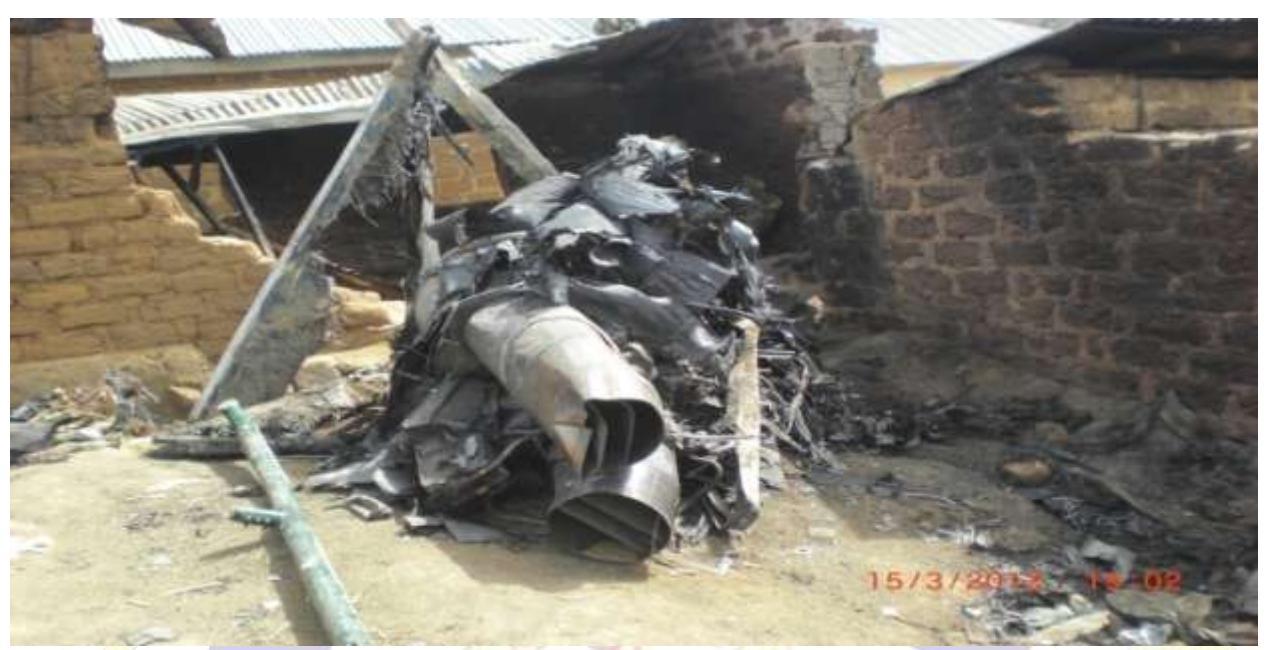
Figure 1: Picture showing the wreckage of the helicopter engine at final impact point

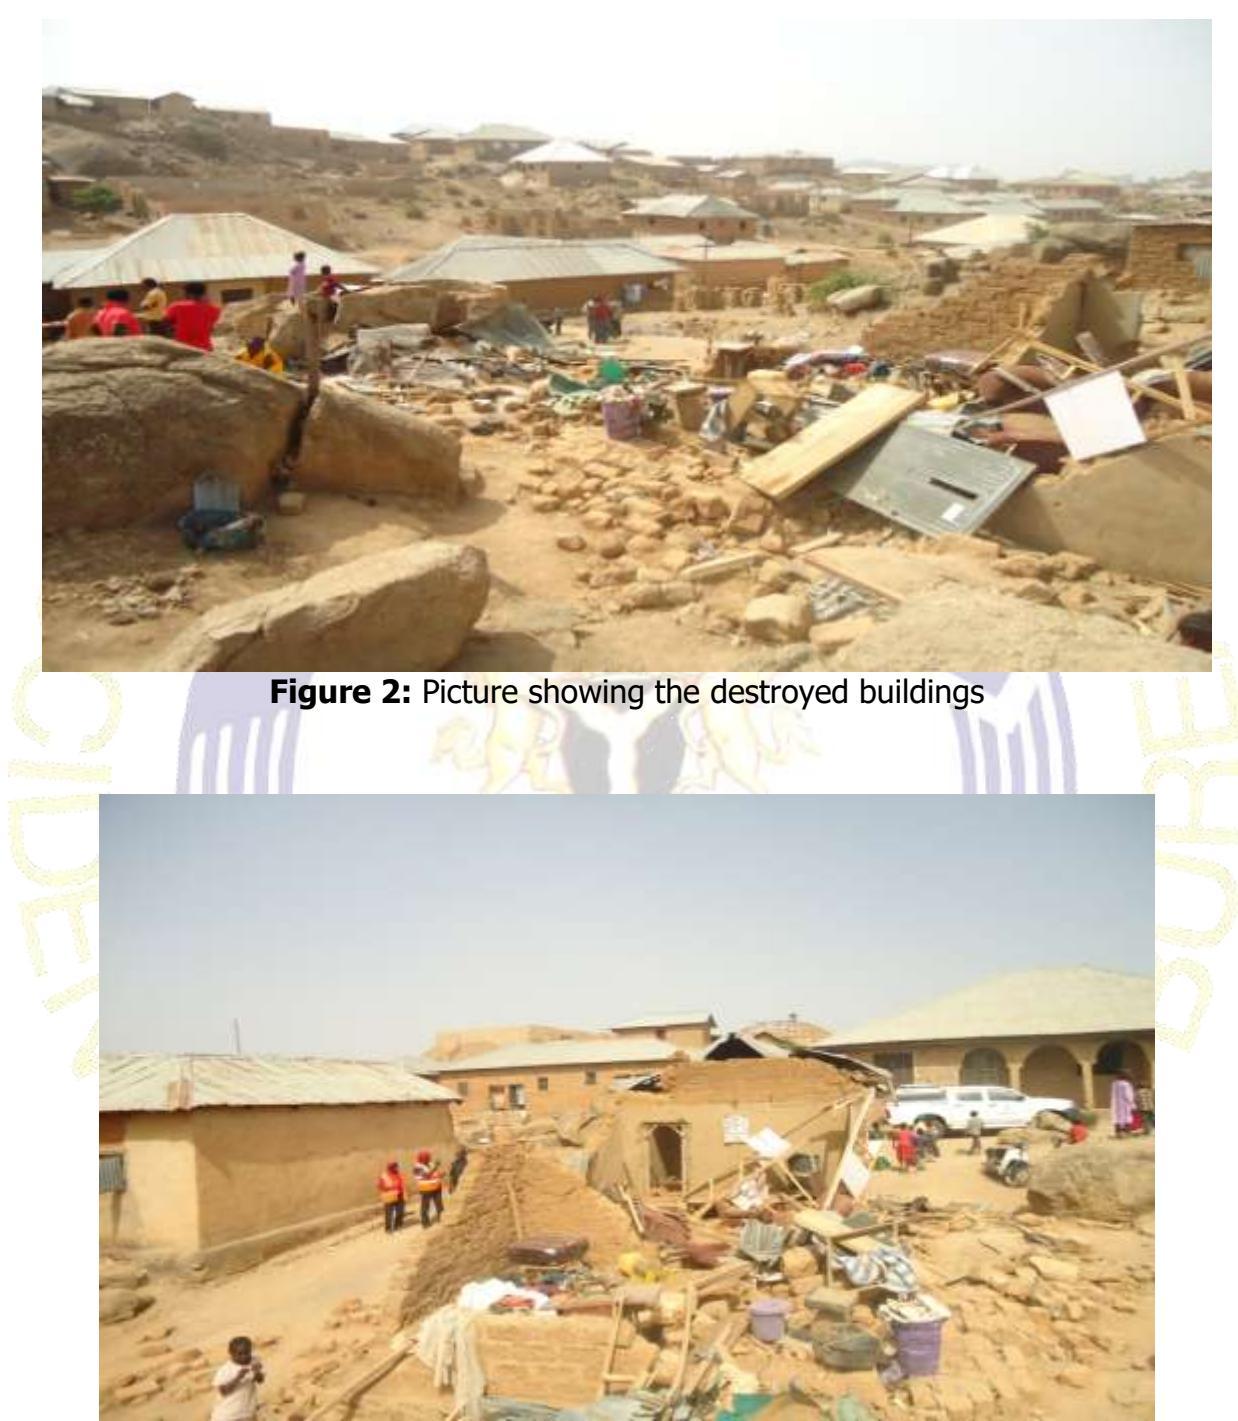
Figure 3: Picture showing the front view of the destroyed buildings

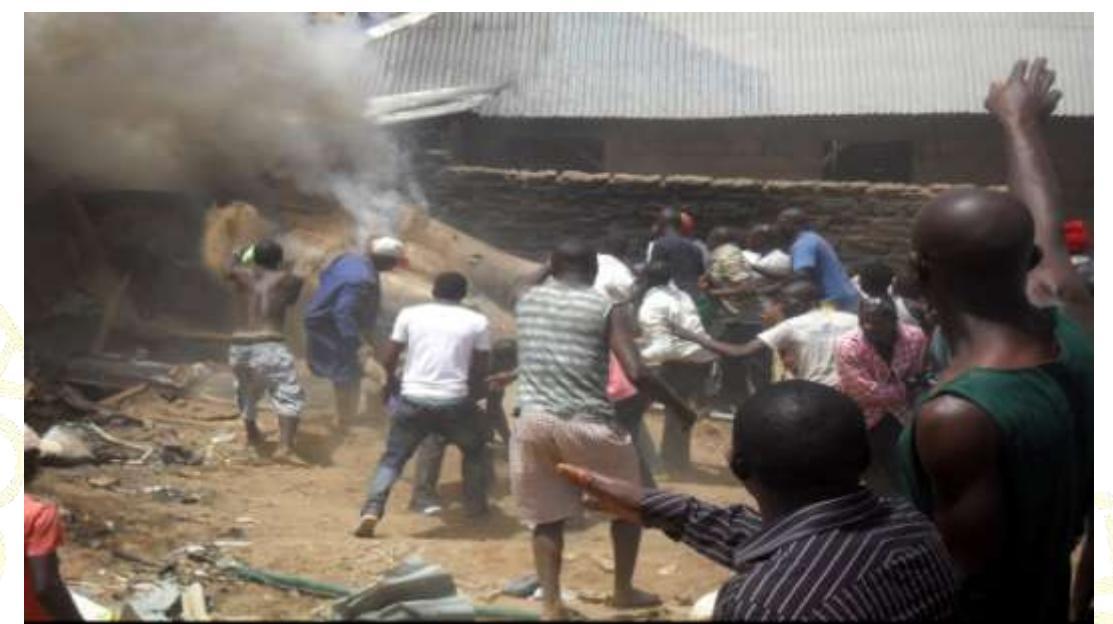
The aircraft wreckage showed heavy impact and fire damage. Examination of the wreckage area and vicinity revealed no evidence of a pre-impact fire or in-flight

Figure 8: Picture showing villagers trying to extinguish the fire at the crash site

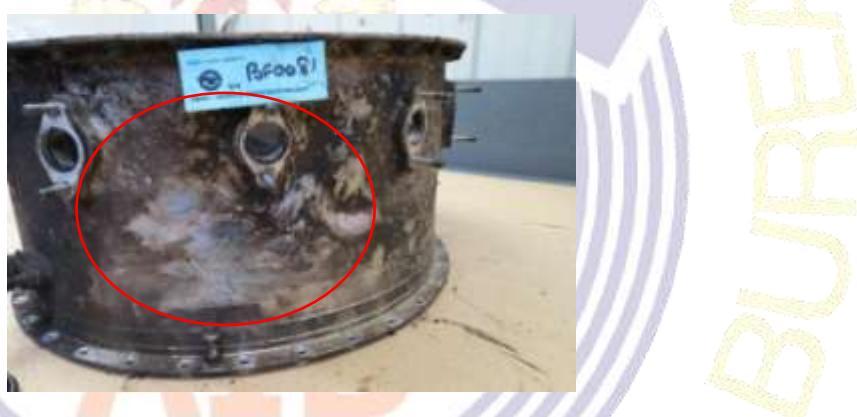
Photo No.15

Gas Generator Case: The gas generator case displayed dust, soot stain and deformation due to impact damage at the 10 o'clock position (Photo No.15).

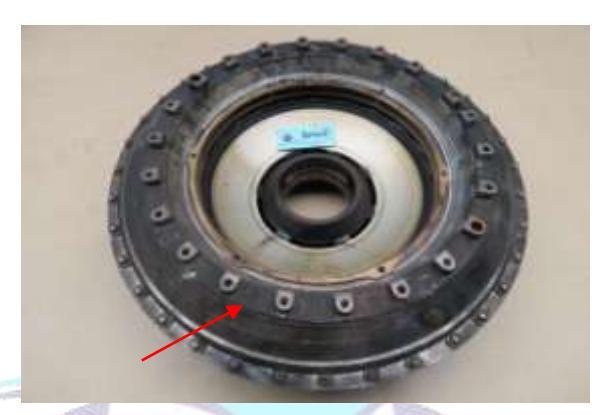
Photo No.16

Diffuser case: The diffuser case displayed soot on external surface (Photo No.16).

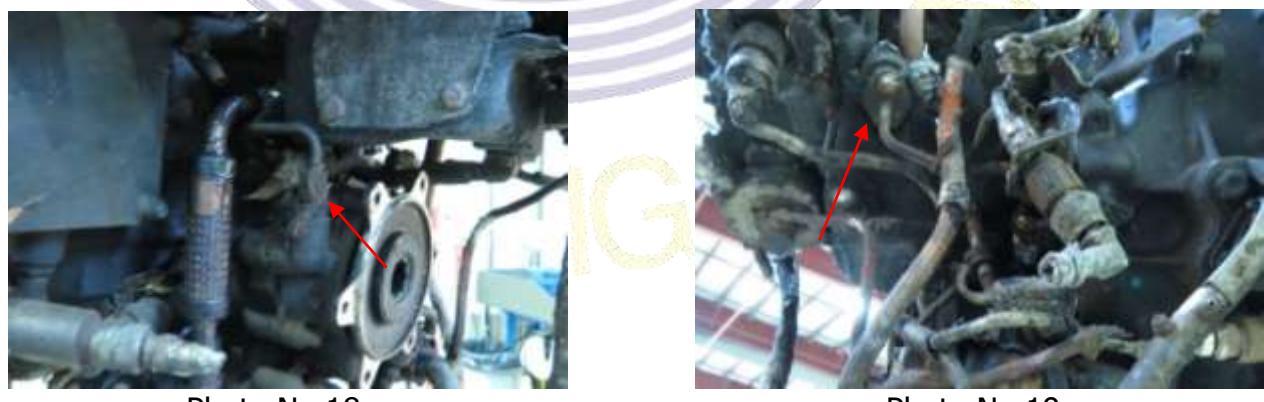
Photo No.18

**Compressor Discharge Air (P3):** The FMM P3 feed line, was still properly installed and lock wired to the #8 bearing carbon seal cover (Photo No.18) but it was partially released at the FMM connector due to post impact fire damage (Photo No.19).

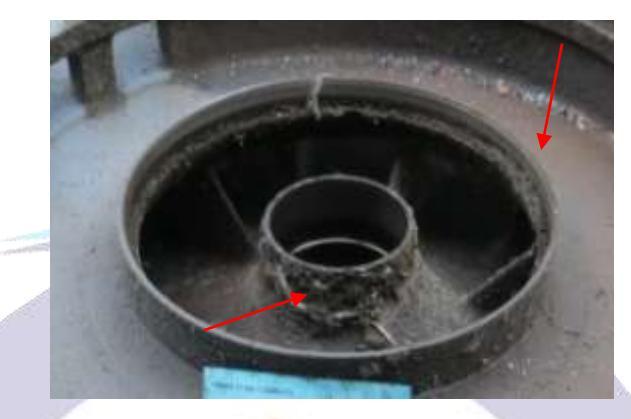
Photo No.23

**Inlet Case:** The inlet case displayed heavy dust stain at inlet area (Photo No.23).

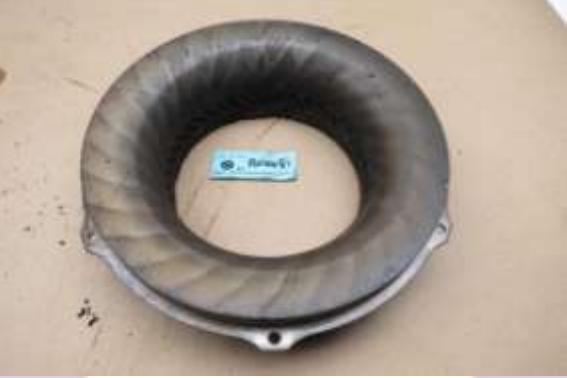
Photo No.26

**Centrifugal Impeller Shroud:** The impeller shroud displayed dirt deposit at abraidable surface and at damper pocket (Photo No.26).

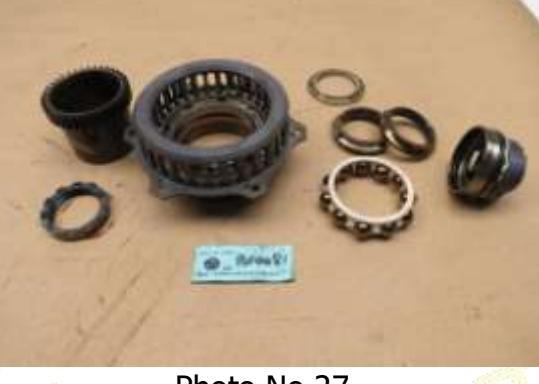
Photo No.27

**No. 3 Bearing and flex housing:** The #3 ball bearing and adjacent hardware were unremarkable (Photo No.27).

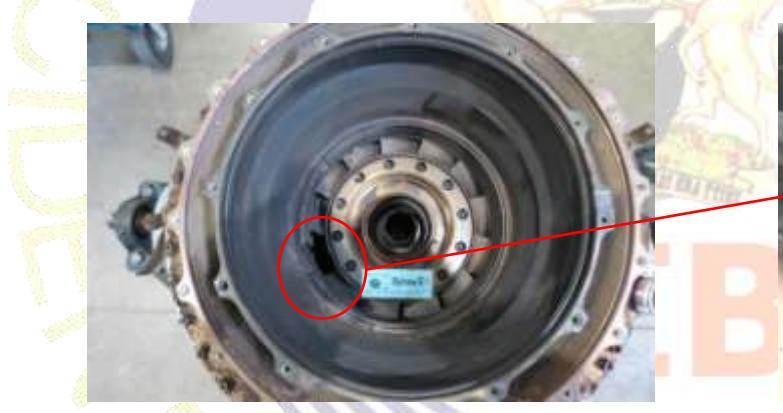
Photo No.35 Trailing edge side

Compressor Turbine Vane Ring: The CT vane ring displayed burning with splattered and melted material at airfoil and outer rim at 8 o'clock position (Photos No.35 to 38).

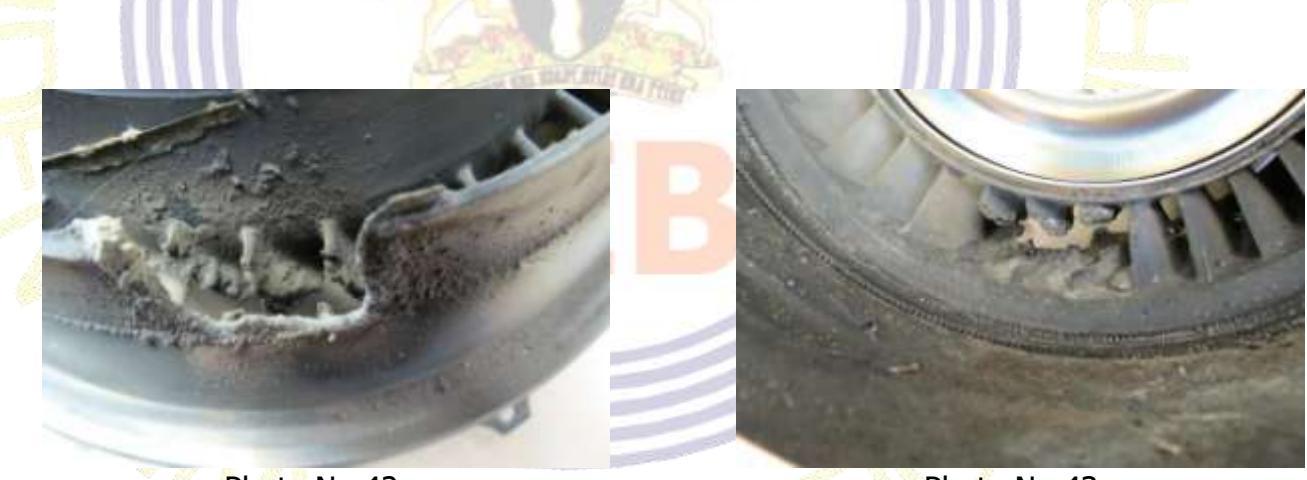
Photo No.42

**Power Turbine (PT) Vane Ring:** The power turbine vane ring displayed burning, splattered and melted material at airfoil and outer rim leading edge side at 8 o'clock (Photos No. 42 & 43). The PT vane ring honey comb seal displayed rubbing indication.

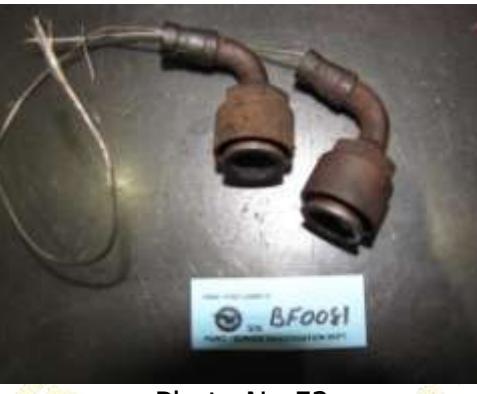
Photo No.52

**Ignition Leads:** The ignition leads were consumed due to post impact fire, the igniters' terminal ferrule displayed soot-stain and surface corrosion (Photo No.52).

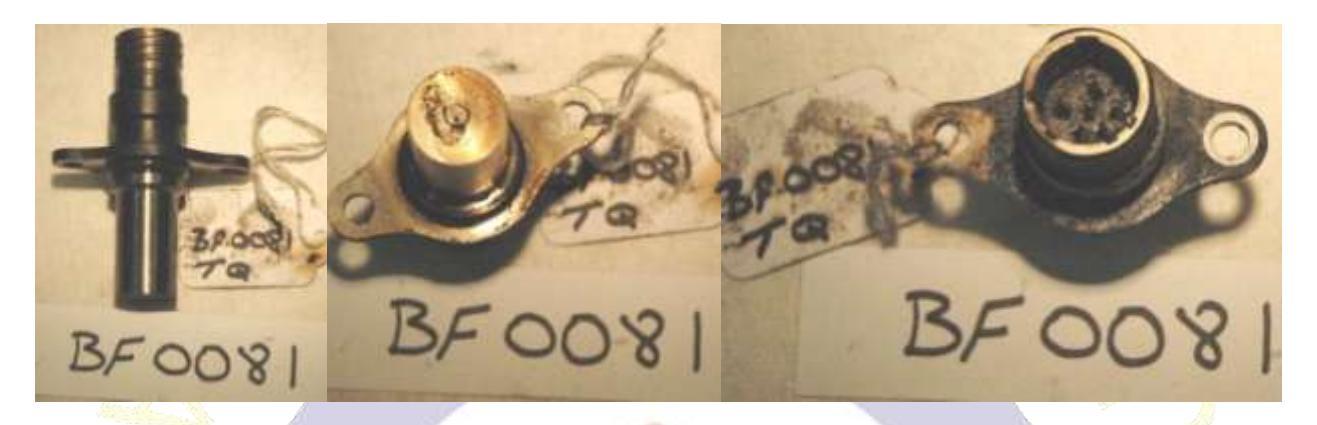
Photo No.62

**Engine Torque (Tq) sensor:** The exterior of the Tq sensor was soot-stained. Dry debris including melted seal material was present inside the electrical connector. The rubber seal in the electrical connector had been damaged by the post impact fire (Photo

No.62). The Tq sensor was bench tested, deviation observed were secondary to post impact fire.

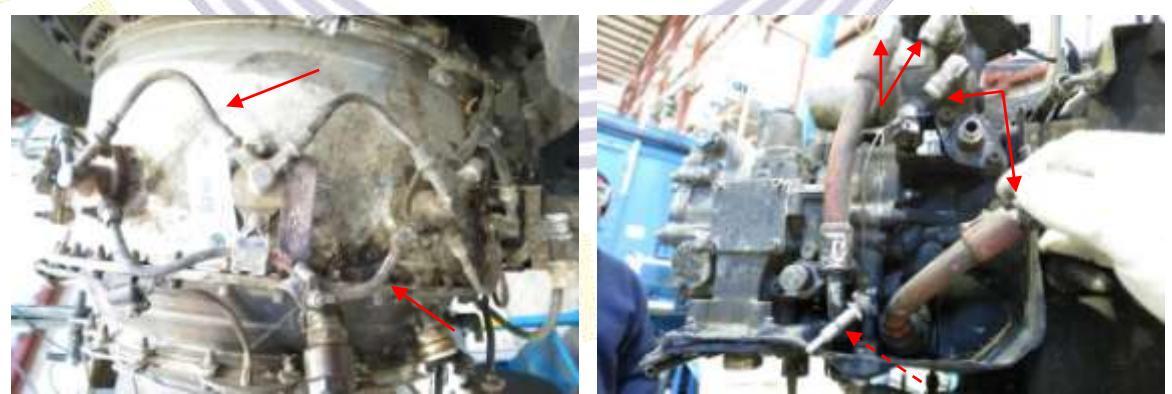
Photo No.67

The engine was entirely exposed to post impact fire, external components displayed soot stains. The fuel manifold silicon cuff was completely melted (Photo No.67). As received, the fuel pump inlet and outlet tubes were disconnected (Arrows Photo No.68) and the fuel filter cover locking pin was removed (Dotted arrow Photos No.68), the Fuel Management Module (FMM) vapour box was disintegrated (Photo No.69). The inlet screen and the engine front and rear fire seals displayed impact and fire damage (Photo No.70). The engine harness and connectors displayed fire damage (Arrow Photos No.71 & 72). The engine harness connectors were still engaged to their terminals (Dotted arrow Photo No. 72).

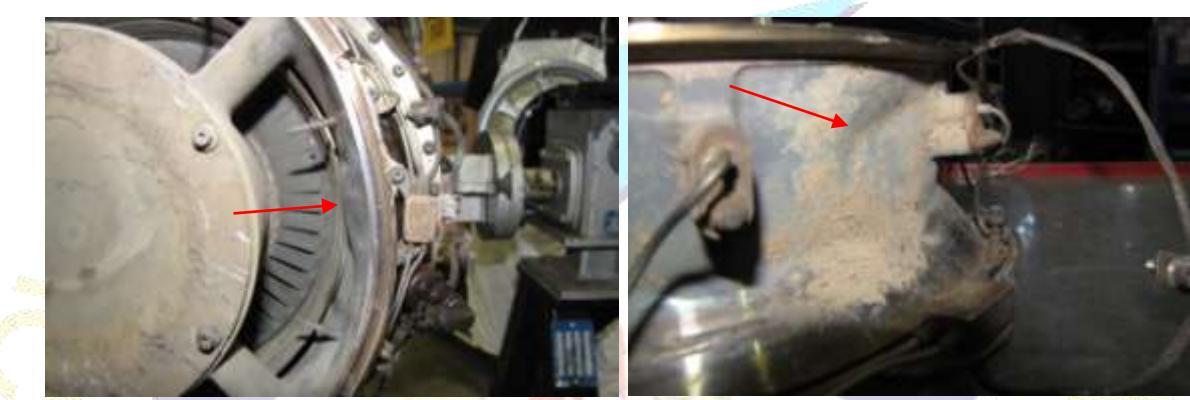
Photo No.73

**Turbine Exhaust Case:** The turbine exhaust case displayed environmental dust stain and impact damage at the 3 o'clock position (Photos No.73 & 74).

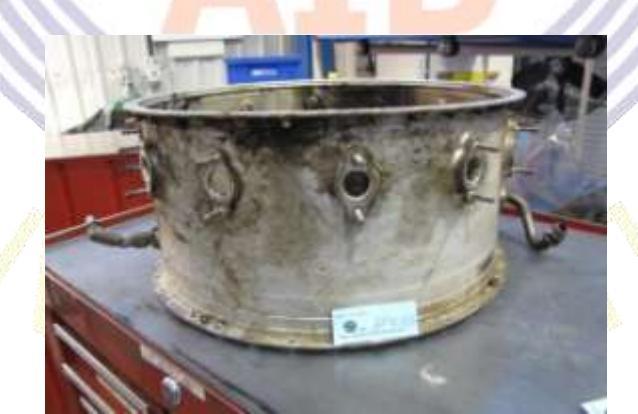
Photo No.75

**Gas Generator Case:** The gas generator case displayed dust and soot stain (Photo No.75).

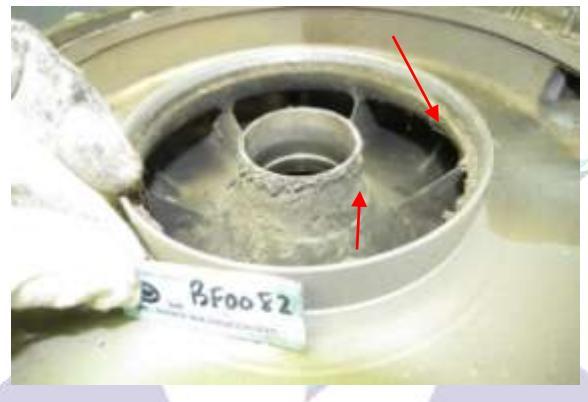
Photo No.76

Inlet case: The inlet case displayed heavy dust deposit at inlet area (Photo No.76).

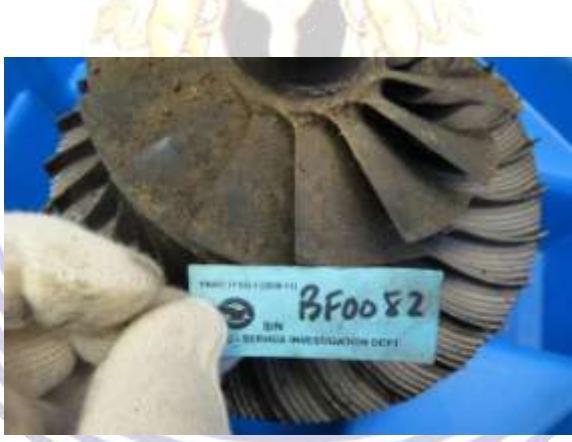
Photo No.81

**Centrifugal Impeller:** The centrifugal impeller inducer side displayed foreign object damage and heavy dirt deposit (Photo No.81), otherwise it was unremarkable. The impeller back face was unremarkable. There was no pre or post impact rubbing indication.

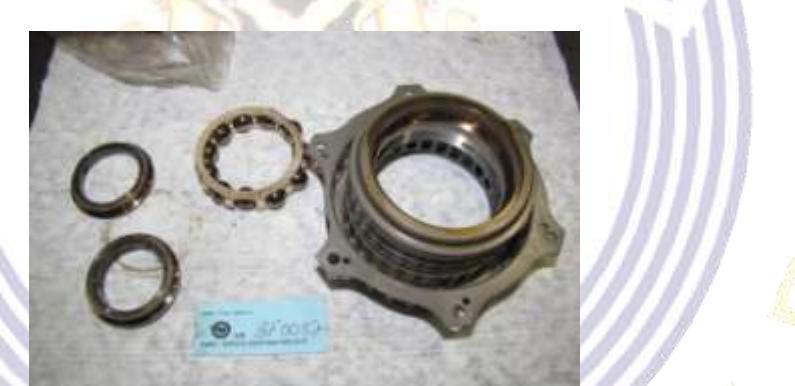
Photo No.84

**No. 3 Bearing and flex housing:** The #3 ball bearing and adjacent hardware were unremarkable (Photo No.84).

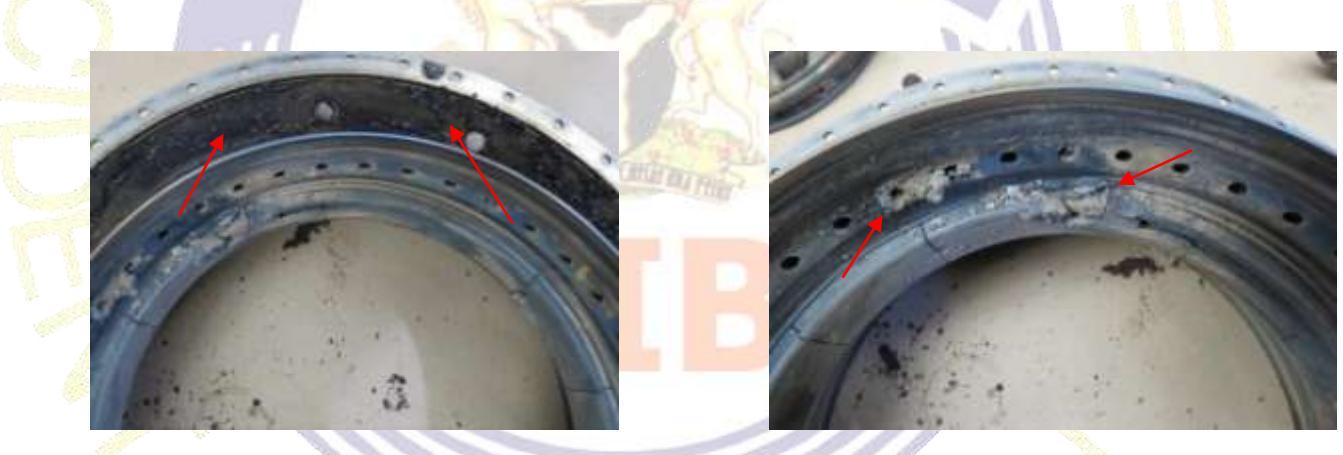
Photo No.100

**Turbine Support Case:** The turbine support case displayed dirt deposit (Photo No.100), post impact fire burning, and soot at 5 O'clock (Photo No.101).

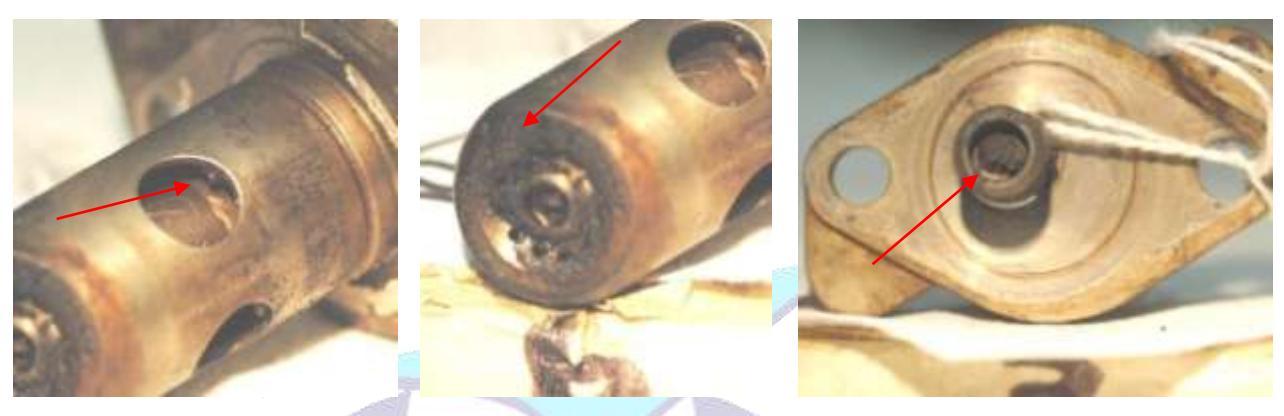
Photo No.114

**Fuel Nozzles:** Brick debris was present between many of the nozzle sheaths and stems (Photo No.114). Carbon deposit was present on the nozzle tips (Photo No.115). Since the combustion liner did not show indication of abnormal burning into the gas path, that carbon deposit is believed to be due to post impact fuel residue burning. Burned residue was present in the inlet strainer of the No. 3 and 5 nozzles (Photo No.116). Chemical analysis of debris from the strainers was composed of carbon with various levels of silicon, aluminium, fluorine, iron, calcium, and potassium. The nozzles were bench tested, the deviations observed were secondary to post impact fire.

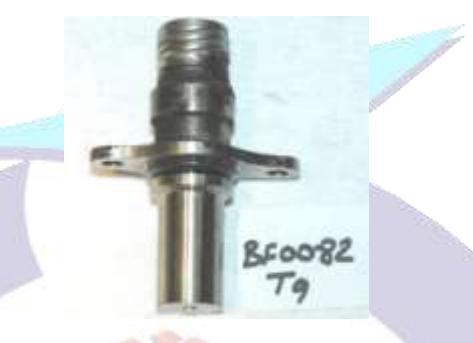
Photo No.119

**Engine Torque (Tq) sensor:** The exterior was soot-stained. Dry debris and burned sealing material was present inside the electrical connector (Photo

No.119). The torque sensor was bench tested, deviations observed were secondary to post impact fire.
