AIRCRAFT ACCIDENT REPORT

AIB /NCAT/ 2008/07/22/F

**Report On The Accident Involving
TAMPICO Club 9
Registration No. 5N-CAV Which Occurred
On the 22nd July, 2008.**

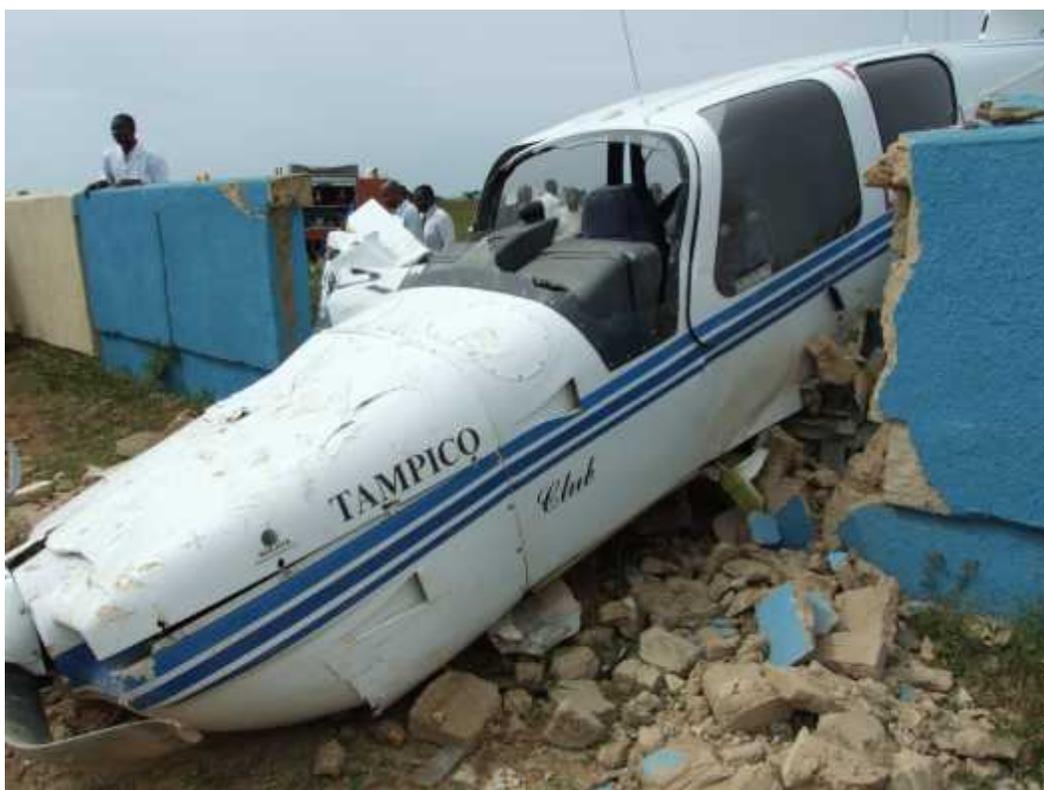
The aircraft was destroyed as a result of impact with the aerodrome fence.

A section of the aerodrome fence was damaged.

Photograph showing damage to the section of the perimeter fence of the Aerodrome and the Aircraft.

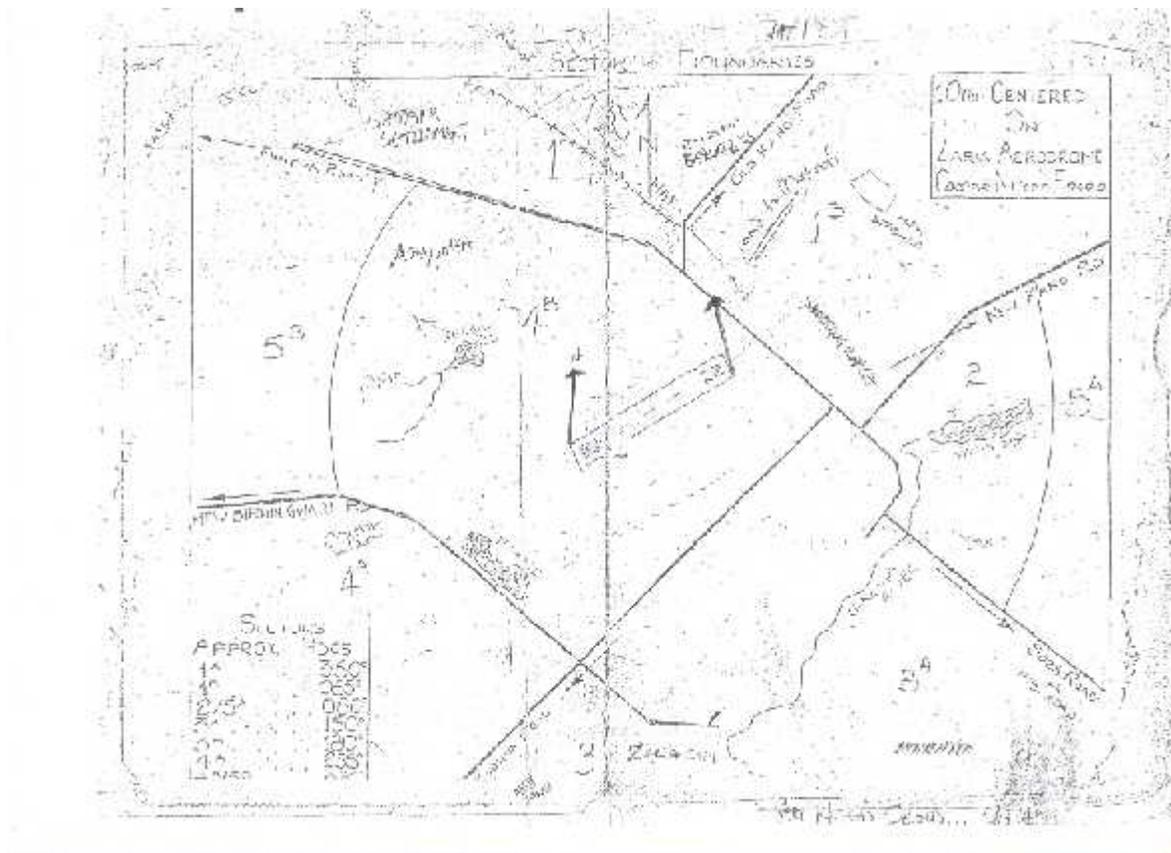
Sketch of the training sectors and their dimensions

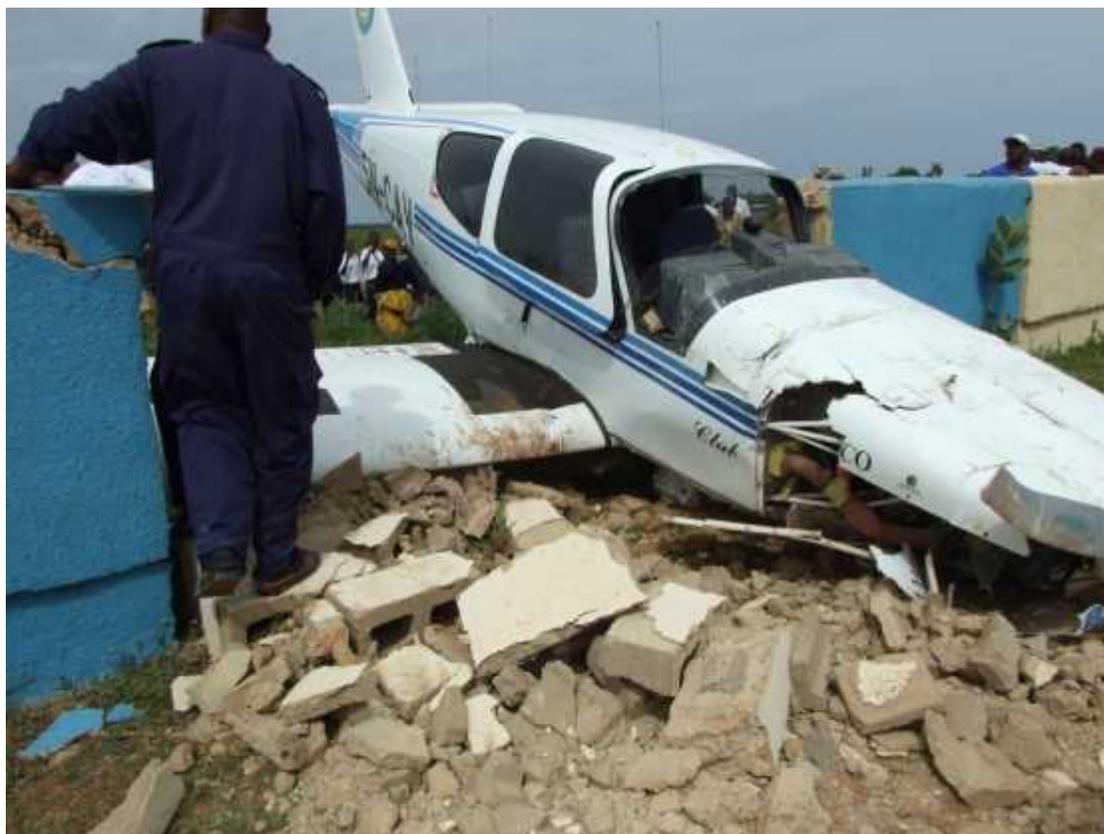
The aircraft's first point of contact with the ground was 435ft to the point of rest, while it impacted and destroyed the Localizer monitor located at 84ft from the point of impact. The total distance from the point of first impact to the final resting position at the fence was 519ft. The aircraft arrived the impact point intact, the starboard wing was substantially damaged due to impact, while the port

wing was twisted backward and bent parallel to the fuselage. The windshield and engine cowling were all damaged. Both fuel tanks were intact and not ruptured.

Photograph showing main wreckage

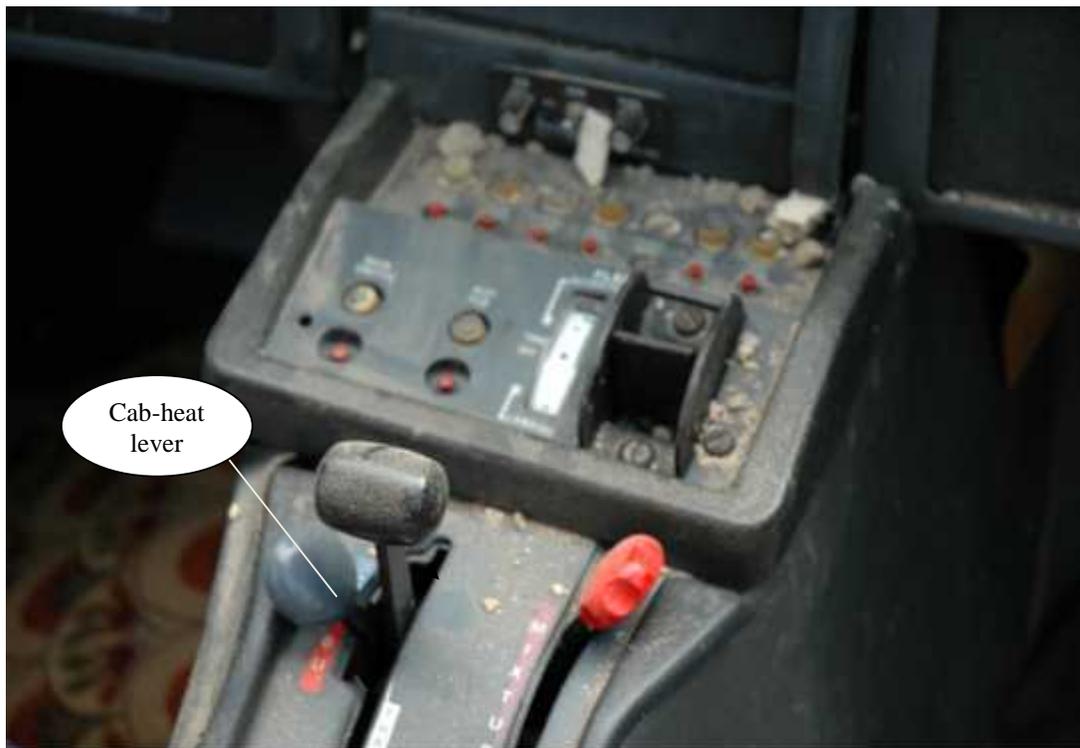
Throttle	:	Forward
Mixture	:	Full rich
Cab-Heat	:	Mid Position
Flaps	:	Up

Photograph showing cab-heat lever in mid position

- 3.1.11 The engine of 5N-CBE, which was fitted on 5N-CAV after overhaul was 14 years old before the overhaul as against 12 years by EADS Socata.
- 3.1.12 The carburetor heat knob was at mid position.
- 3.1.13 Zaria aerodrome had an Emergency Response Plan (ERP) in place but there was no evidence that it had been tested in accordance with ICAO annex 14 recommendations.
- 3.1.14 Physical examination and checks of cockpit controls revealed no evidence of pre-impact failure or malfunction.
- 3.1.15 Damage to the airframe, propeller and marks on the ground were all consistent with engine under power at impact.

- (i) The inappropriate use of carburetor heat by the student led to reduced power, engine vibration, which consequently caused the student to panic and lost control of the aircraft.
- (ii) Non-adherence to procedures for release of the student for first solo flight as specified in the NCAT Flight Training Manual.

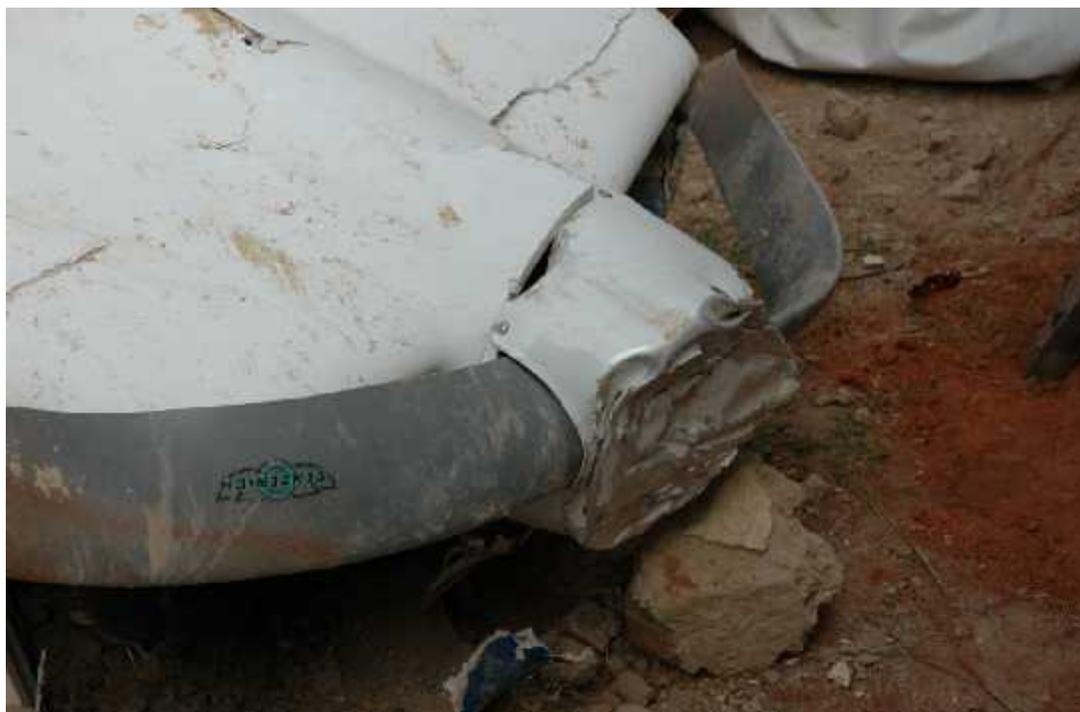
Photograph showing damaged propeller blades
