AIRCRAFT ACCIDENT REPORT

BHNL/2016/02/03/F

Accident Investigation Bureau

**Report on the Accident involving a Bristow Helicopters
(Nigeria) Limited Sikorsky S76C++ Helicopter with
nationality and registration marks
5N-BQJ which occurred at 77 NM offshore from
Murtala Muhammed Airport on Radial 139°
on 3rd February 2016**

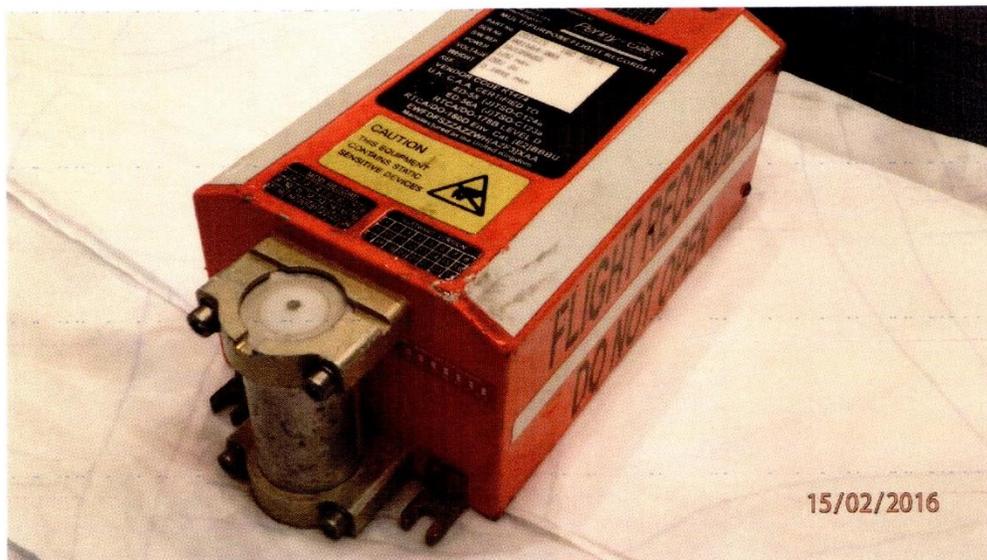
1. The top cover of the unit was removed to provide access to the crash protected memory module. It was noted that there was no evidence of impact penetration to the case.

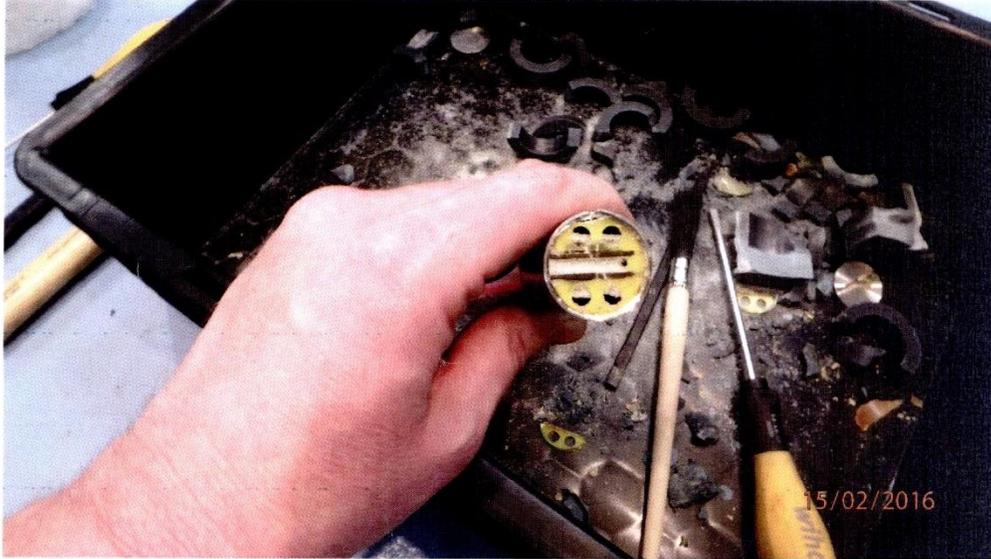
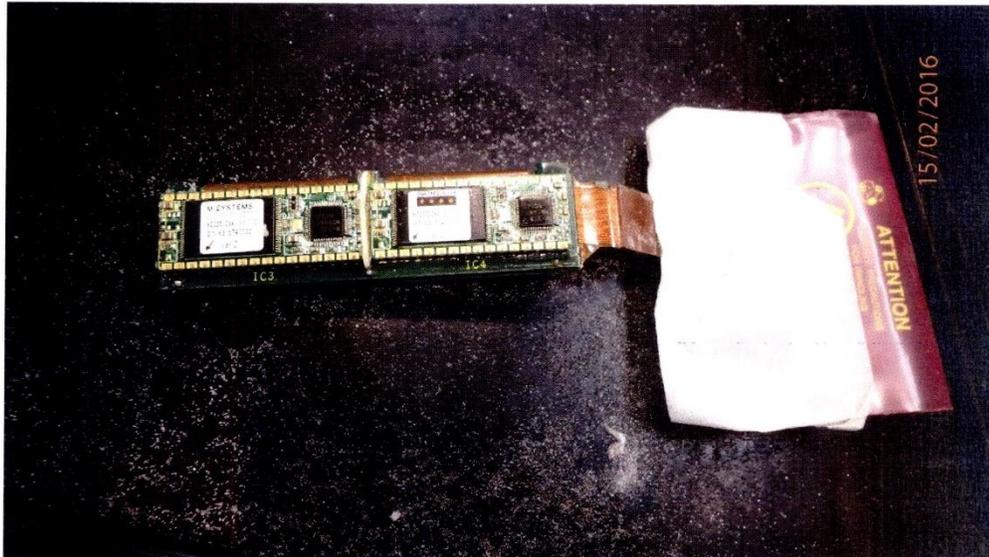
7. Water had entered the inner cylinder. The memory board was cleaned, inspected and placed in a humidity controlled drying cabinet for 48 hours at 50°C. No defects were identified during inspection of the board.

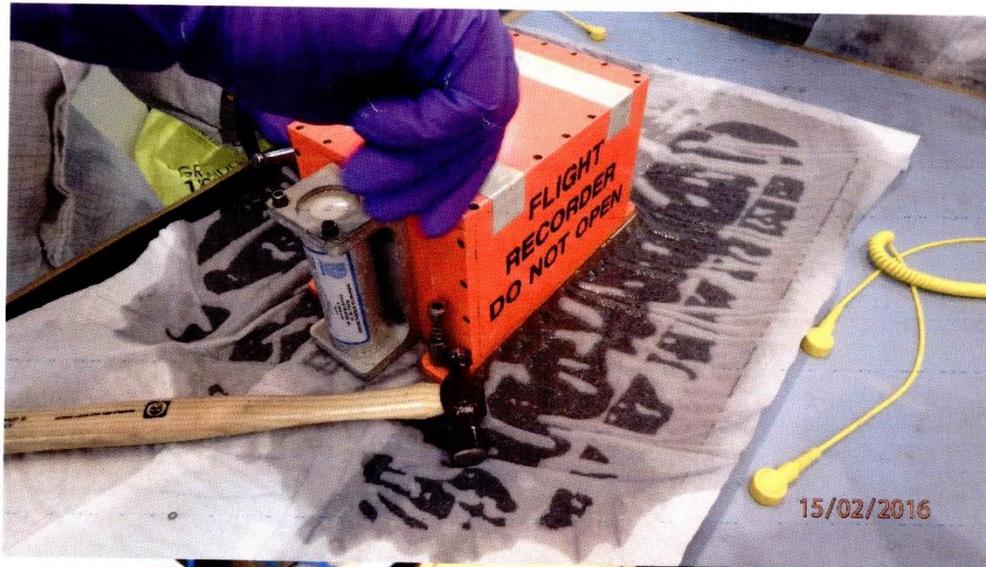
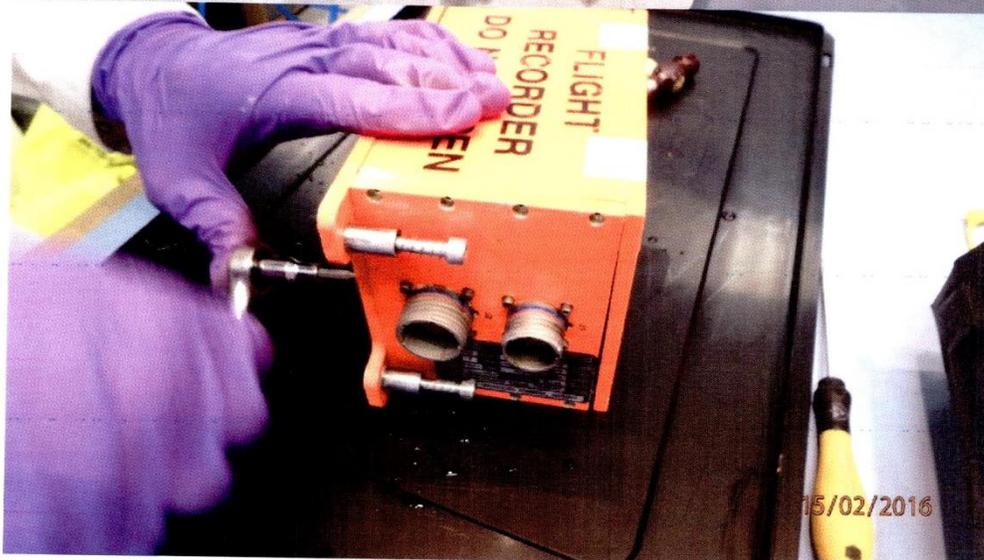
1. The crash protected memory module was removed from the chassis. It was noted that there was no evidence of impact penetration to the case.

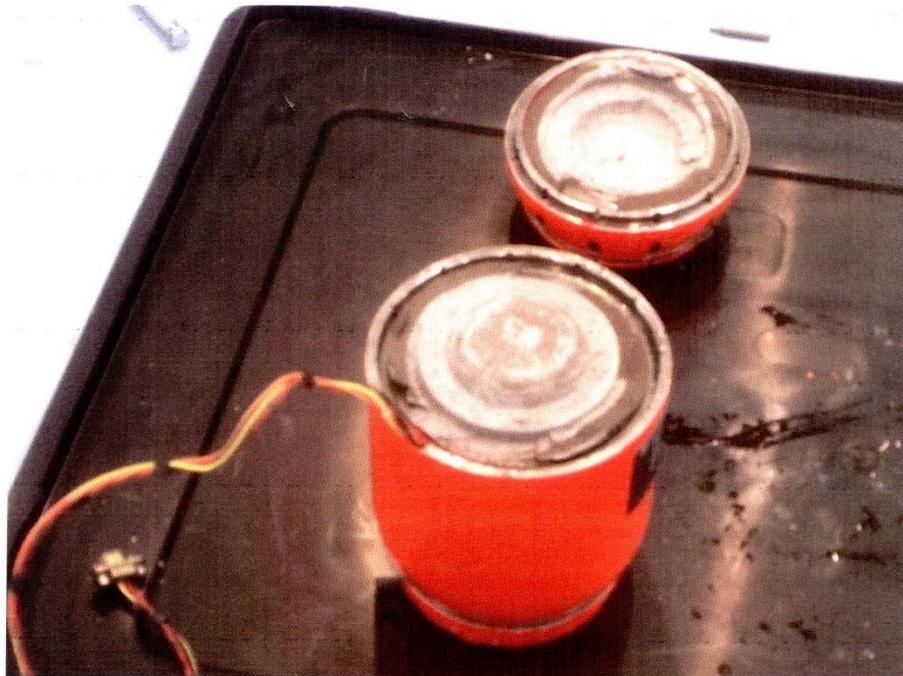
2. The memory module was opened to determine if water had entered the protective cylinder that contains the memory board. Water was found to have entered the outer insulating material, but the inner cylinder appeared dry. As a precaution, the memory module was placed in a humidity controlled drying cabinet for 10 hours at 50 °C.

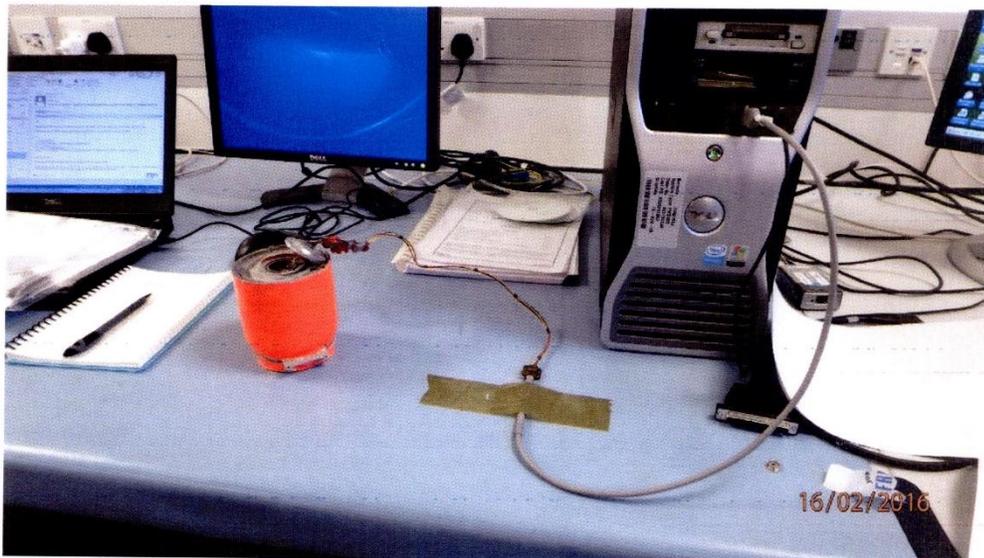
It was noted that one wire attached to the memory board was loose. A small movement of the wire restored the connection and a successful download was achieved with no errors displayed. A further four downloads were made and the data files compared. No discrepancies in the size of the data files were noted, indicating that all of the available data had been extracted successfully.

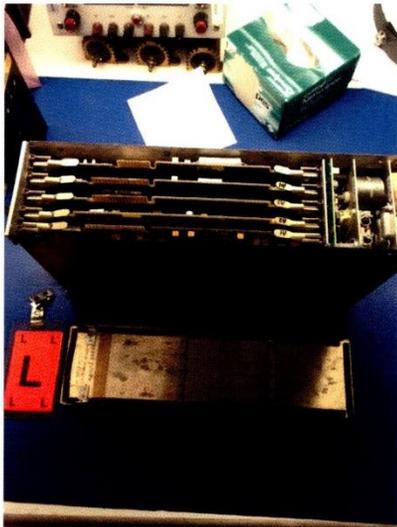
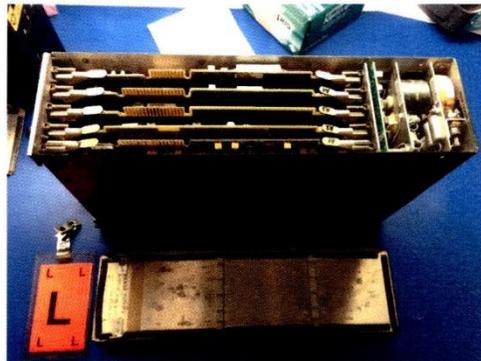
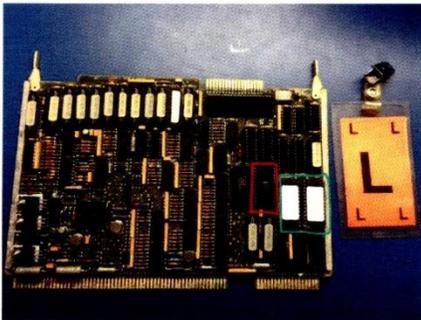
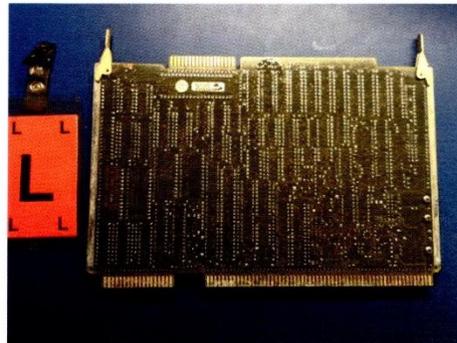
The red "L" tag designates unit 1 ("Co-Pilot").

The EEPROM containing the error codes is highlighted in a red box above. Also, the flight software memory devices are highlighted by the green box.

Both units had corrosion on the board connectors. The corrosion on the connector was able to be cleaned off with a toluene solution.

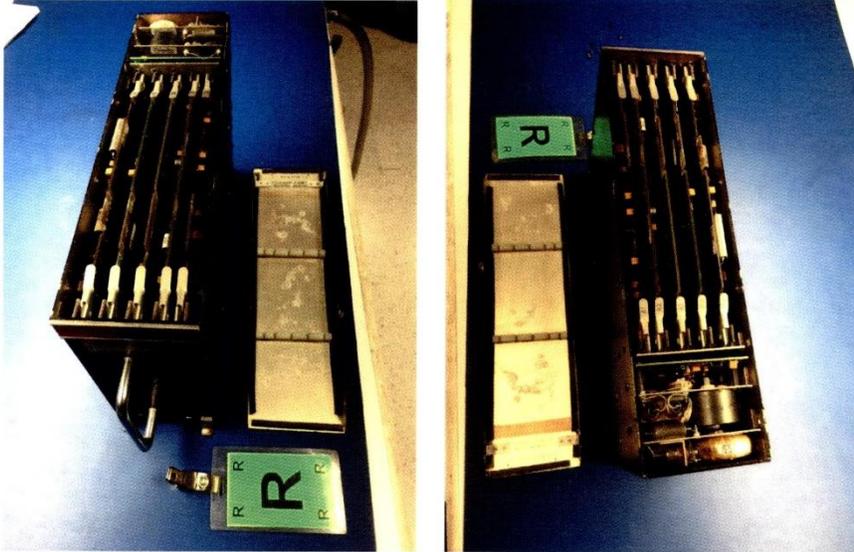
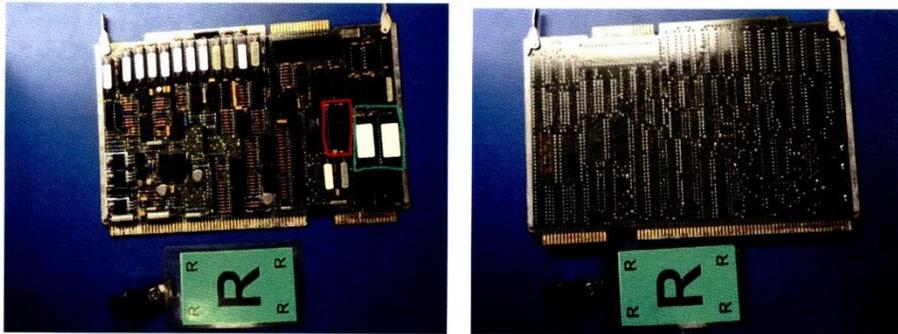
The green "R" tag designates unit 2 ("Pilot").

The EEPROM containing the error codes is highlighted in a red box above. Also, the flight software memory devices is highlighted by the green box.

All of the boards appeared to exhibit signs of corrosion as well as the backplane, which these processor units were plugged into. In an effort to mitigate the risk of introducing additional error codes into the EEPROM due to the corrosion on the hardware, it was decided that each processor board would be installed in a slave test unit.
