# AIRCRAFT ACCIDENT REPORT

PAAN/2004/07/26/F

**Report on the Accident to a Pan African Airlines  
Nigeria Ltd Bell 412 EP Helicopter with registration  
5N-BDZ which occurred near SEDCO Energy Rig  
Platform, Off Nigeria's Southern Coastline  
on 26th July, 2004**

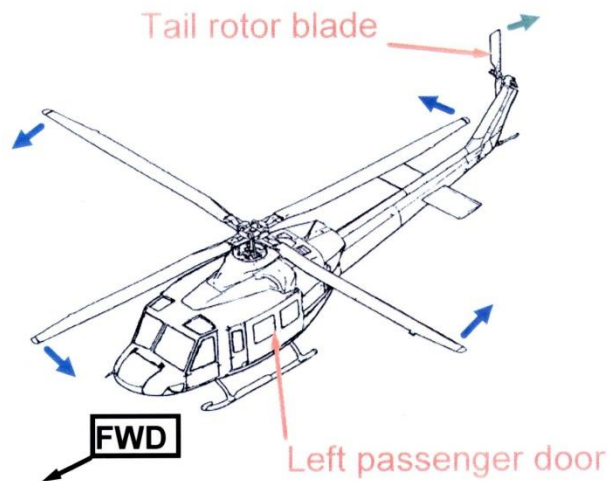
Reportedly, the helicopter took off from an oil platform off the coast of Nigeria and contact was lost after 3 minutes. The components received for examination were the only structural items reportedly recovered from the water. The sketch in figure 1 illustrates the aircraft with the left passenger door and the tail rotor located and identified. The direction of rotation of the main rotor, as indicated by the blue arrows, is counterclockwise when viewed from above. The direction of rotation of the tail rotor, as indicated by the green arrow, is counterclockwise when viewed from the right side of the aircraft. The forward (FWD) direction is also indicated.

Figure 1. Sketch of the accident aircraft type with the left passenger door and the tail rotor blade indicated.

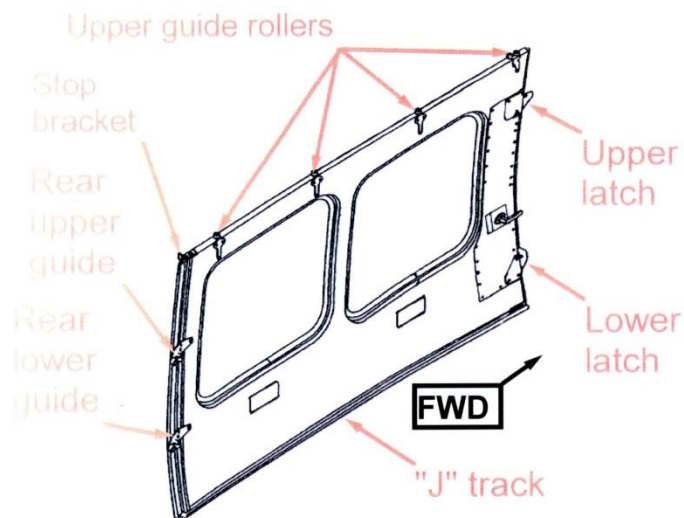
The sketch in figure 2 illustrates a left passenger door, viewed from the inside of the aircraft, with the forward and up directions indicated. The door components that interact with the fuselage are identified and consist of the four upper guide rollers, the upper latch, the lower latch, the "J" track along the lower edge, the rear lower guide, the rear upper roller guide and the stop bracket.

Figure 2. A sketch of the interior surface of the left passenger door.
