AIRCRAFT ACCIDENT REPORT

IAC/2013/11/25/F

Accident Investigation Bureau

**Report on the Accident involving a Diamond DA40D
Aircraft operated by International Aviation College
(IAC) Ilorin with Nationality and Registration Marks
5N-BRD which occurred at Ilorin International Airport,
Ilorin, Kwara State, Nigeria
On 25th November, 2013**

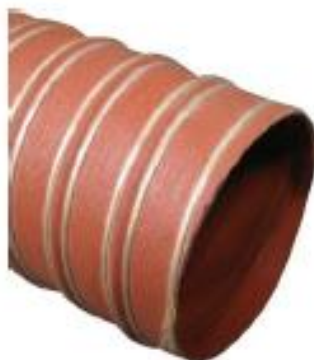
- Suitable Quality: 2 strings (one close to each side of the wire) and a maximum of bonding area between each winding

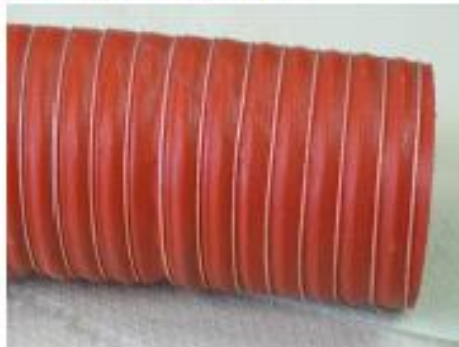
- Other Quality available (NOT suitable):

- If a NOT suitable quality is identified, replace turbocharger hose with DAI P/N SG2M-64-920mm according to WI-MSB D4-075 Revision 1 or later issue.
