# AIRCRAFT ACCIDENT REPORT NPF/2012/03/14/F

Accident Investigation Bureau

Report on the accident involving Bell 427 Helicopter belonging to the Nigeria Police Force, registration 5N-POL which occurred at Kabong, Jos South L.G.A Plateau State on the 14<sup>th</sup> of March, 2012

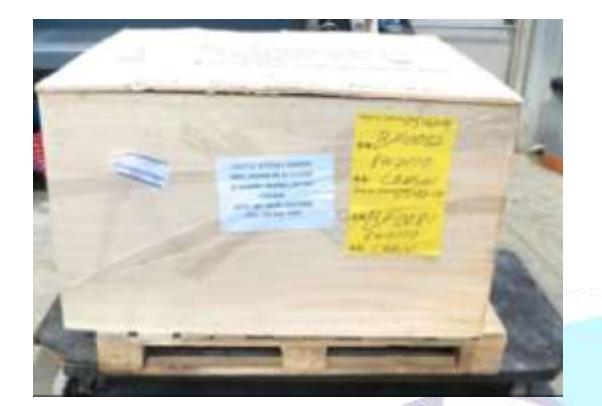
Photo No.1

The engines were received at P&WC Saint-Hubert Service Centre packed together in a wooden box (Photos No.1 & 2). Engine s/n BF0081 was upside down in the box.

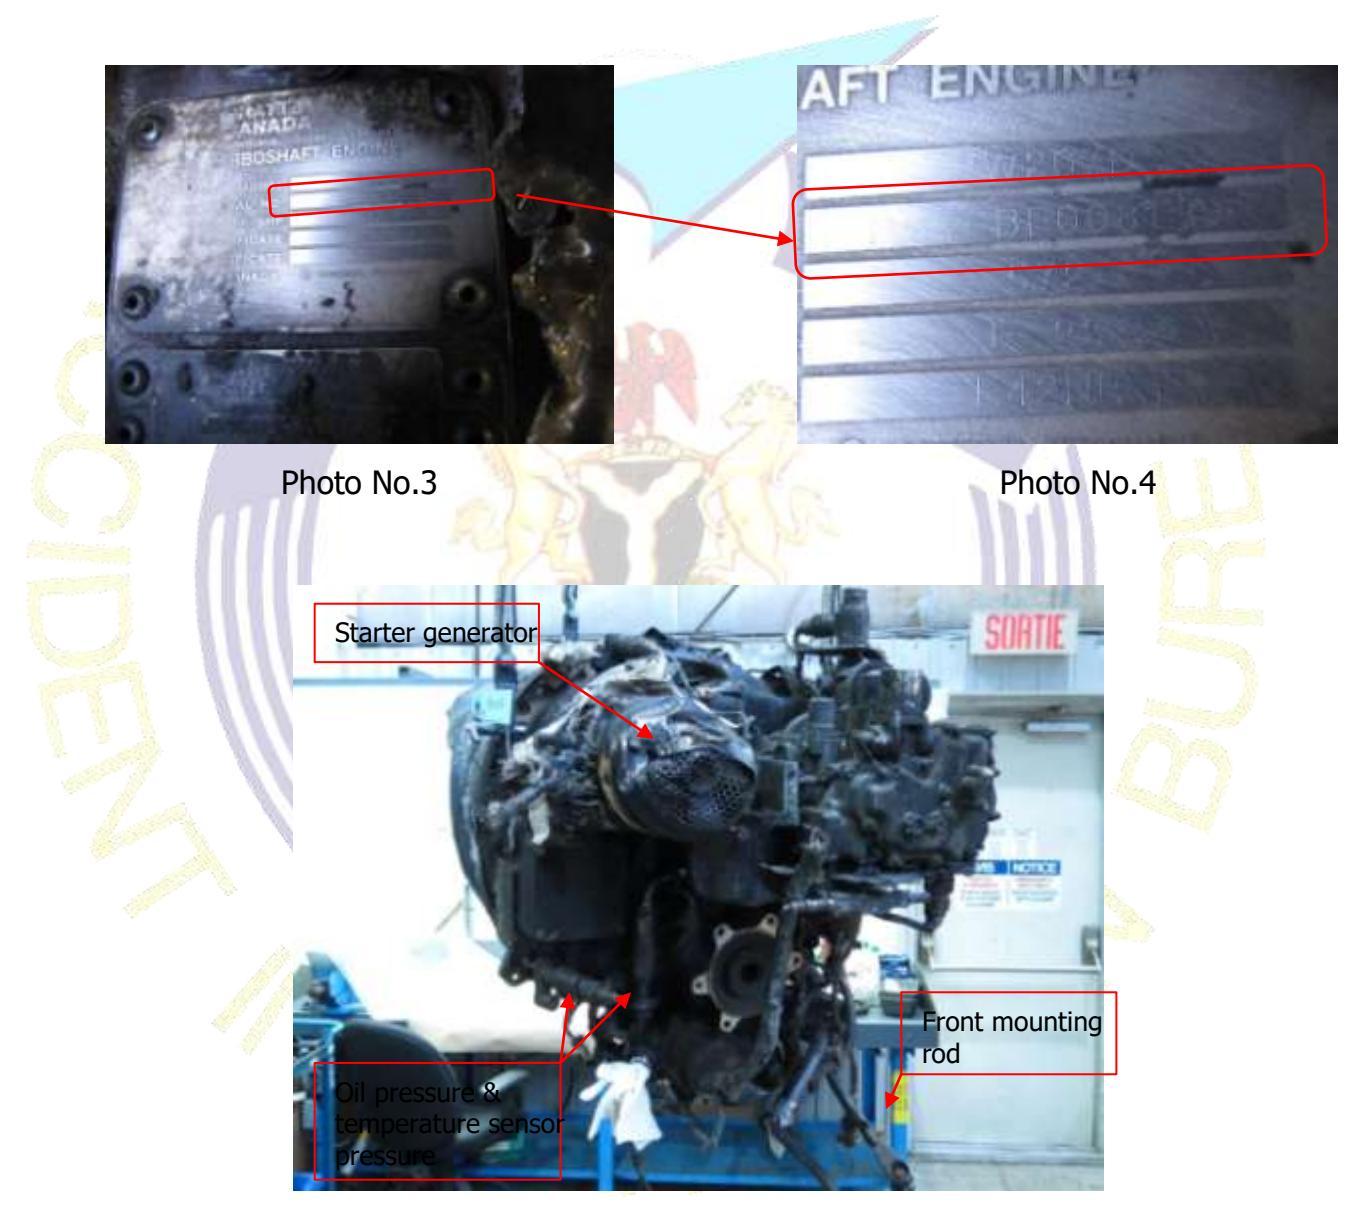
Photo No.5

starter generator, front engine mounting rod, oil pressure and temperature sensors (Photo No.5), rear airframe fire seal, P3 bleed tube (Photo No.6) and rear airframe mounting rod (Photo No.7).

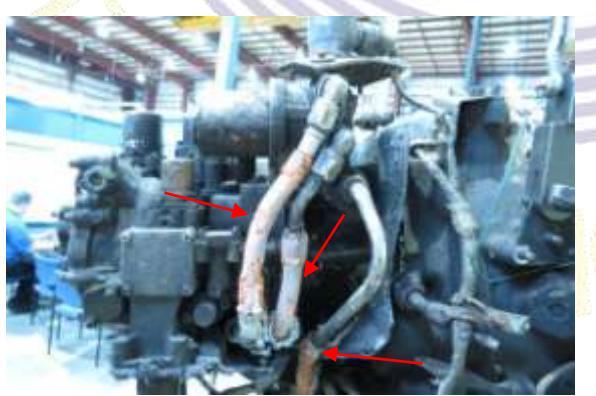
Photo No.8

The engine was entirely exposed to post impact fire, the external components displayed soot stain. The fuel manifold, the fuel pump inlet and outlet tubes silicon cuff was completely melted (Photos No.8 & 9). The Fuel Management Module (FMM) vapour box was disintegrated (Photo No. 10). The inlet screen, the front and rear engine fire seals displayed impact and post impact crash fire damage (Photo No.11). The engine harness and connectors displayed fire damage (Dotted arrow Photo No.12). The engine harness connectors were still engaged to their terminals (Photos No. 12 & 13).

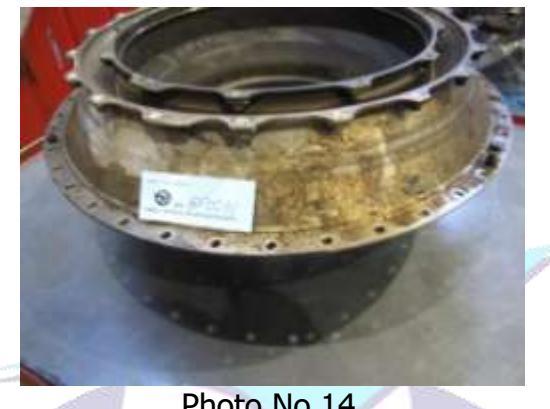
**Turbine Support Case:** The turbine support case external surface displayed environmental dust and soot stain (Photo No.14).

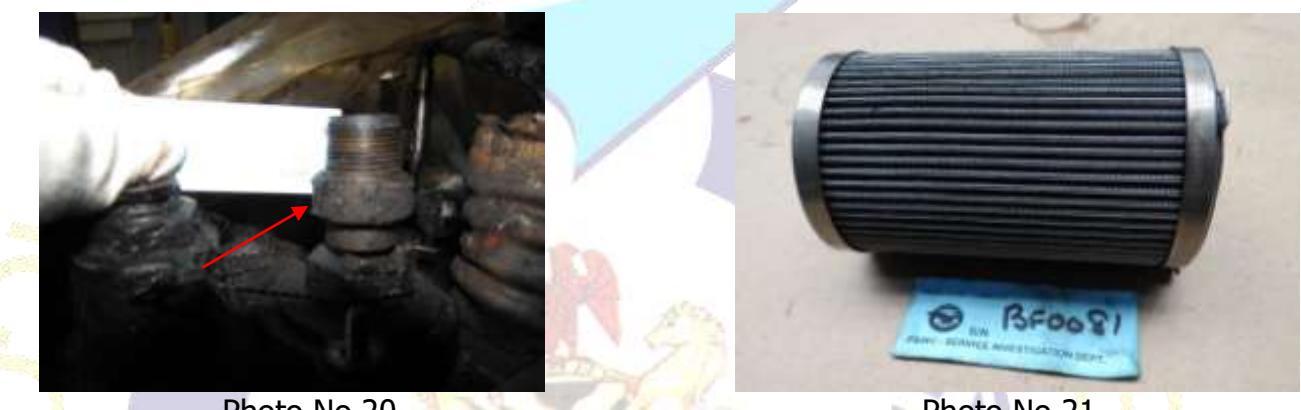
Photo No.20

**Reduction Gearbox Chip Detector:** Was seized into the RGB front housing. (Photo No.20)

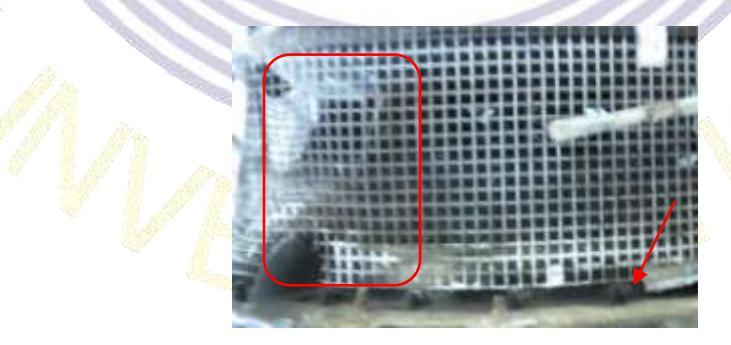
Photo No.22

**Inlet Screen:** The compressor inlet screen displayed deformation at wire mesh and melted outer rubber sealing bands (Photo No.22).

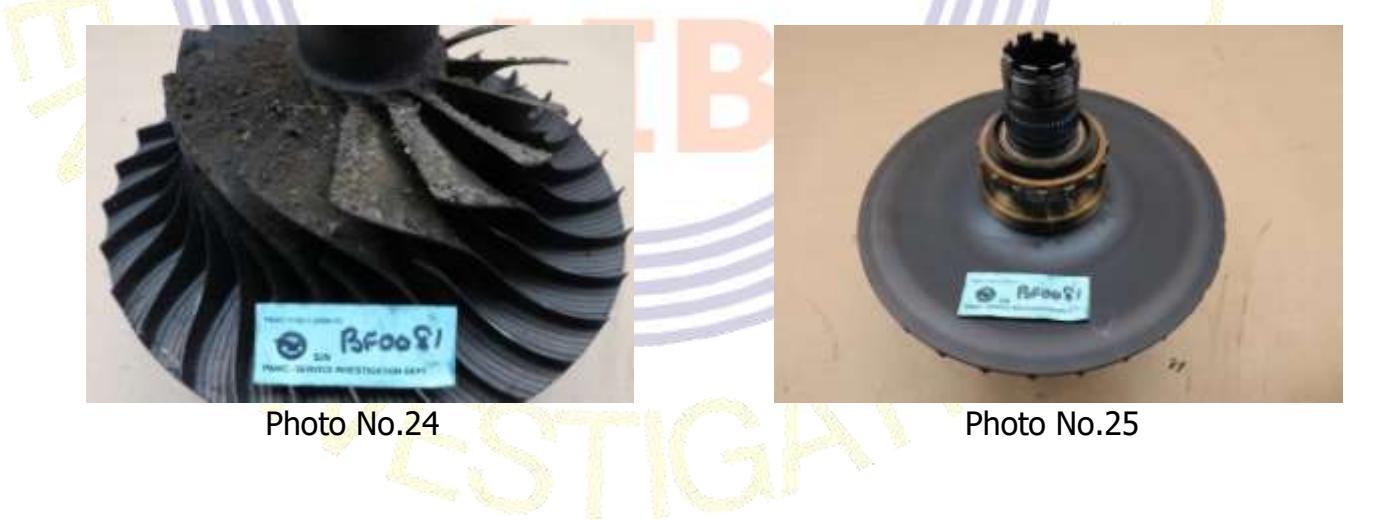
**Centrifugal Impeller:** The centrifugal impeller displayed foreign object damage and dirt deposit at inlet vane (Photo No.24), otherwise it was unremarkable. The impeller back face was unremarkable (Photo No.25). There was no pre or post impact rubbing indication.

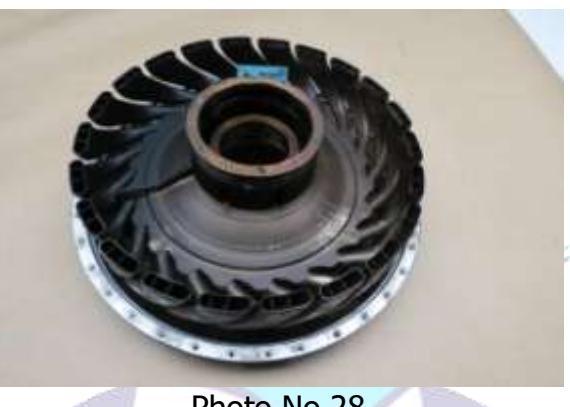
**Diffuser Case:** The diffuser case displayed light foreign object damage at apex area and combustion soot at P3 area (Photo No.28).

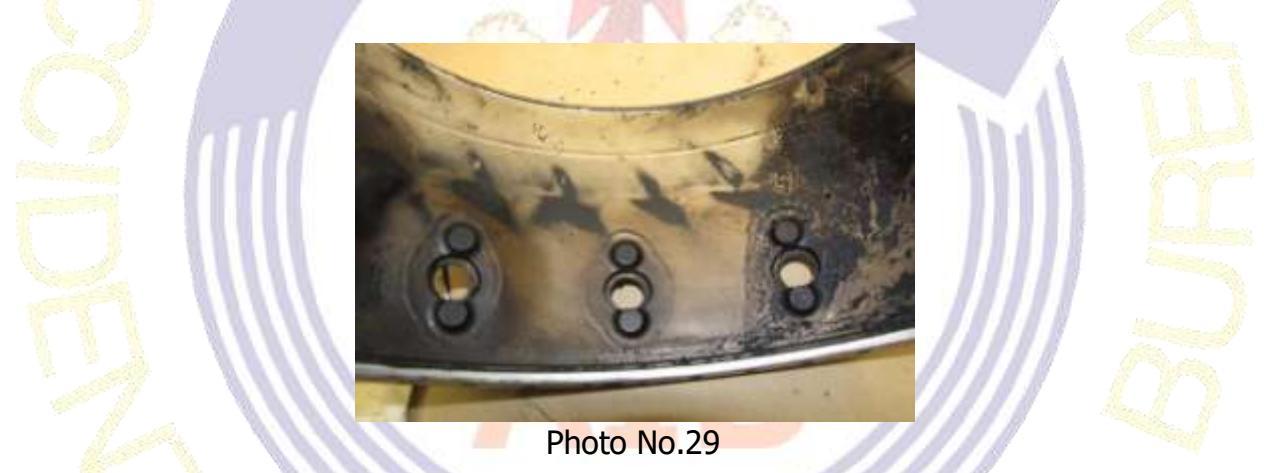
**Gas Generator Case:** The gas generator case displayed dirt deposit and post impact fire soot stains (Photo No.29).

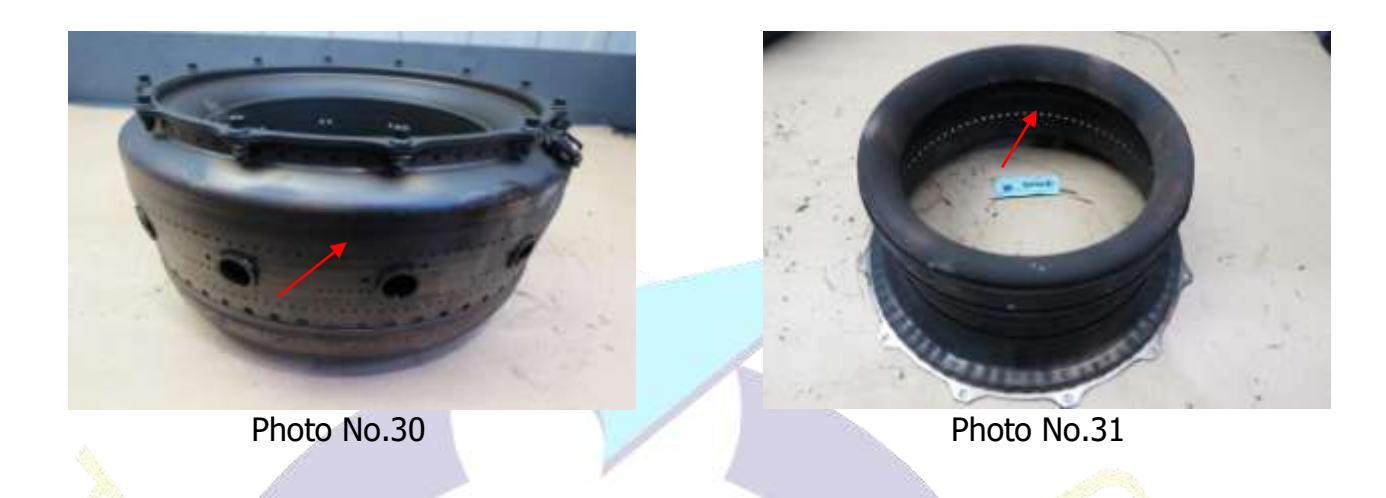
**Combustion Chamber Liners:** The inner and outer liners displayed soot on external surface due to post impact internal fire into the gas generator core area (Photos No.30 & 31).

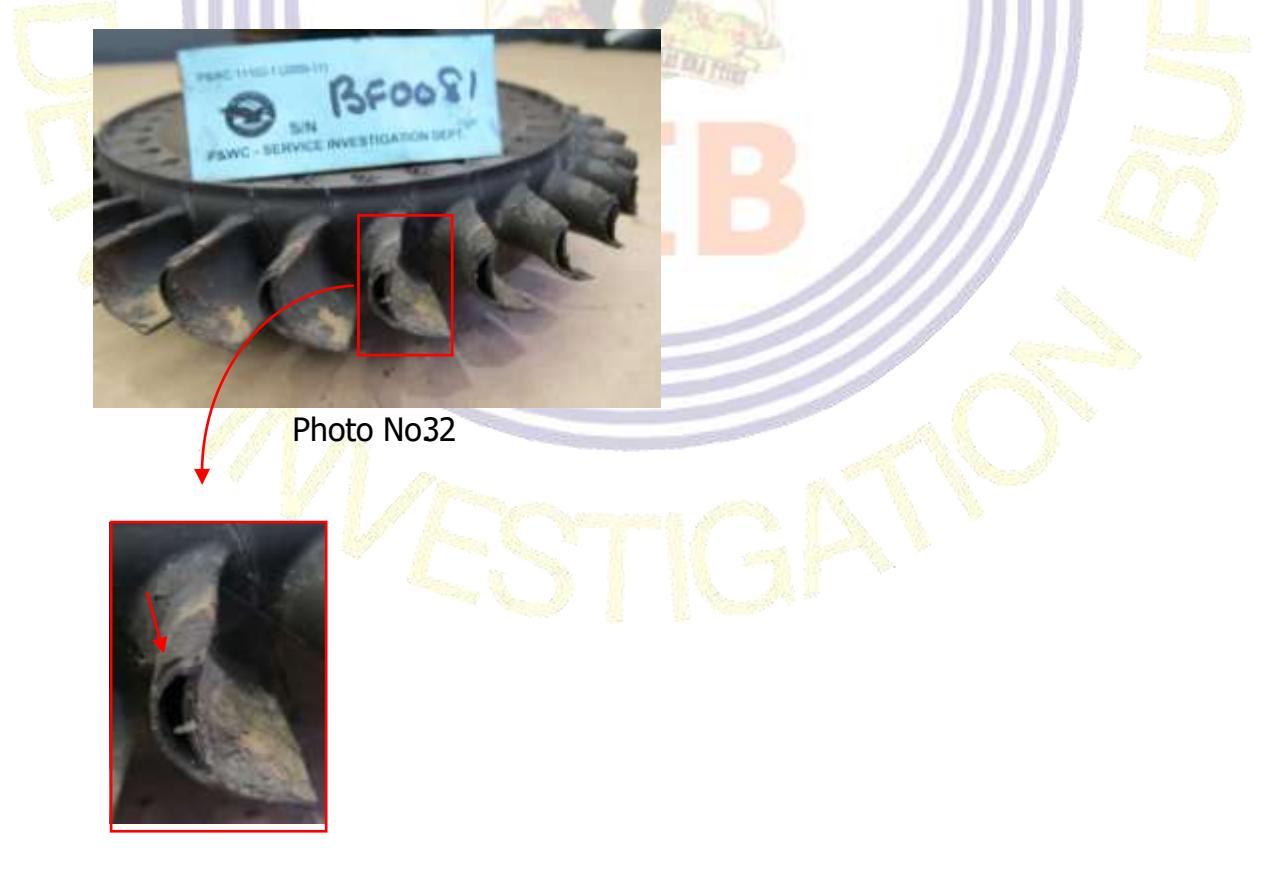
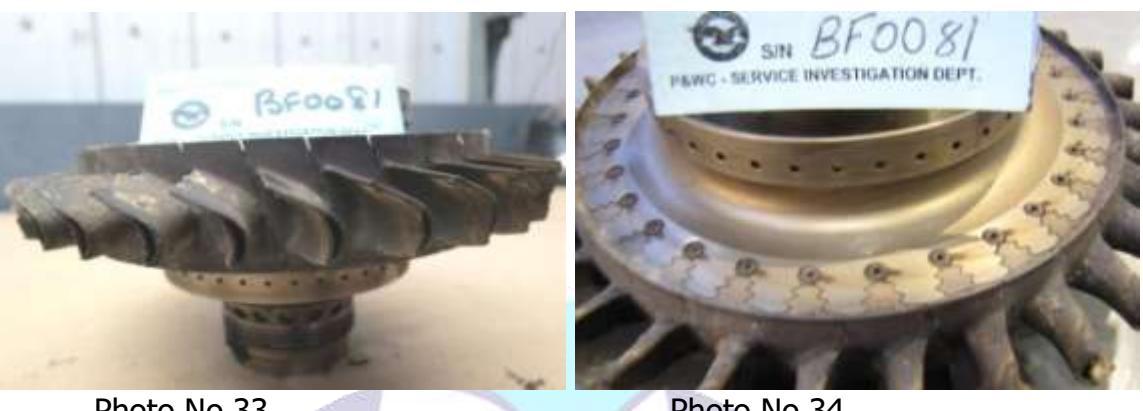
**Compressor Turbine (CT) Disk & Blades:** The CT blades displayed burning, flaked surface coating at airfoil tips (Photos No.32 & 33), impact damage and dirt deposit at airfoil surface. The C.T. disk was unremarkable (Photo No.34).

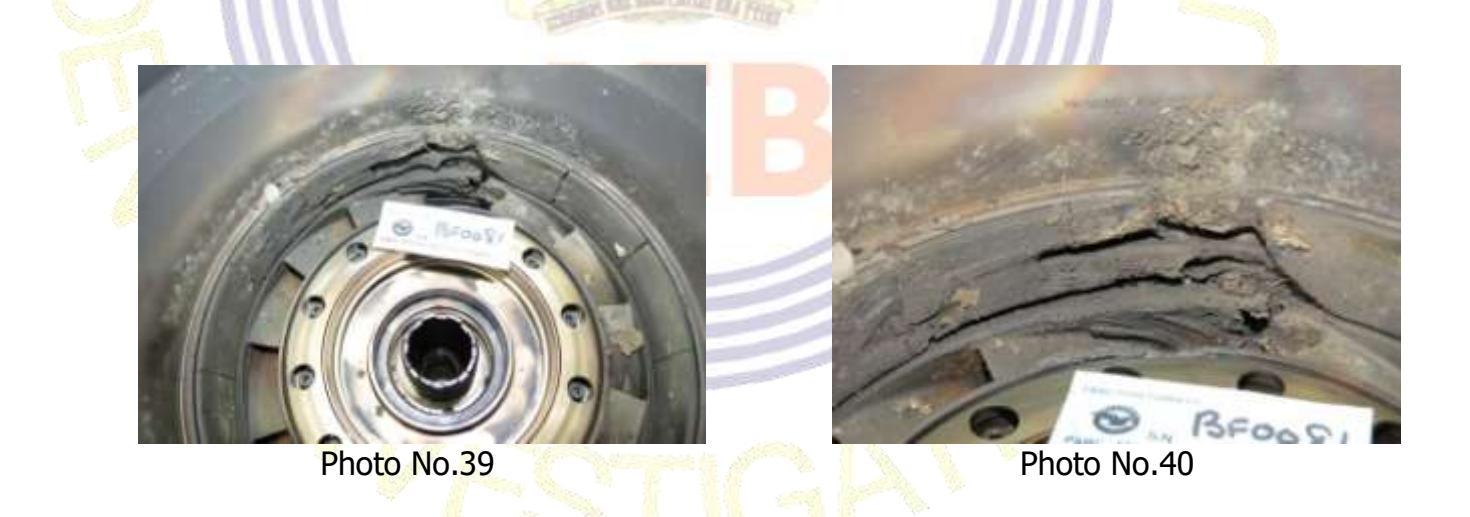
**Compressor Turbine Shroud Segments:** The CT shrouds segments displayed burning associated with splattered material and impact damage at 8 o'clock position (Photos No. 39 & 40).

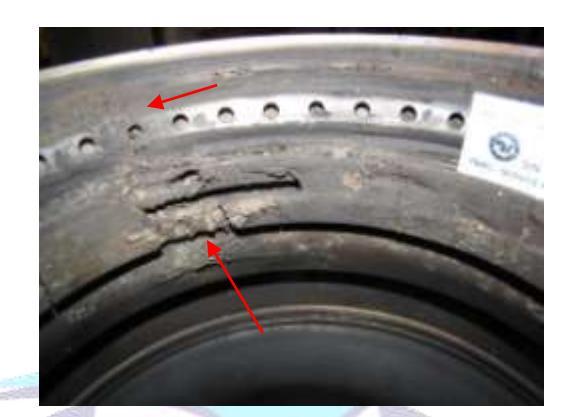
**Turbine Support Case:** The turbine support case displayed burning and melted material at CT shroud segments retaining lip area and CT vane seal ring sealing diameter 8 o'clock position (Photo No.41).

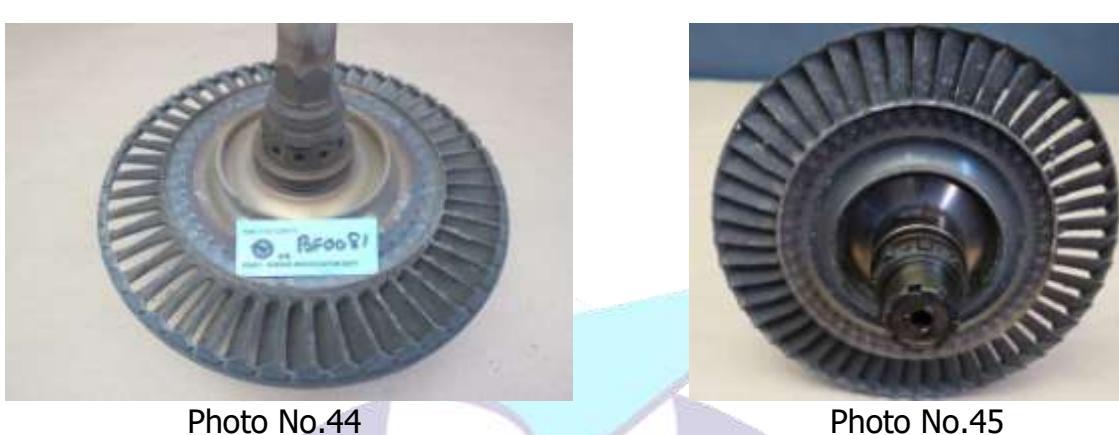
**Power Turbine Disk and Blades:** The PT blades displayed impact and splattered material at blades airfoil (Photos No.44 & 45). The PT blades shroud knife edge displayed light rubbing indication.

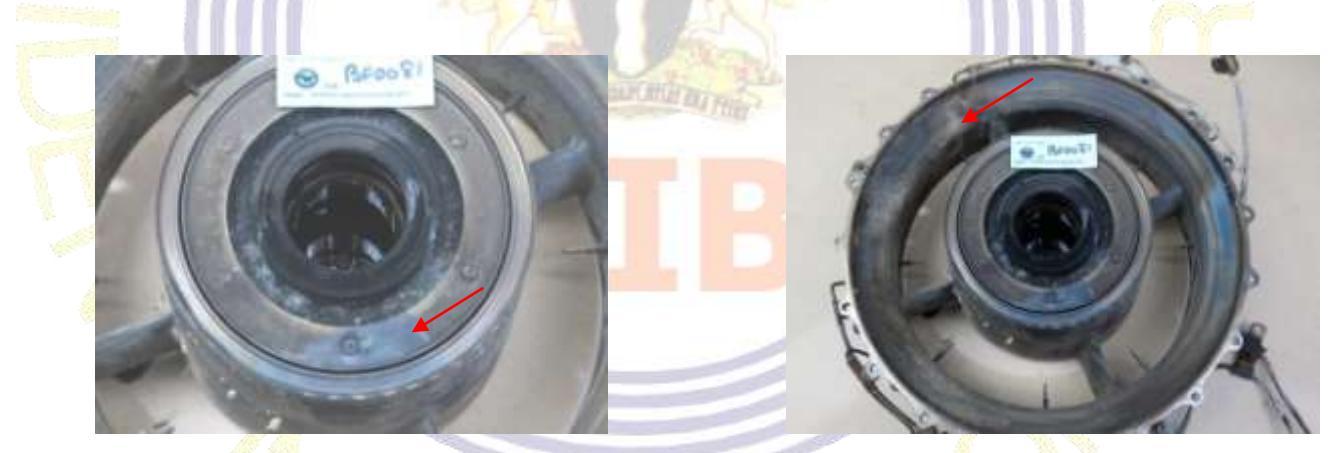
**Turbine Exhaust Case:** The turbine exhaust case displayed cooked oil deposit at #5 bearing area (Photo No.46) and soot at gas path (Photo No.47).

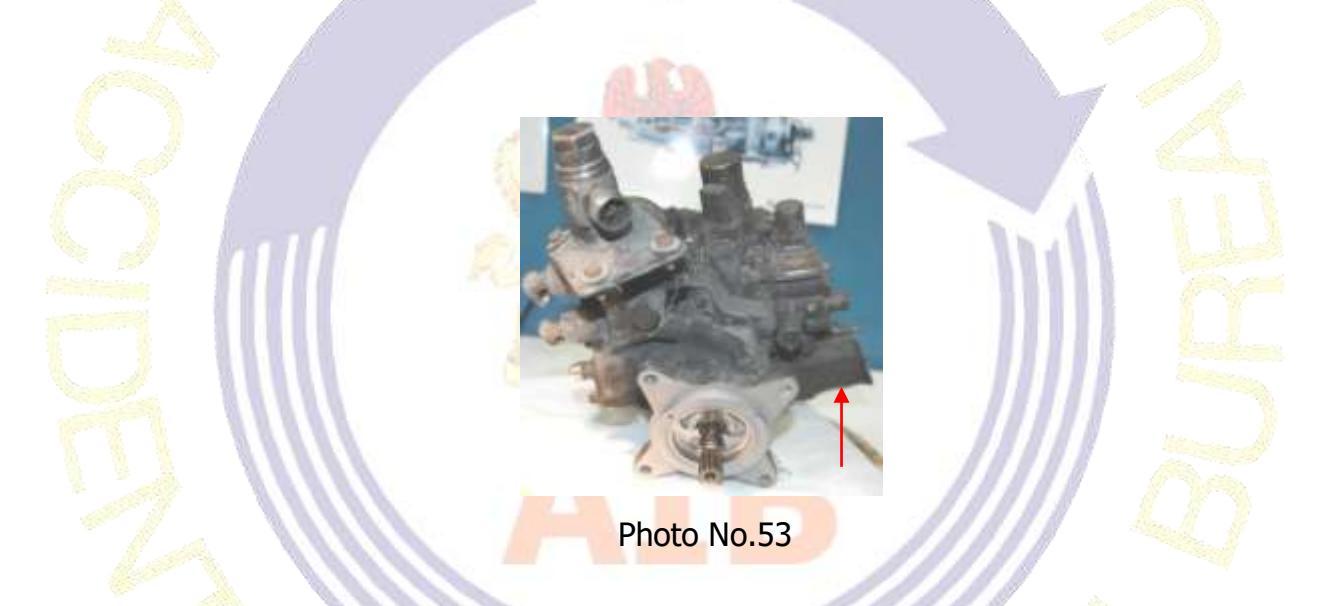
**Fuel Management Module (FMM):** The exterior of the fuel management module (FMM) was blackened, ash and soot was attached to the exterior, impact damages were observed, and the fireshield had been partially consumed by the post impact fire (Photo No.53). FMM by-pass switch/indicator and power lever potentiometer were loose and could be moved by hand. There was no fuel remaining in the filter bowl and the filter element had been damaged by the post impact fire, but there was no debris visible in the pleats. Lockwire was present at all locations.

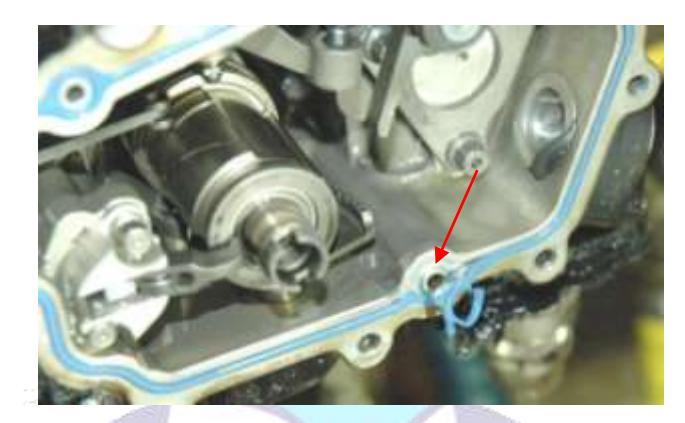
Photo No.54

The FMM was installed with a slave fuel filter on the test stand; it was observed that fuel was leaking from the cover and the overboard drain. The cover was removed and the packing gasket was found to be heat-damaged (Photo No.54). A new gasket was installed and the prior test repeated and further leaks were observed, indicating that it would not be possible to conduct the test sequence. The electrical tests were completed. The FMM was disassembled, no major discrepancies were observed.

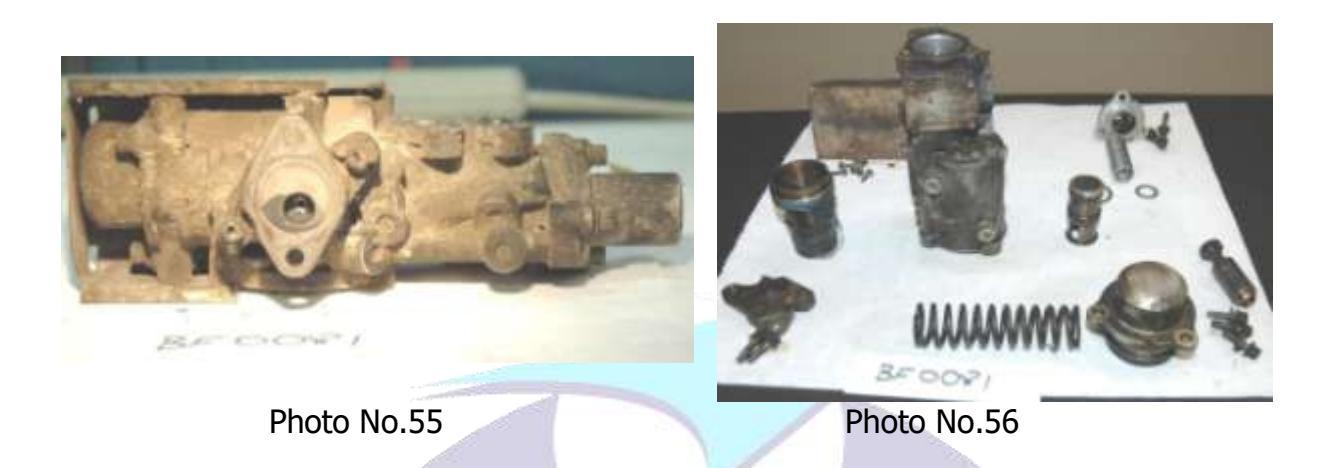
**Flow Divider Valves (FDV):** The exterior of the flow divider valve (FDV) and the heat-shield were discoloured due to heat exposure (Photo No.55). Burned residue was present in the fuel ports. Chemical analysis of the residue indicated that it was composed of carbon with fluorine, suggesting that it was burned packing. Lockwire was present at the inlet adapter mounting. It was not possible to conduct a complete test as the FDV was leaking. However, the limited testing that was possible indicated that the flow divider functioned to transfer fuel pressure between primary, secondary and dump. The FDV was disassembled, the internal components were blackened and the packing had been damaged by the post impact fire (Photo No.56). There were no scratches observed on the interior or exterior surfaces of the valves or in the bores of the housing that would have prevented normal operation of the FDV prior to the event.

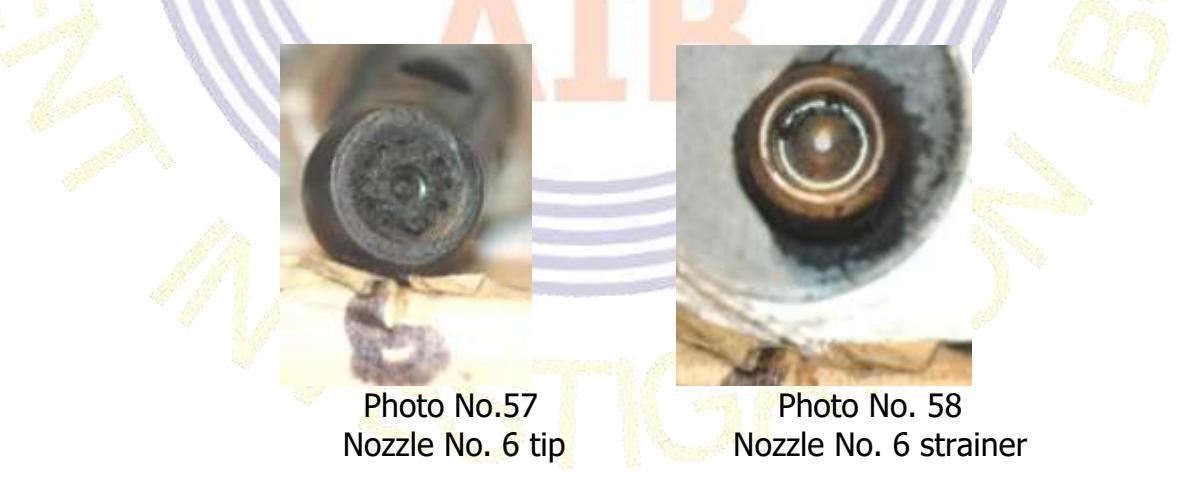
**Fuel Nozzles:** Carbon deposits were present on the nozzle tips. The stains were heavier at the No. 3, 6, 9, 10 nozzles (Photo No.57). Since combustion liner did not show indication of abnormal burning into gas path, that carbon deposit is believed to be due to post impact fuel residue burning. Burned residue was present in the inlet strainer of the No. 2, 4, 6 and 11 nozzles (Photo No.58). Chemical analysis of debris collected on strainers nozzles was mainly composed of carbon with fluorine (suggestive of burned packing material). The nozzles were bench tested, the deviation observed were secondary to post impact fire.

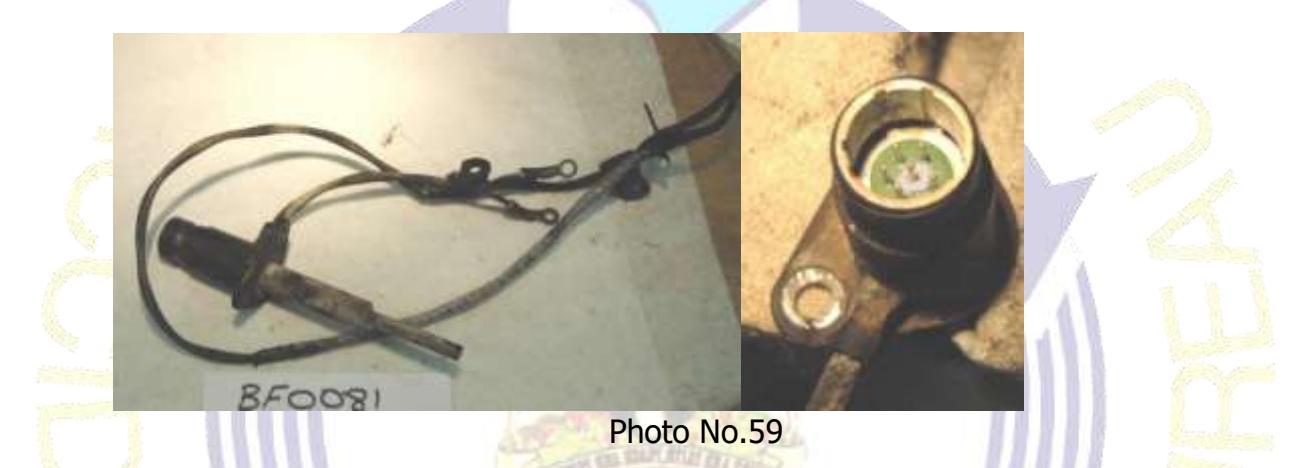
**Inlet temperature (T1) thermocouple:** The exterior of the engine inlet (T1) thermocouple was soot-stained. The inside of the electrical connector was heat-damaged (Photo No.59). The T1 thermocouple was bench tested, deviation observed were secondary to post impact fire.

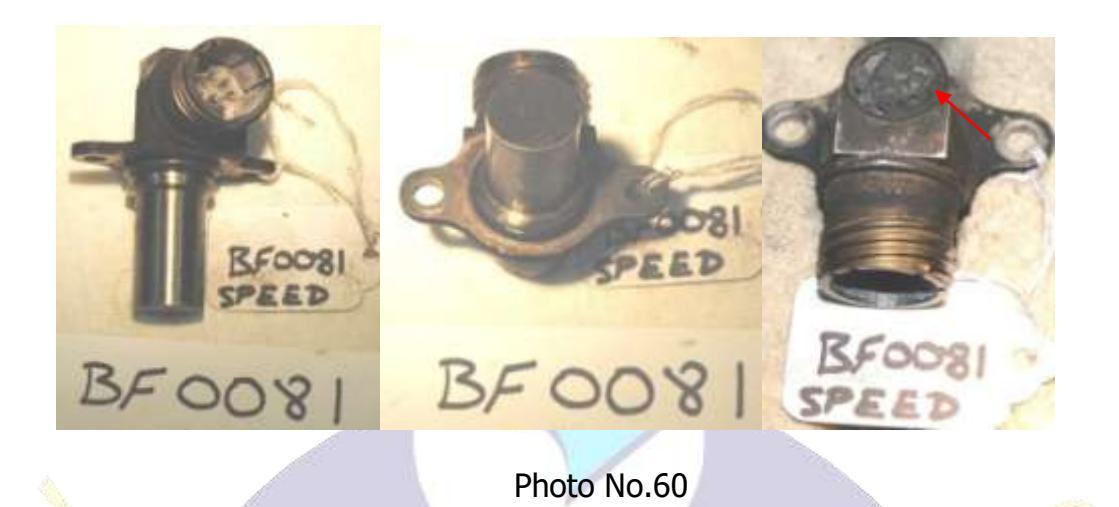
**Gas Generator (Ng) speed sensor:** The exterior of the Ng speed sensor was soot-stained. Burned debris was present inside the electrical connector and the rubber seal was heat-damaged. There was melted residue adhering to the exterior of the electrical connector shell. The cover at the sensor housing was missing (Arrow Photo No.60). The Ng sensor was bench tested, deviations observed were secondary to post impact fire.

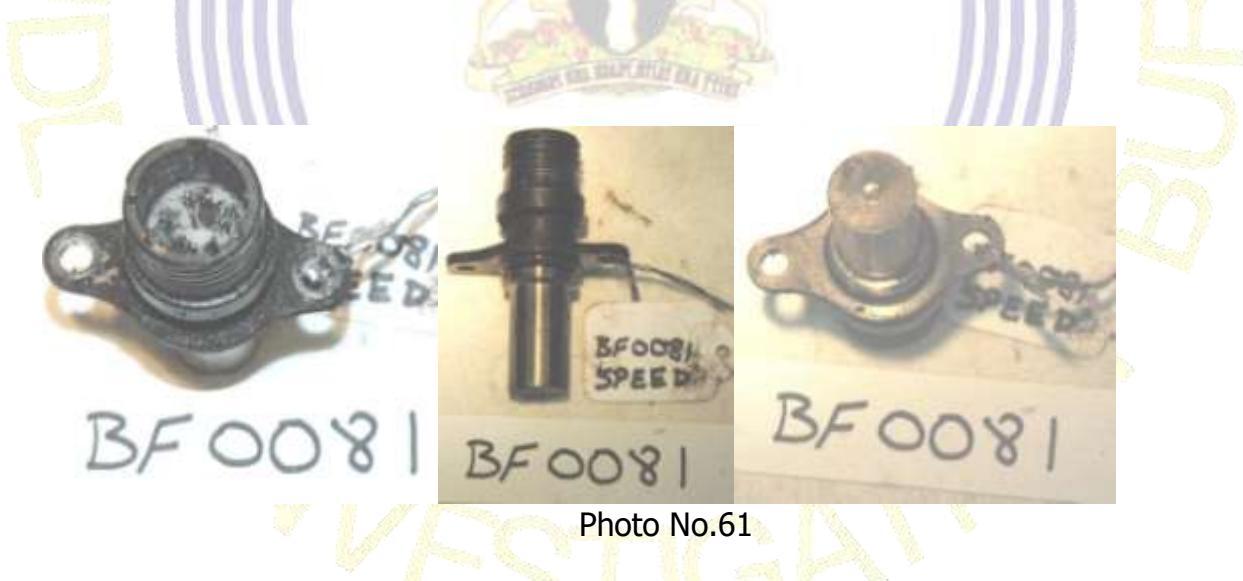
**Power turbine (Npt) speed sensor:** The exterior of the Npt speed sensor was sootstained. Burned, damp debris was present inside the electrical connector and the rubber seal was heat damaged (Photo No.61). The Npt speed sensor was bench tested, deviation observed were secondary to post impact fire.

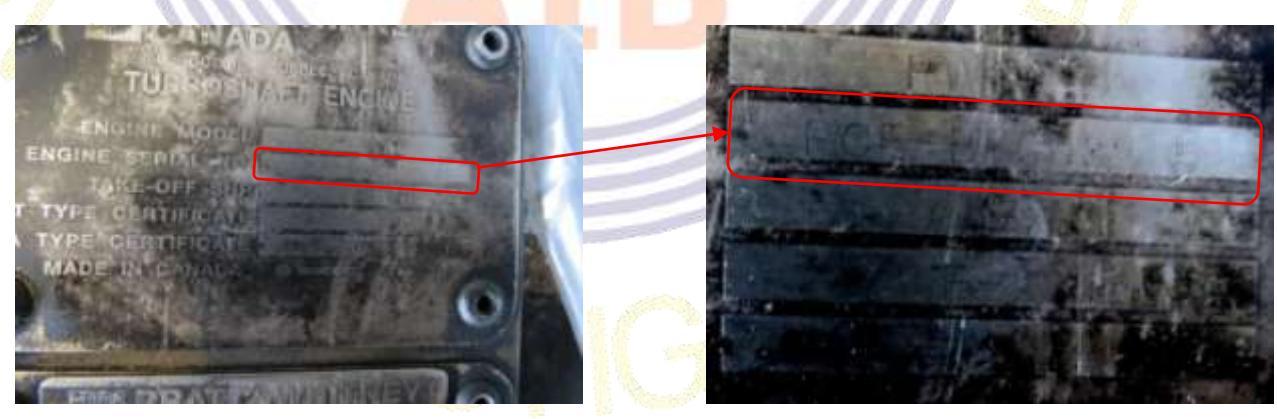
The engine was removed from the wooden box and installed on a disassembly stand for detail inspection. The data plate confirmed the engine serial number (Photos No.63 & 64). Airframe related components were still installed on engine; starter generator, oil pressure and temperature sensors (Photo No.65), the rear airframe fire sealand the P3 bleed tube (Photo No.66).

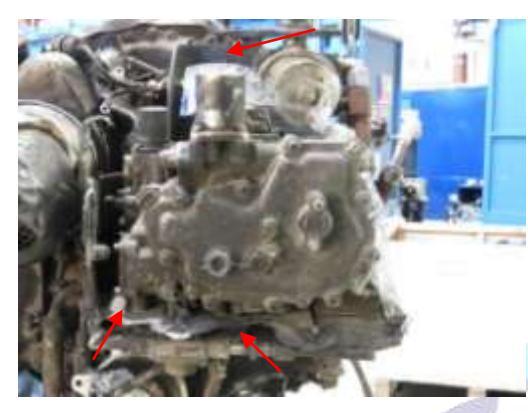
Photo No.69

The engine was entirely exposed to post impact fire, external components displayed soot stains. The fuel manifold silicon cuff was completely melted (Photo No.67). As received, the fuel pump inlet and outlet tubes were disconnected (Arrows Photo No.68) and the fuel filter cover locking pin was removed (Dotted arrow Photos No.68), the Fuel Management Module (FMM) vapour box was disintegrated (Photo No.69). The inlet screen and the engine front and rear fire seals displayed impact and fire damage (Photo No.70). The engine harness and connectors displayed fire damage (Arrow Photos No.71 & 72). The engine harness connectors were still engaged to their terminals (Dotted arrow Photo No. 72).

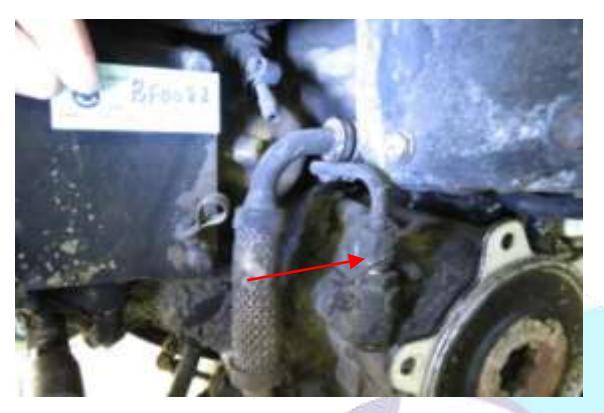
Photo No.77

**Compressor Discharge Air (P3):** The FMM P3 feed line from the #8 bearing carbon seal cover nipple to the FMM, was still properly installed and lock wired (Photo No.77). It was, however, partially released at the FMM connector due to post impact fire damage (Photo No.78).

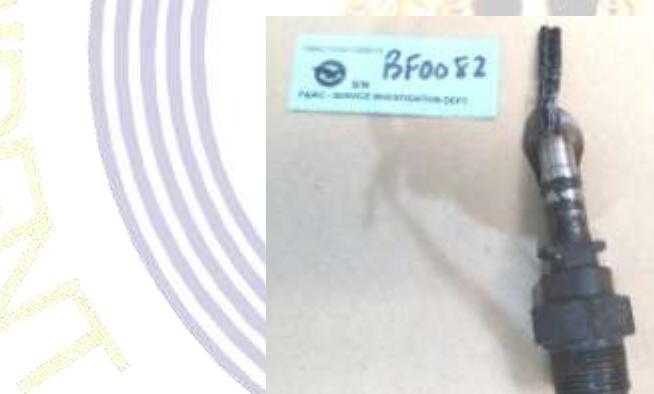
Photo No.79

Reduction Gearbox Chip Detector: The reduction gearbox chip detector was

melted due to post impact fire (Photo No.79).

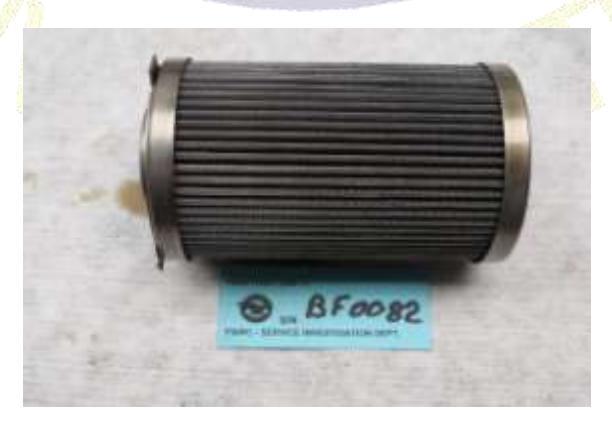
Photo No.80

Oil Filter: Clean (Photo No.80).

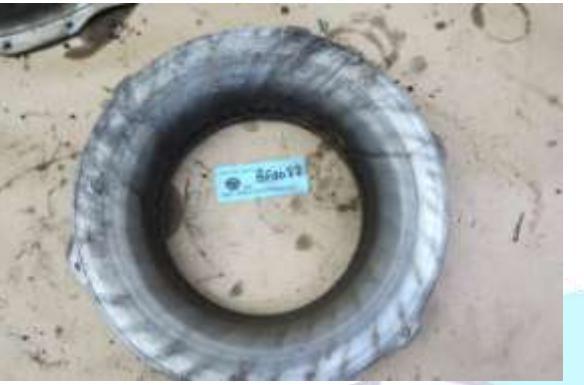
Photo No.82

**Centrifugal Impeller Shroud:** The impeller shroud displayed dirt on the abraidable surface (Photo No.82). The damping cavities also displayed dirt deposits (Photo No.83).

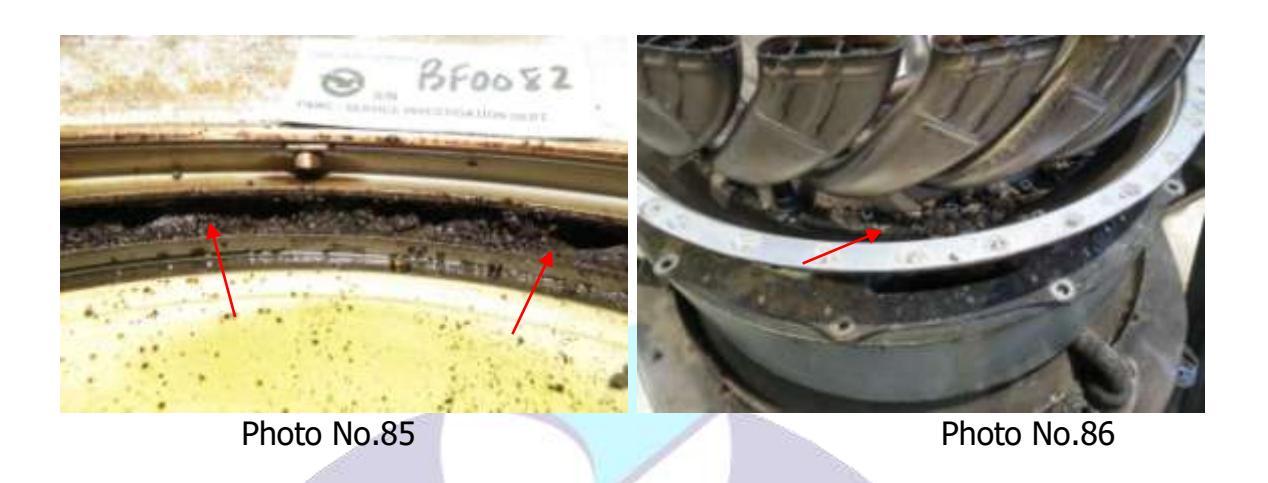
**Diffuser Case:** The diffuser case displayed foreign object damage and dirt deposit at the apex and P3 area (Photos No.85 & 86).

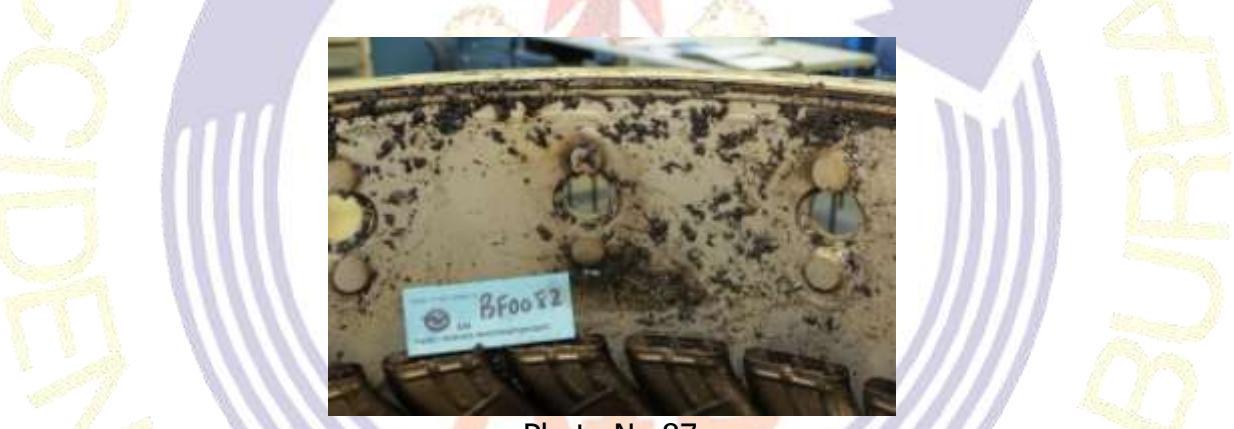
Photo No.87

**Gas Generator Case:** The gas generator case displayed dirt deposit on the inner wall (Photo No.87).

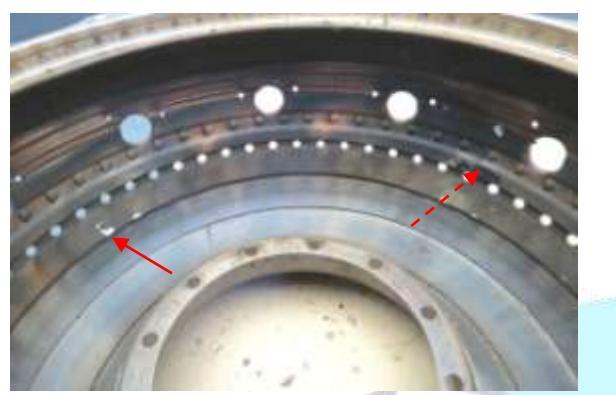
Photo No.88

**Combustion Chamber Outer Liner:** The outer liner displayed coating loss (Arrow Photo No.88) and carbon build-up (Dotted arrow Photo No.88); otherwise was unremarkable (Photo No.89).

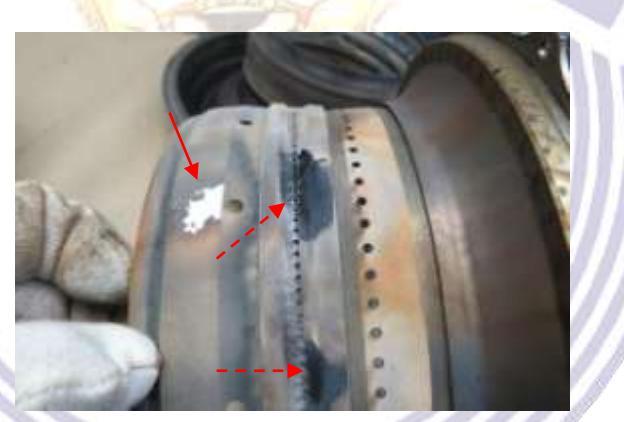
Photo No.90

**Combustion Chamber Inner Liner:** The inner liner displayed coating loss (Arrow Photo No.90) and carbon build-up (Dotted arrows Photo No.90); otherwise it was unremarkable.

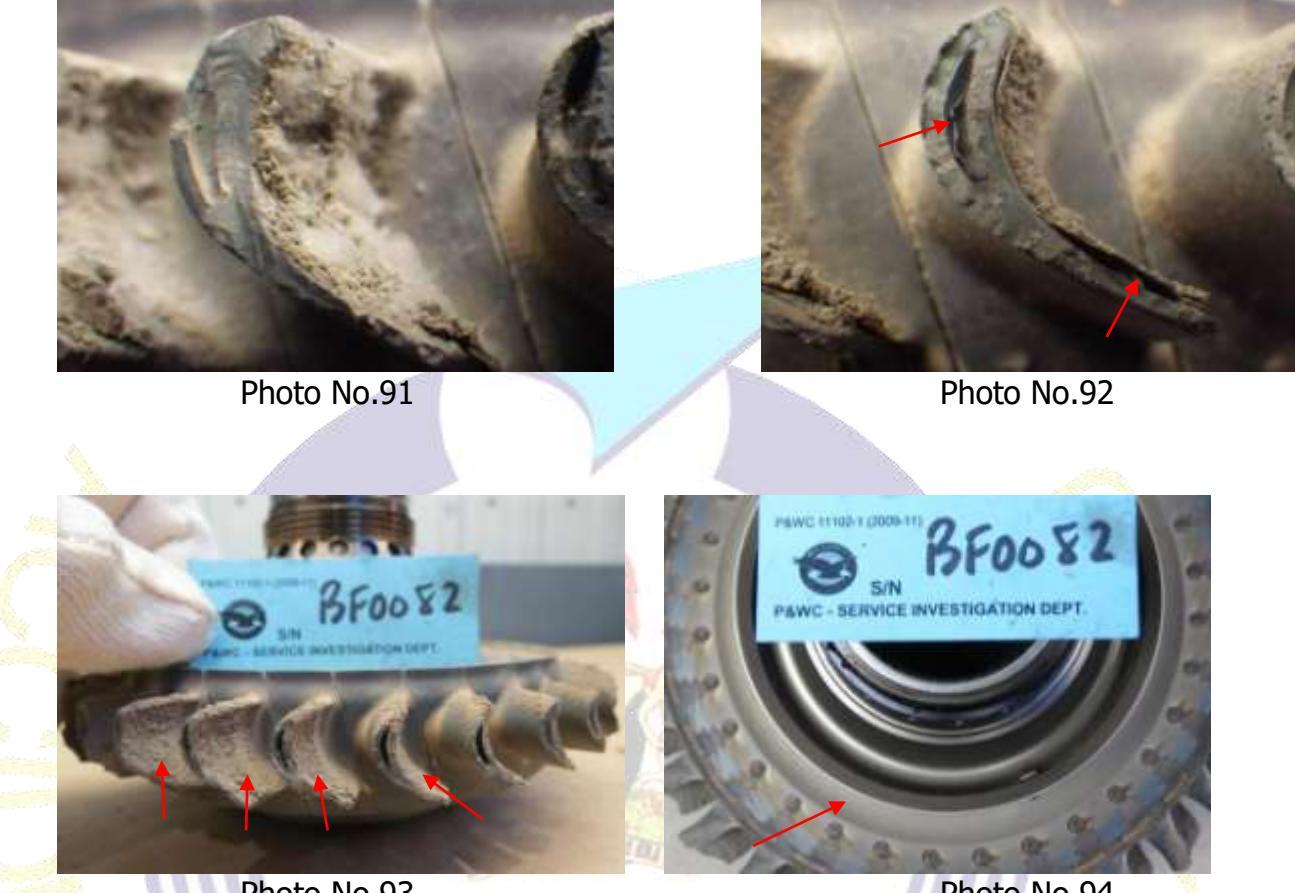
**Compressor Turbine (CT) Disk & Blades:** The CT blades displayed fractured tips (Photo No.91 & 92), flaked surface coating (Arrow Photo No.92), and heavy dirt deposit at airfoil surface (Photo No.93). The absence of dirt deposit on the CT blade tips indicates that the fractures occurred later following the aircraft ground impact and dirt ingestion. The CT disk was unremarkable (Photo No.94).

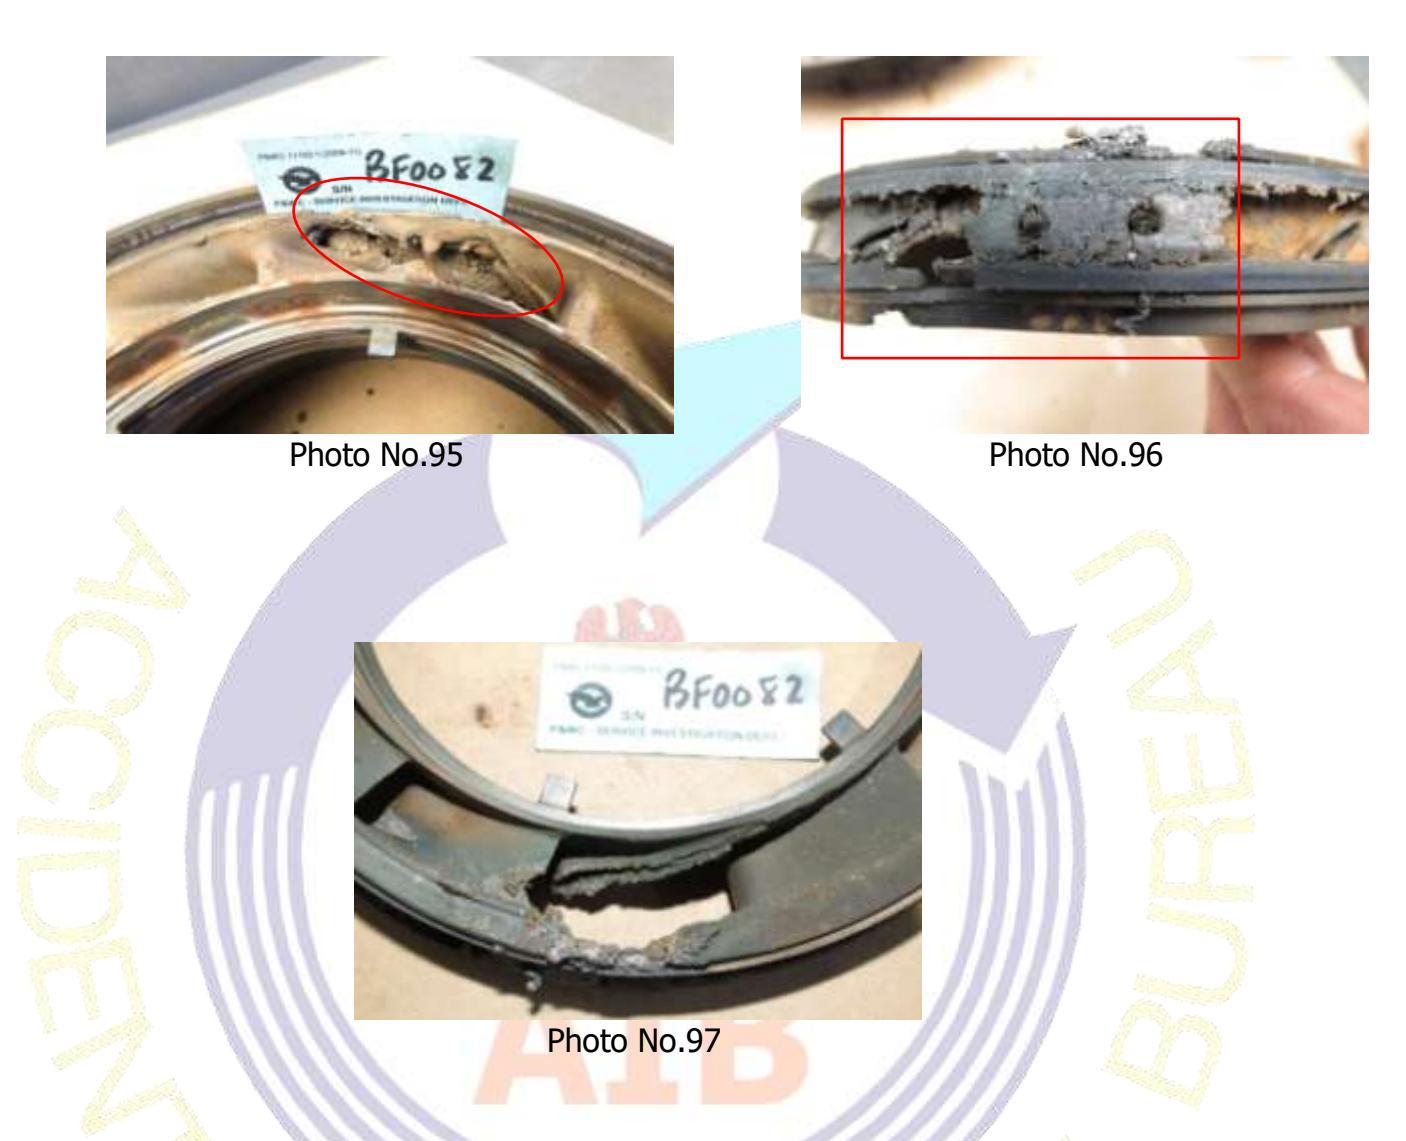
Compressor Turbine Vane Ring: The CT vane ring displayed burning with melted and splattered material at the airfoil and outer rim at 5 O'clock (Photos No.95 to 97).

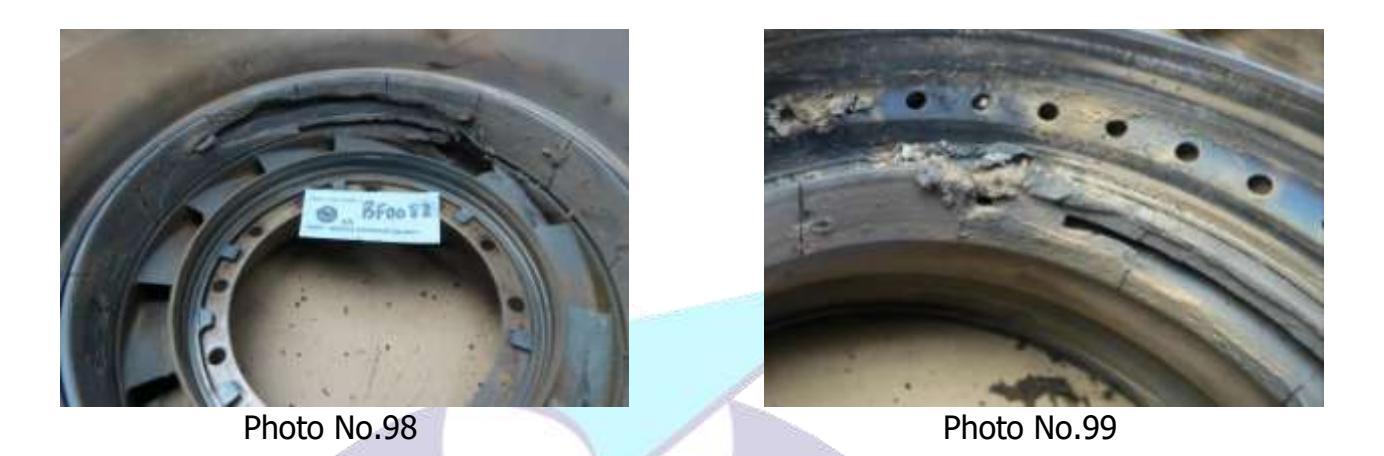
**Compressor Turbine Shroud:** The CT shrouds segments displayed burning associated with splattered material and impact damage at the 5 o'clock position (Photos No. 98 & 99).
