# AIRCRAFT ACCIDENT REPORT NPF/2012/03/14/F

Accident Investigation Bureau

Report on the accident involving Bell 427 Helicopter belonging to the Nigeria Police Force, registration 5N-POL which occurred at Kabong, Jos South L.G.A Plateau State on the 14<sup>th</sup> of March, 2012

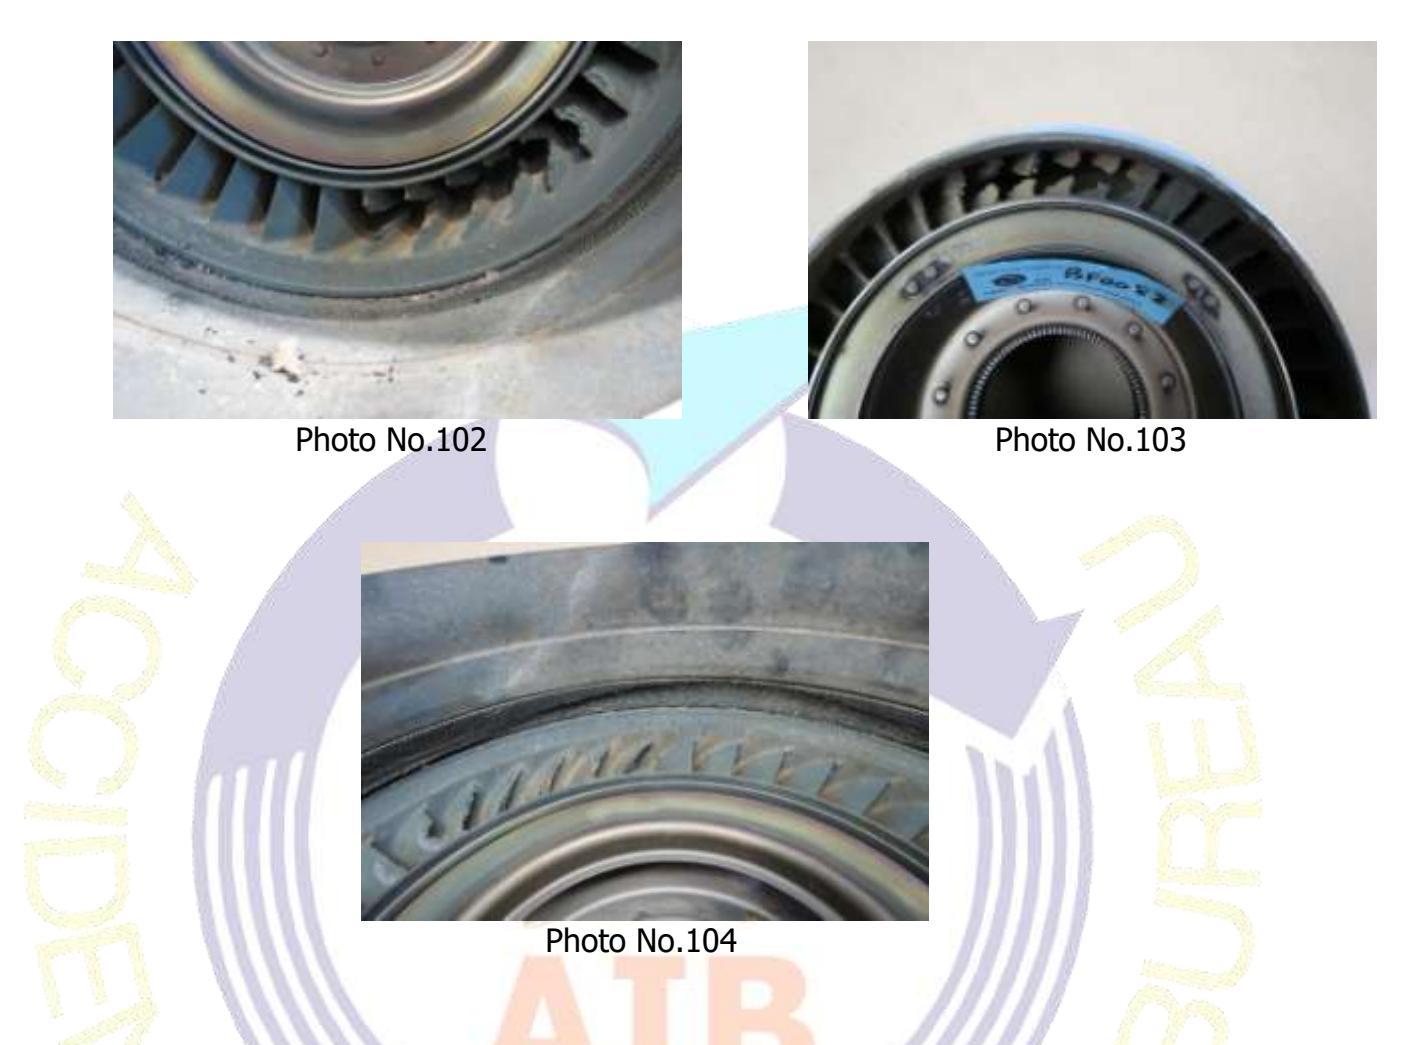
**Power Turbine (PT) Guide Vane Ring:** The power turbine vane ring displayed burnt, splattered and melted material at airfoil and outer rim at 5 o'clock (Photos No.102 & 103). The PT vane ring honey comb seal displayed rubbing and burning indication (Photo No.104).

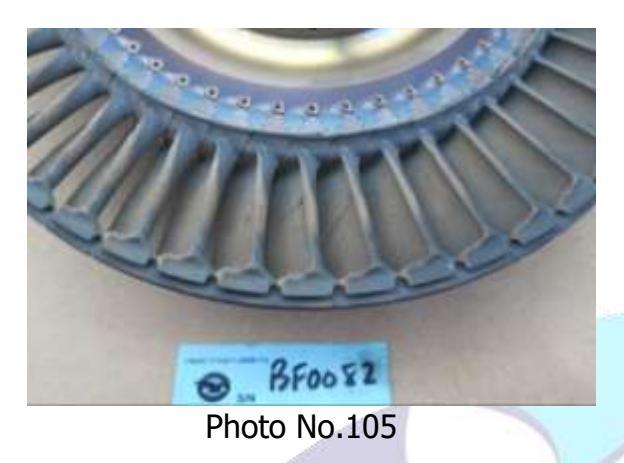
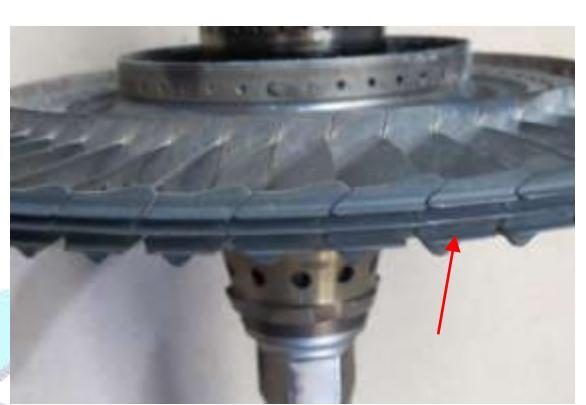
**Power Turbine Disk and Blades:** The PT blades displayed impact and splattered material at airfoil (Photo No.105). The PT blades shroud knife edge displayed rubbing indication (Photo No.106).

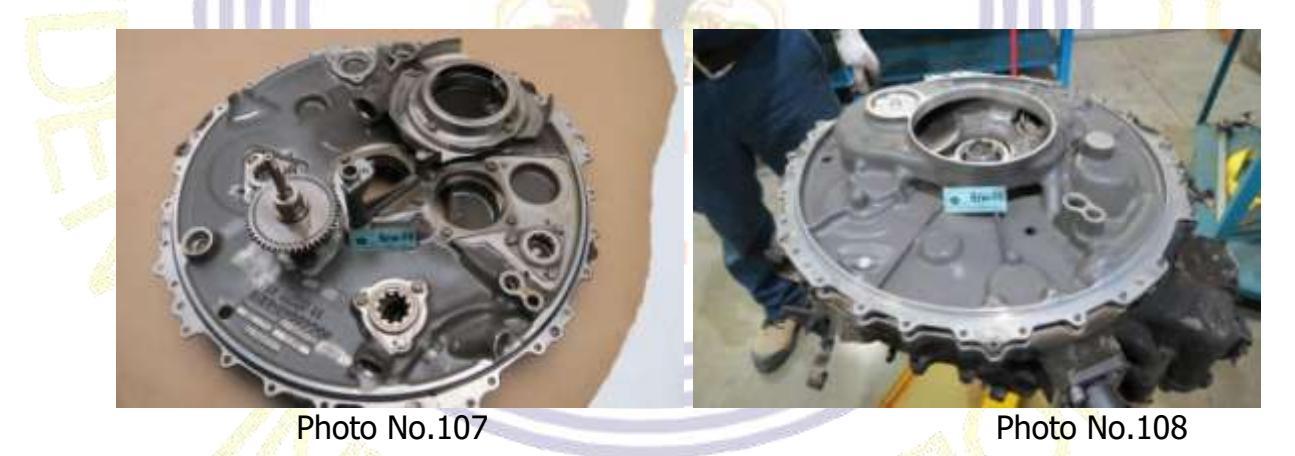
**Rear Housing:** The rear RGB housing and installed hardware was visually unremarkable (Photos No.107 & 108).

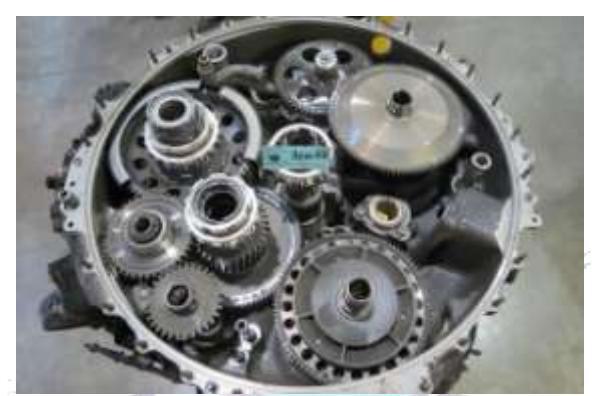
Photo No.109

**Front Housing:** The front RGB housing, the reduction gear train, the no. 1, 2 & 6 to 16 bearings and the accessory gearbox hardware were visually unremarkable (Photo No.109).

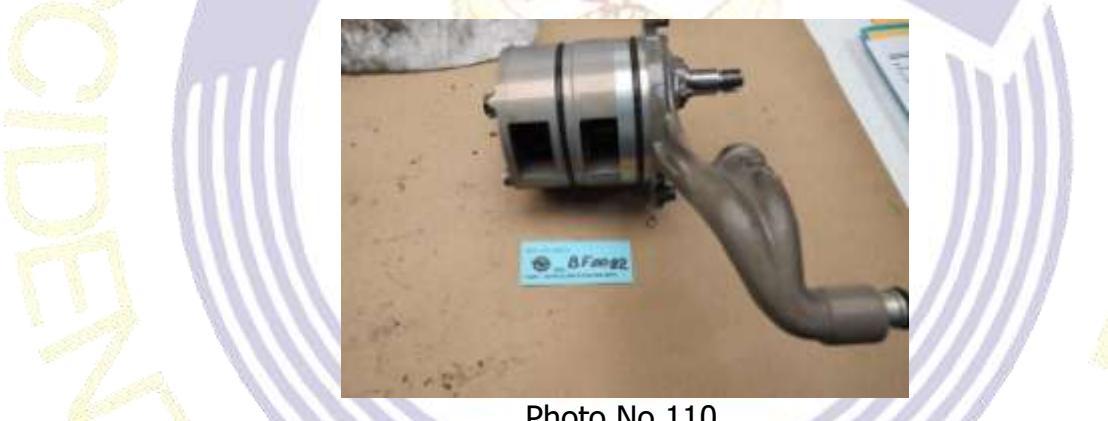
# Photo No.110

Oil Pump Assembly: The oil pump pack was unremarkable (Photo No.110).

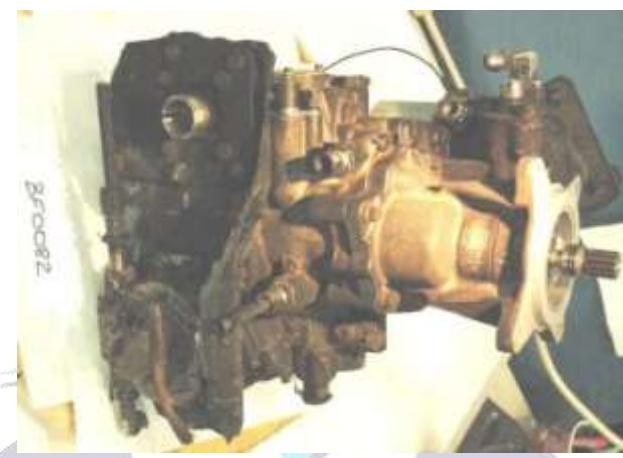
Photo No.111

**Fuel Management Module (FMM):** The exterior of the fuel management module (FMM) was blackened, and the fire-shield had been partially consumed by the post impact fire (Photo No.111). The locknuts at the airframe power lever cable/cam-box were loose and the fittings could be turned by hand. The bypass switch/indicator and the power lever potentiometer were loose and could be moved by hand. The filter dowel retaining pin was not in the drain-port. On removal of the fuel filter, a small amount of fuel that was present was collected. There was soot present in the fuel, but no evidence of water. The filter element was darkened, but there was no debris visible in the pleats. Lockwire was missing from the power lever cam-box locknut. Lockwire was present at all other locations. A slave filter was installed and the FMM was tested.

Chemical analysis of the contents of the original fuel filter element confirmed the presence of iron based particles with silicon and traces of aluminium. Chemical analysis of the contents of the slave fuel filter element confirmed the presence of aluminium with traces of sodium. There were no anomalies evident that would have prevented normal operation of the FMM prior to the event.

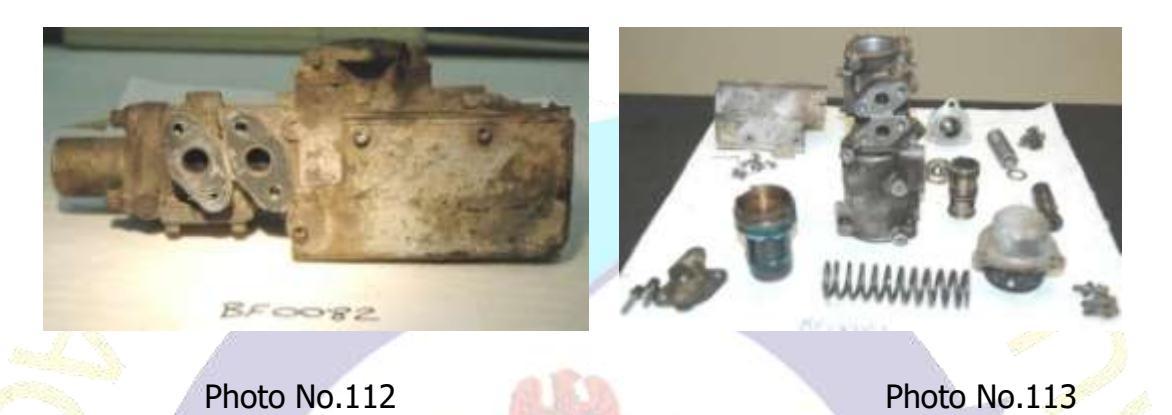
**Flow Divider Valves (FDV):** The exterior of the flow divider valve (FDV) and the heat-shield were discoloured due to heat exposure (Photo No.112). Burned residue was present in the fuel ports. Chemical analysis of the residue indicated that it was composed of carbon with fluorine, suggesting that it was burned packings. Lockwire was present at the inlet adapter mounting.

It was not possible to conduct a complete test as the FDV was leaking. The limited testing that was possible indicated that the flow divider did not transfer fuel pressure between primary, secondary, and dump.

The FDV was disassembled (Photo No.113) to determine the cause of the observations recorded during testing. The internal components were blackened and the packing's had been damaged by the post impact fire. There were no scratches observed on the interior or exterior surfaces of the values or in the

bores of the housing. The transfer valve movement was restricted due to the burned packings. There were no defects evident that would have prevented normal operation of the FDV prior to the event

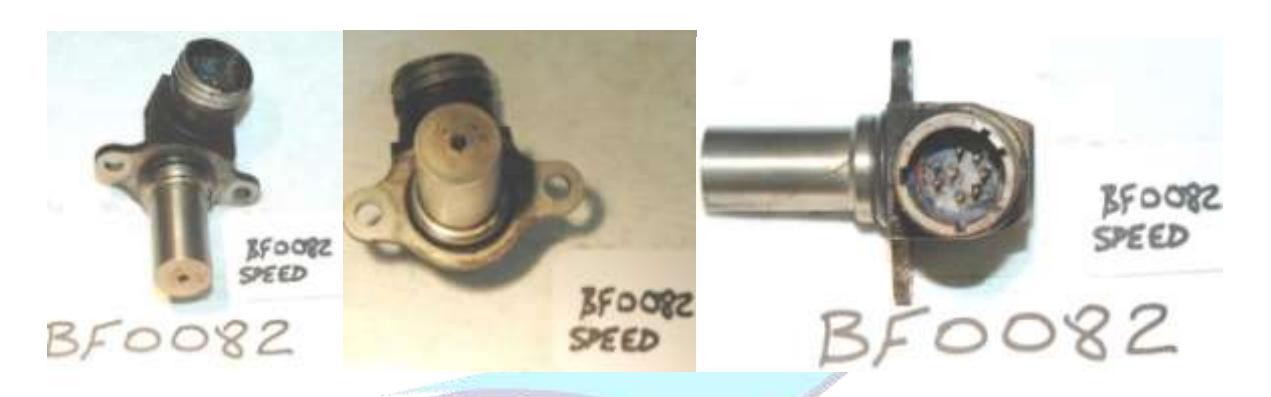
Photo No.117

**Gas Generator (Ng) speed sensor:** The exterior of the gas-generator (Ng) speed sensor was soot stained, burned, damp debris was present inside the electrical connector, and the rubber seal was heat-damaged (Photo No.117). The Ng speed sensor was bench tested, deviations observed were secondary to post impact fire.

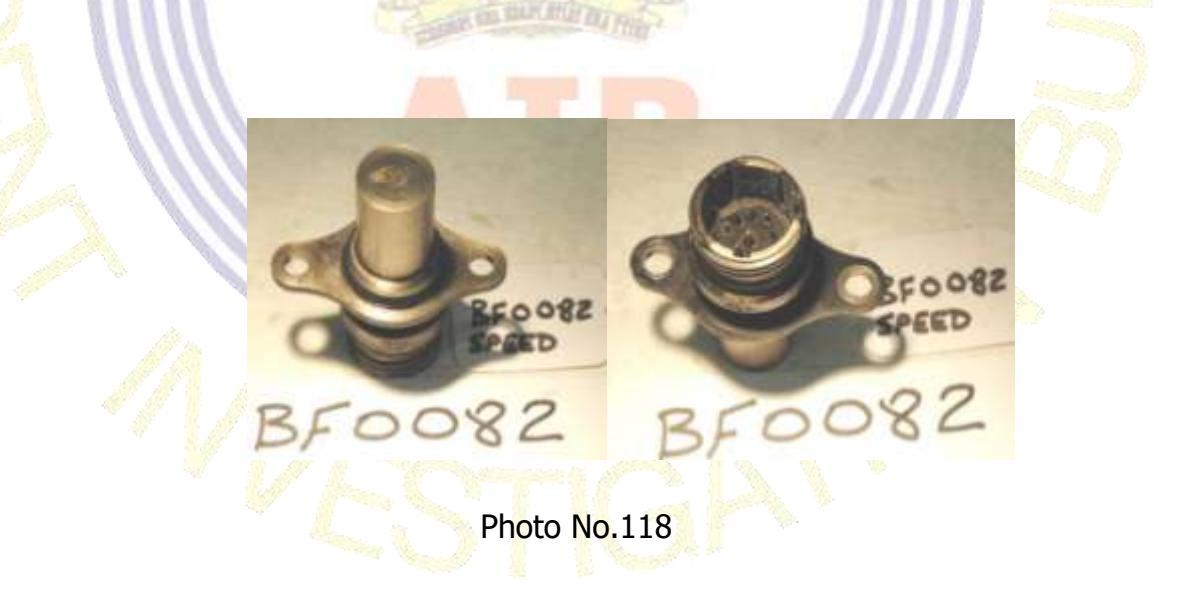
**Power Turbine (Npt) speed sensor:** The exterior of the power-turbine (Npt) speed sensor was soot-stained, burned, damp debris was present inside the electrical connector and the rubber seal was heat-damaged. All connector pins were dirty (Photo No.118). The Npt speed sensor was bench tested, deviations observed were secondary to post impact fire.

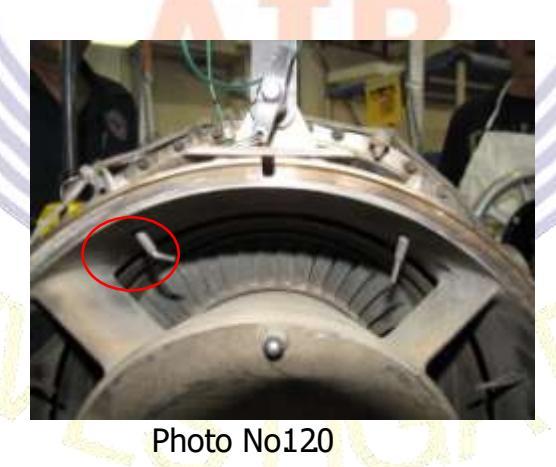
**ITT Probes and T6 Harness:** The T6 left harness displayed one bent T6 probe (Photo No.120) otherwise both harnesses were visually unremarkable.
