## **AIRCRAFT ACCIDENT REPORT**

**PAAN/2012/10/27/F**

**Report on the Accident Involving  
Pan African Airlines Nigeria Limited (PAAN), Bell 206  
L4 Helicopter with Registration 5N - BFF, At Chevron  
Okan Production Platform, Escravos Offshore, Delta  
State which occurred on 27<sup>th</sup> October, 2012.**

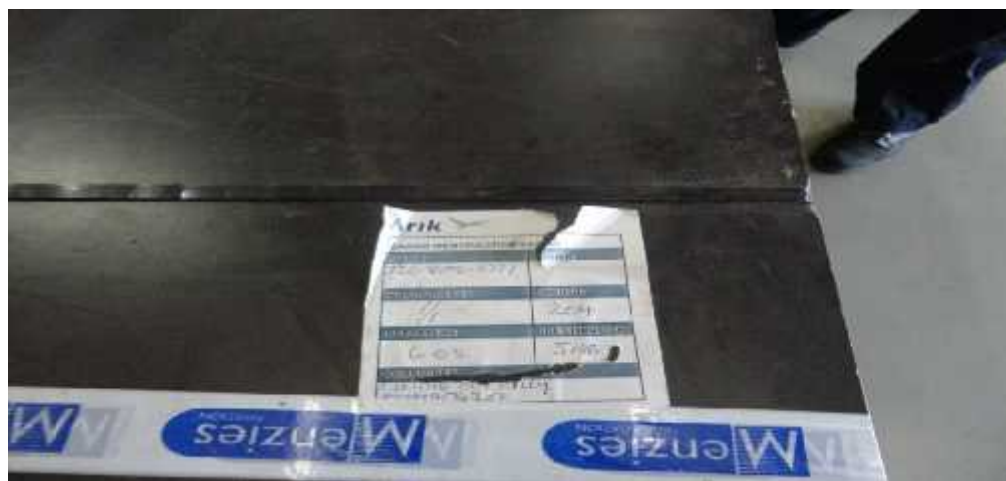
Fig.1.16a: picture showing the containerized engine as received at NAC facility in Johannesburg, South Africa.

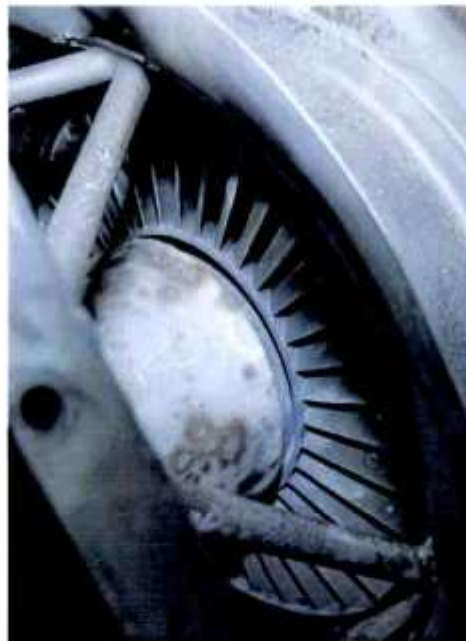
Photo 3 Fourth Stage Turbine Wheel

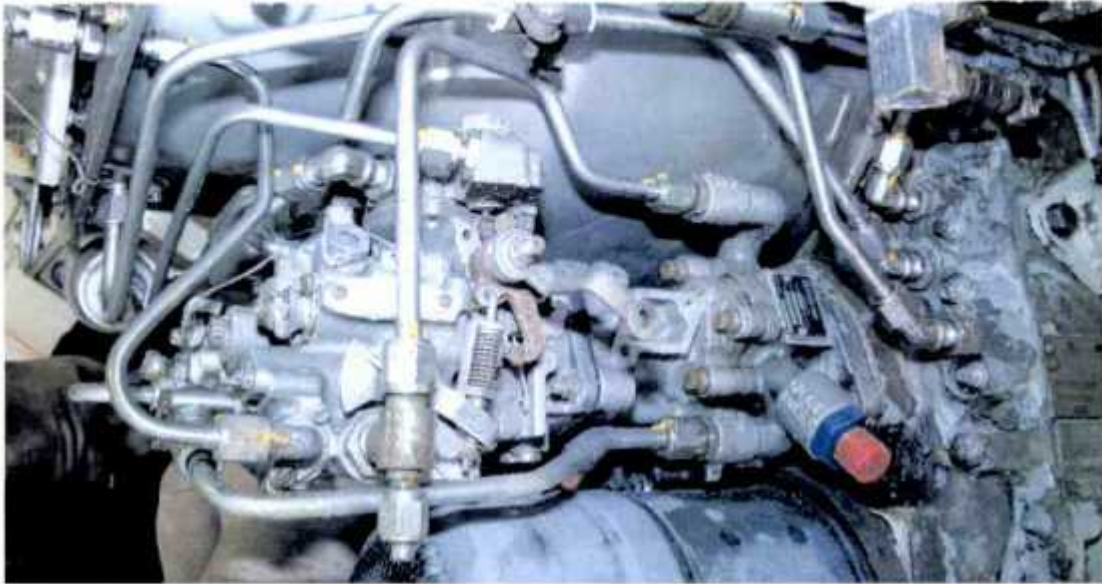
Photo 4 Fuel Control Unit and Fuel Pump prior to removal

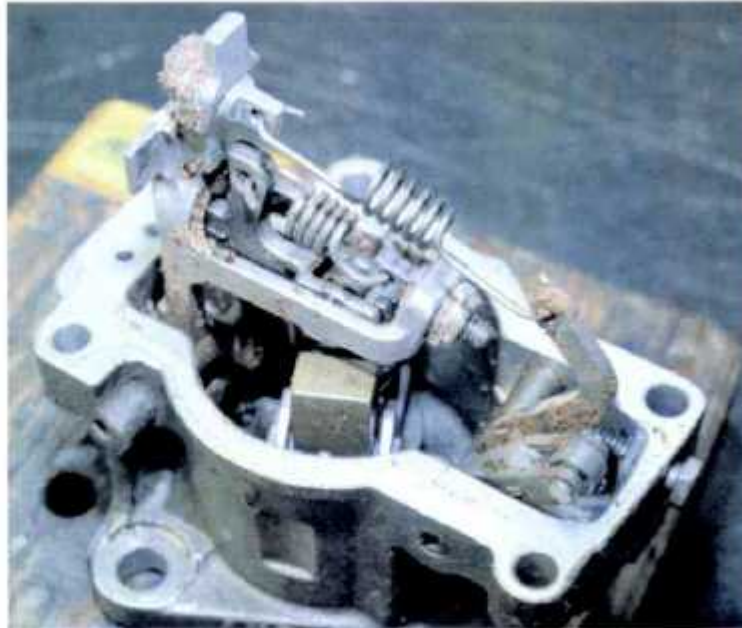
Photo 8 Fuel Control Unit interior

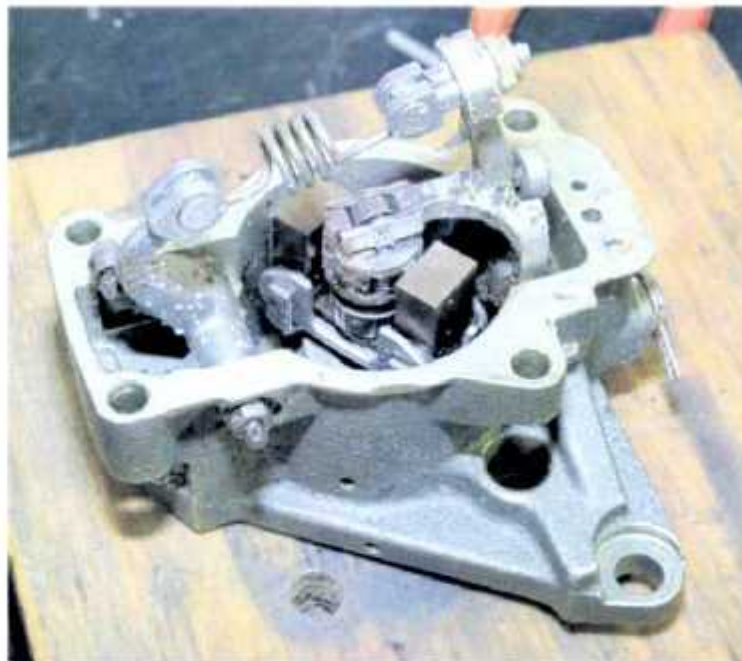
Photo 9 Power Turbine Governor interior

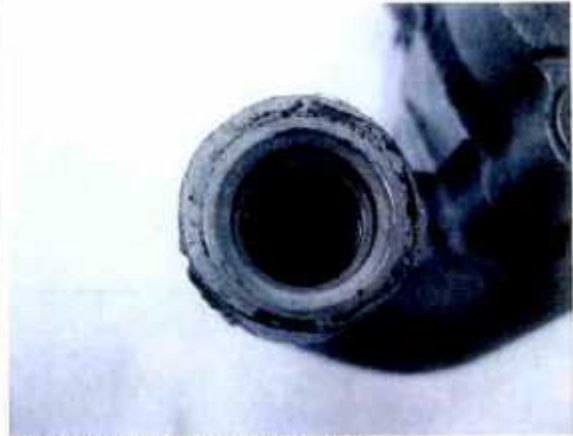
Figure AI-20: Pump discharge port

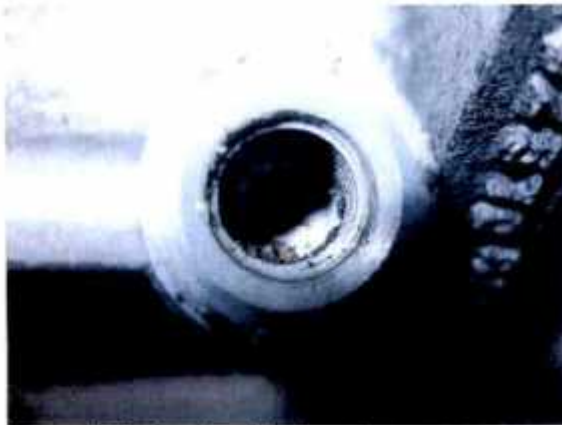
Figure AI-21: Overboard drain port

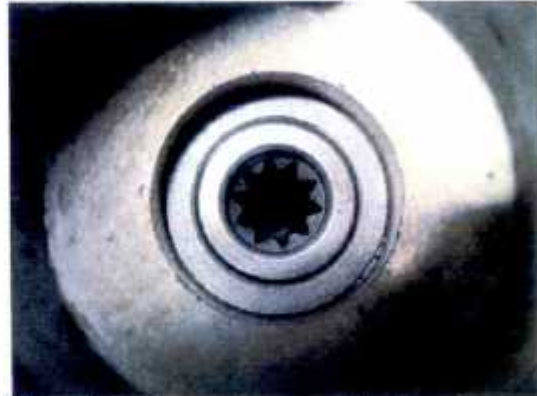
Figure AI-32: Pump driver gear and fixed bearing (installed)

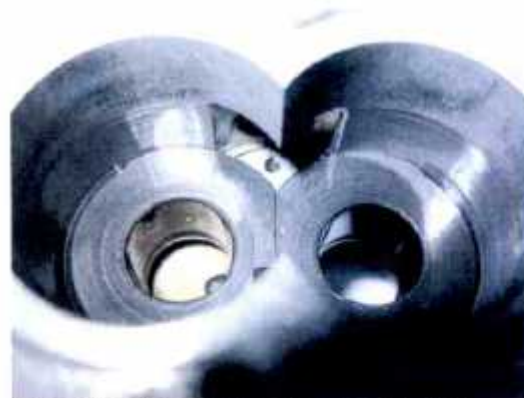
Figure AI-35: Pump floating bearings (installed)

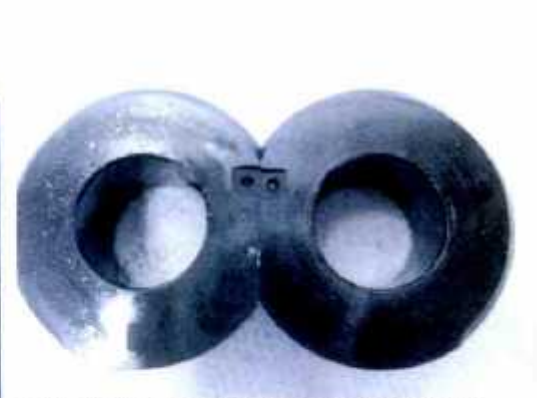
Figure AI-36: Pump floating bearings (removed)
