AIRCRAFT ACCIDENT REPORT
PAAN/2010/04/16/F

Accident Investigation Bureau

**Report on the Serious Incident involving
Pan African Airlines Nigeria Limited
Bell 412-EP Helicopter Registration 5N-BFU at NNPC
Housing Complex, Warri, Delta state, Nigeria
On 16th April, 2010.**

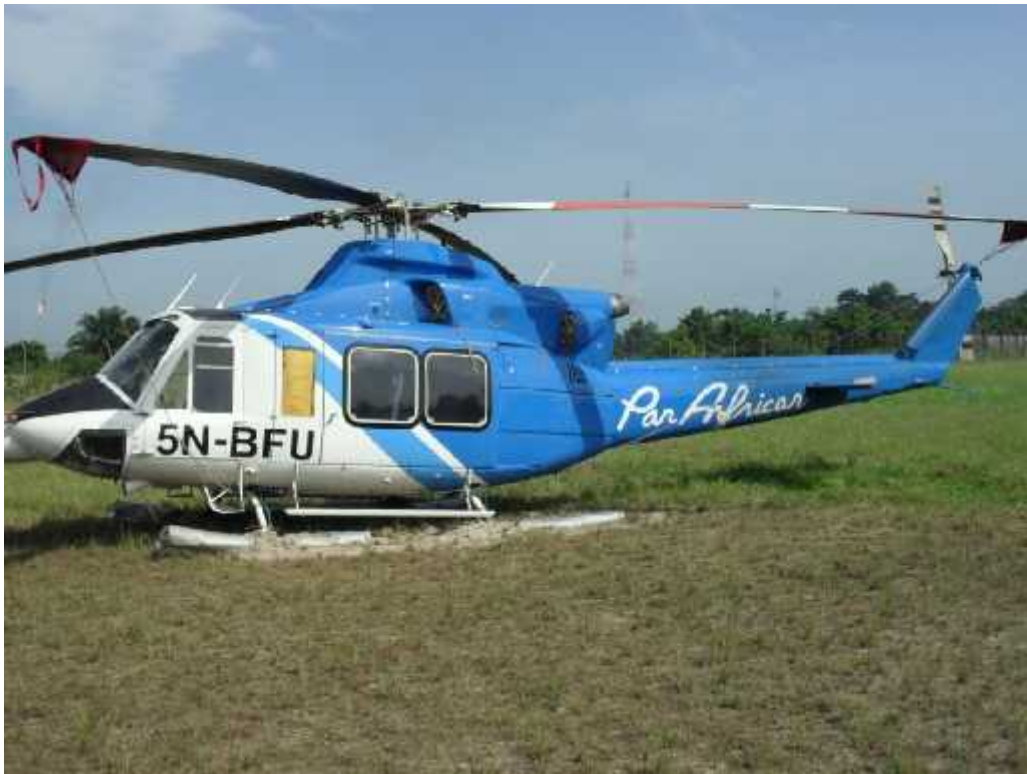
The aircraft came to rest at the NNPC housing complex and was found intact. The Main Drive Shaft coupling sheared off from its attachment point at the combining gear box end. The tunnel area housing the Main Drive Shaft and the combining gear box was also damaged.

Fig 1.12b: Picture showing aircraft in its final rest position

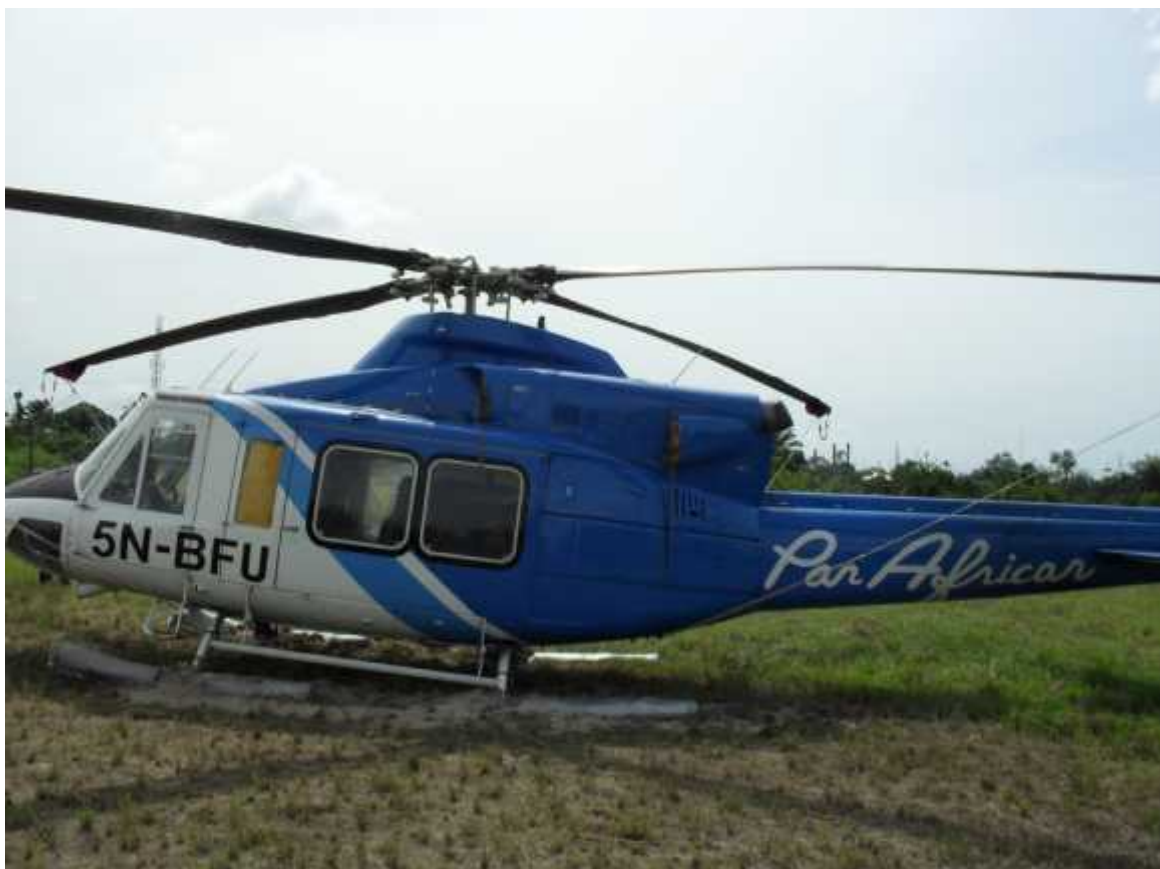
The emergency response procedure was initiated by Chevron Fire Fighting and Rescue Service. The incident was survivable since there was no damage to the aircraft cockpit and cabin areas. There was livable volume available after the incident. The damage to the aircraft was confined within the engine compartment area.

Fig 1.15 Showing aircraft intact

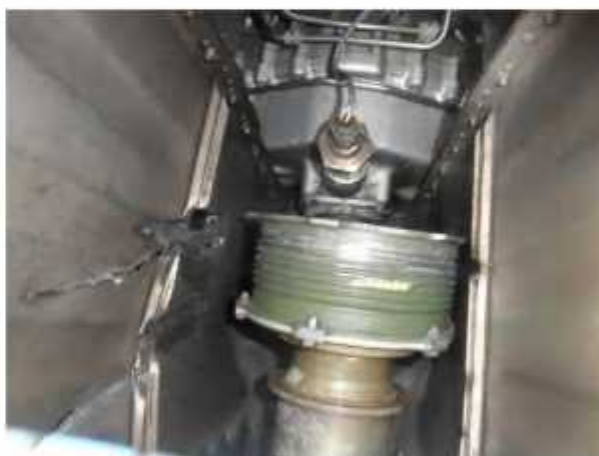
Photo No. 1 (Photo Taken in the field)

- 1.3 The engine modules were separated in the field and were sent back to P&WC St Hubert Service Centre in three individual shipping containers. The main drive shaft coupling (Photo No. 1) is an airframe component and was not subject to a P&WC evaluation.

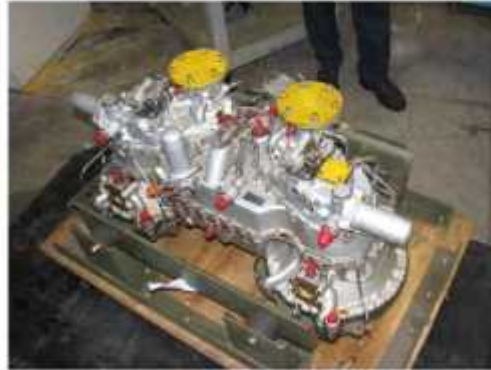
Photo No. 2

- 3.1 Visual examination of the reduction gearbox (RGB) external did not show any apparent damage (Photo No. 2).

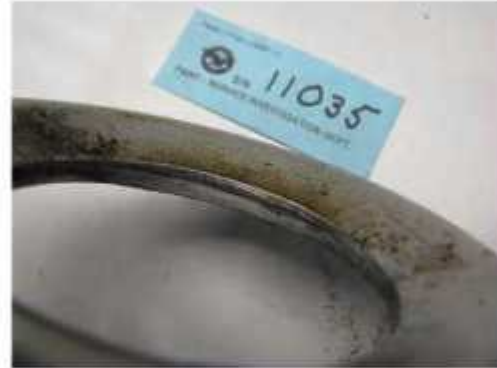
Photo No. 6

- 3.3 Examination of the RGB output gearshaft area did not show apparent damage except for the output shaft drain cover (Photo No. 5) that was rubbed on the inner diameter mainly at the 6 o'clock position (Photo No. 6). The RGB rotated freely and both clutch assemblies were showing normal engagement.

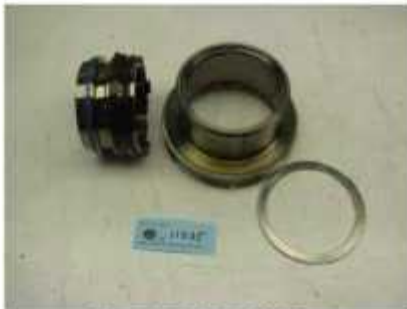
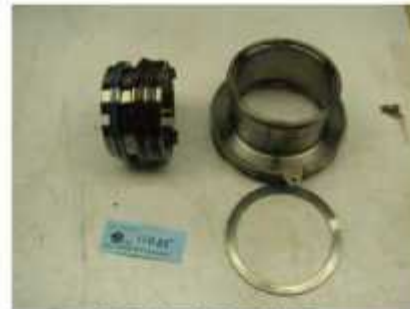
- 3.4 The RGB right and left hand cover were removed and no damage was observed. The torque meter pistons and cylinder were inspected and no damage was observed (Photos No. 7 and 8).

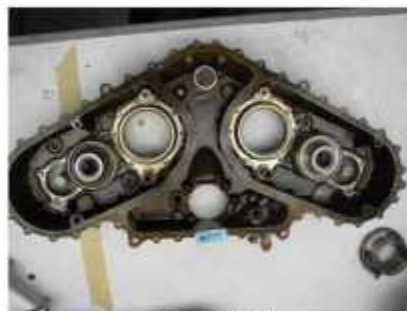
Photo No. 9

- 3.5 The RGB input housing was removed and examination did not show any apparent damage (Photo No. 9). The R/N and L/H idler gears were removed and examination of the No. 8 ball bearings did not show any damage (Photo No. 10 and 11).

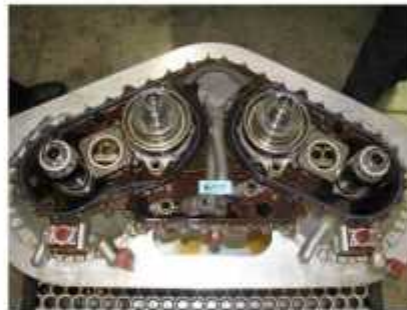
Photo No. 12

- 3.6 The diaphragm area did not show any apparent damage (Photo No. 12).

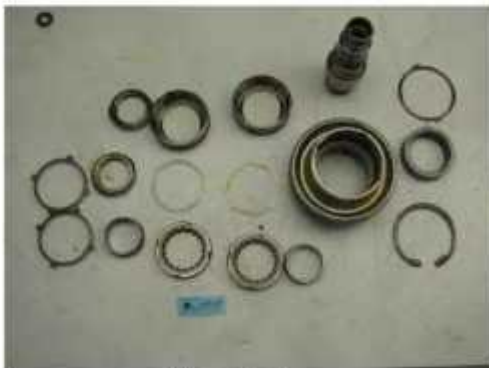
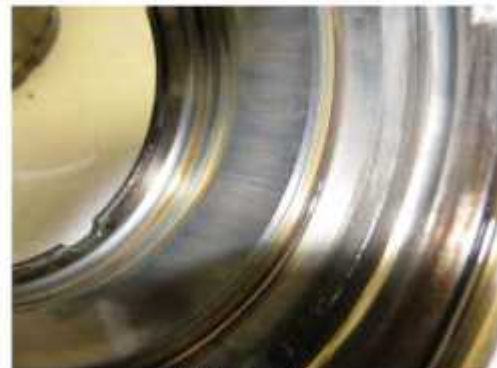
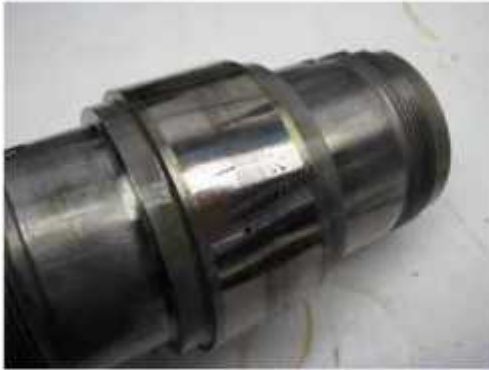
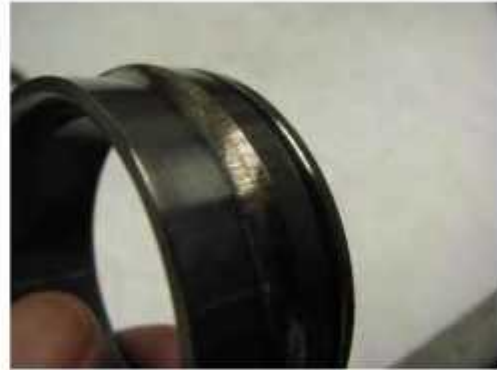
- 3.7 The clutch assemblies were removed. The L/H clutch assembly was engaging normally (Photo No. 13). Disassembly of the L/H clutch assembly revealed normal engaging witness marks on the clutch gear inner diameter and on the clutch shaft with no evidence of discoloration or slippage (Photos No. 14 and 15). There was evidence of some false-brinelling on the No. 12 ball bearing (Photo No. 16) which is normal operational wear.

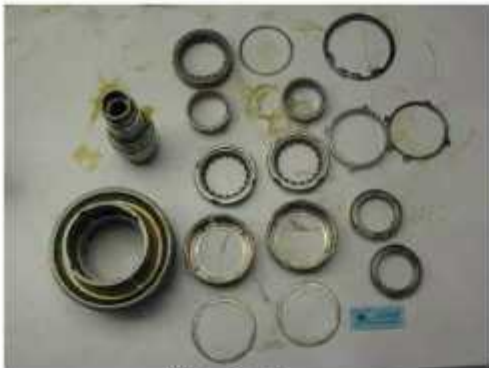
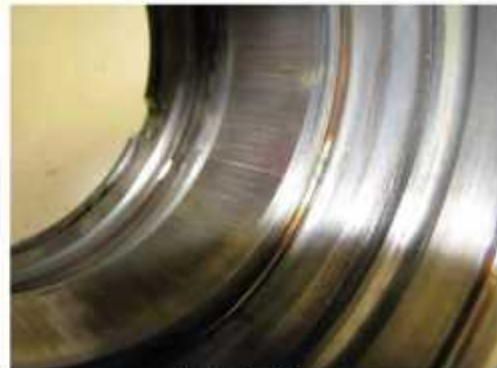
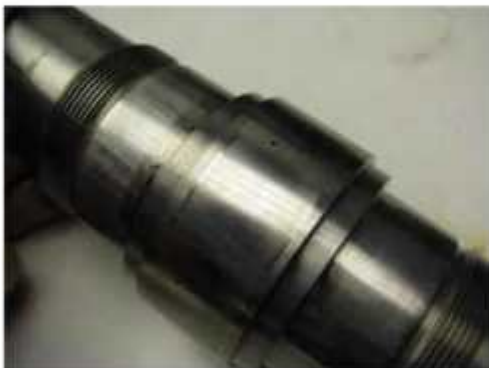
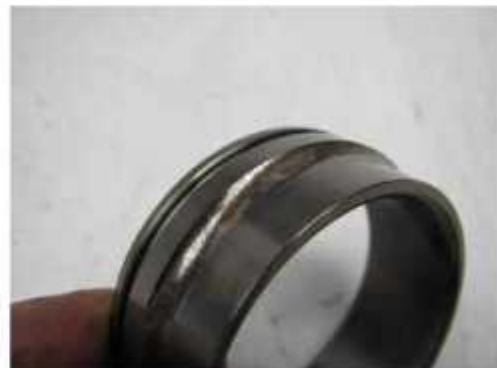
- 3.8 Disassembly of the R/H hand clutch assembly revealed normal engaging witness marks (Photo No. 17) on the clutch gear inner diameter and on the clutch shaft with no evidence of discoloration or slippage (Photos No. 18 and 19). There was evidence of some false-brinelling on the No. 12 ball bearing (Photo No. 20) which is normal operational wear.

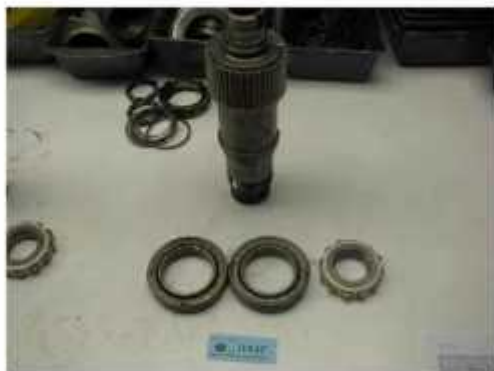
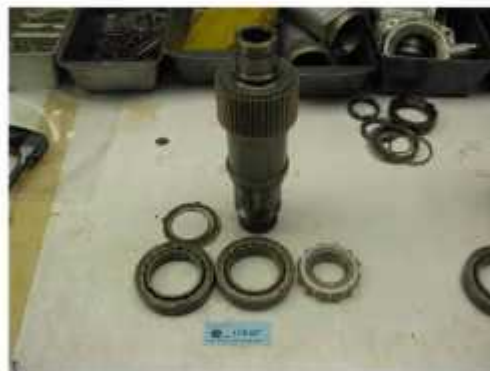
- 3.9 Both L/H and R/H input gearshafts were removed and examination of the No. 5 duplex ball bearings did not show any damage (Photo No. 21 and 22).

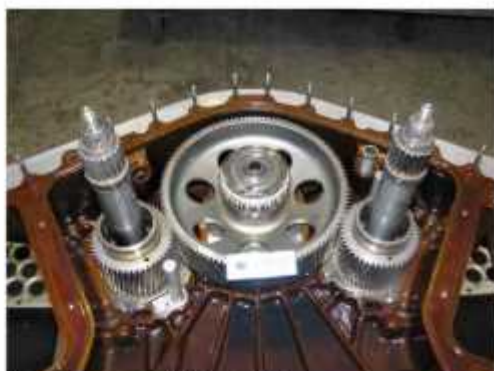
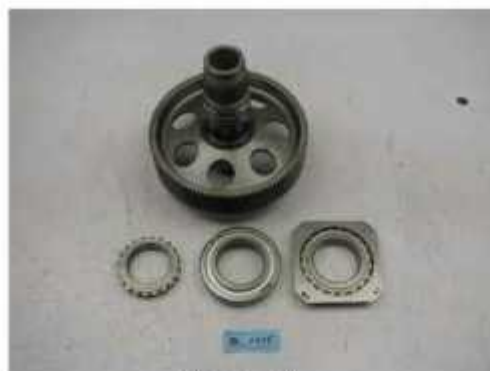
- 3.10 The output gearshaft area was examined and no apparent damage was observed (Photo No. 23). The output gearshaft was removed and examination of the No. 15, 16 and 17 bearings did not show any damage (Photo No. 24).

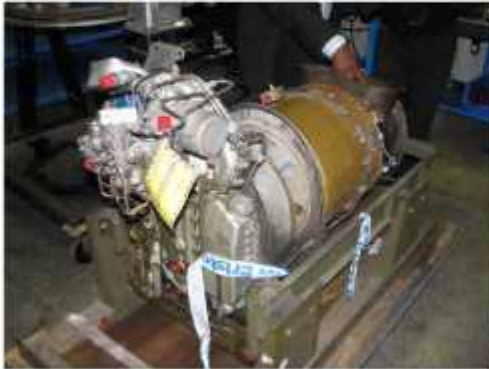
Photo No. 25

- 4.1 Examination of the R/H (No. 2) power section (Photo No. 25) showed no external damage except for a crack on the left hand side of the exhaust case (Circle Photo No. 26).

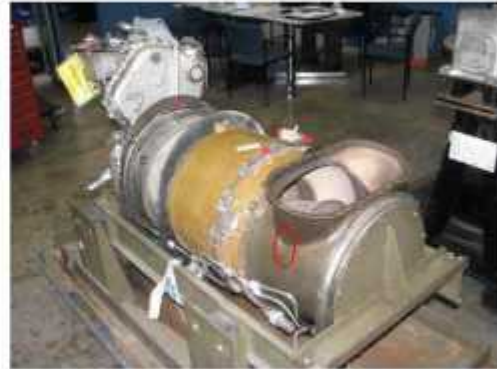
Photo No. 26

- 4.2 The crack on the exhaust case wall ran radially for approximately 1.750 inch from the exhaust port weld, and 0.630 inch through the weld and exhaust port, then branched axially 1.225 and 1.075 inch. into the exhaust port (Photo No. 27).

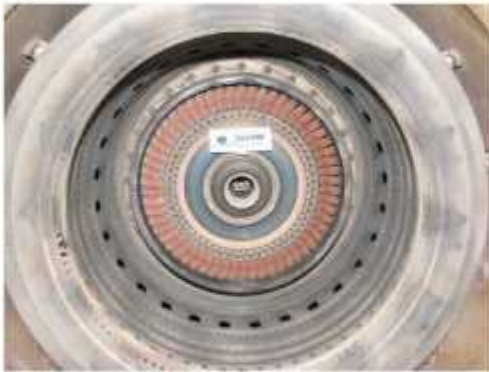
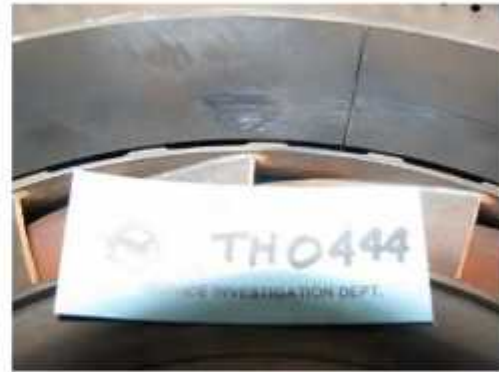
- 4.3 The power section was separated at the "C" flange and the examination of the hot section area did not show any damage (Photo No. 28). The compressor turbine (CT) blade tip clearance measured 0.019 inch to 0.024 inch with evidence of rubbing on one shroud segment at the 10 o'clock position (Photo No. 29). This is considered normal operation condition.

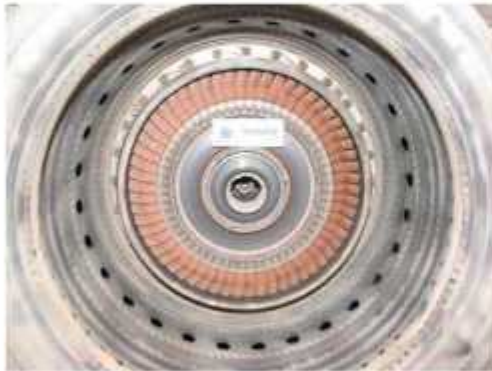
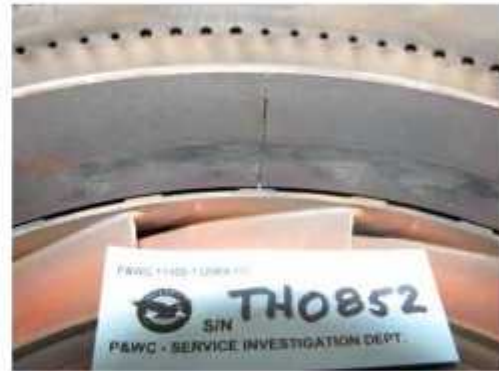
- 5.2 The power section was separated at the "C" flange and examination of the hot section area did not show any damage (Photo No. 37). The compressor turbine (CT) blade tip clearance measured 0.018" to 0.022" with evidence of rubbing on the shroud segments (Photo No. 38). One shroud segment showed axial crack initiating from the upstream edge (Photo No. 39). The blade tip clearance is considered normal, however, the cracking found on one of the shroud is not but did not influence the engine performance.

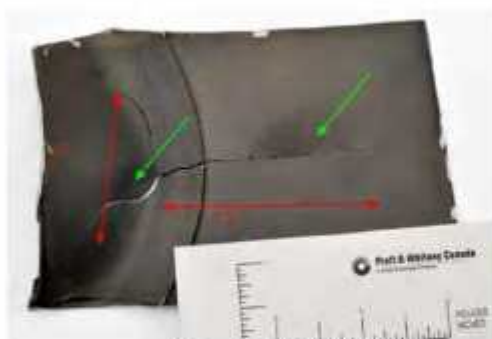
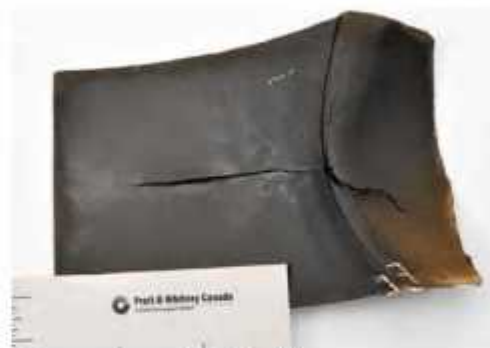
- 6.1 The exhaust case of the R/H power section was submitted to P&WC Material Investigation Laboratory for analysis of the cracking.
- 6.2 The cracked area was cut from the case in the laboratory to examine the fracture surfaces. The crack was extending on both sides of the resistance weld (red oval and Photo No. 46). The outer surface of the case showed a branching crack associated with buckling of the base material (green arrows). The inner surface at the cracked area showed no evidence of impact or others damages (Photo No. 47).

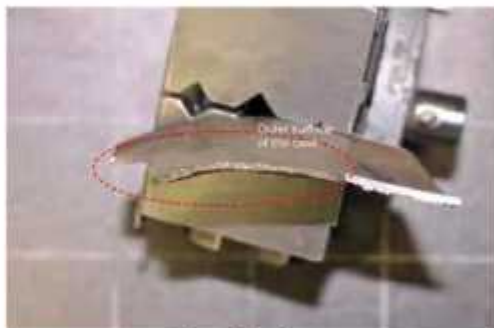
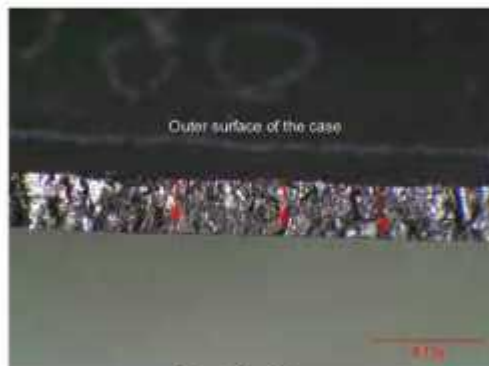
- 6.4 The surface of fracture "A" exhibited a granular dull gray coloration suggesting that the fracture was older. The fracture occurred as the result of fatigue initiating from multiple origins along the outer surface of the case (Photo No. 49). Close-up views of the fracture surface (Photo No. 50) showed faint river lines emanating from the outer surface.

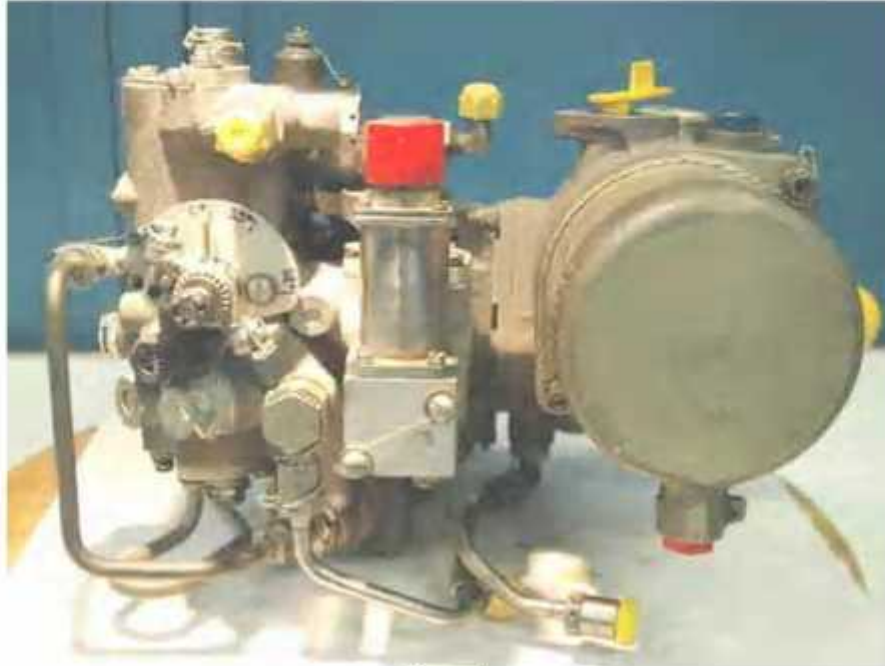
Figure 1
TH0852 fuel control and pump pack as received

The AFCU was removed as part of a pack with the manual fuel control unit and the fuel pump. The exterior was soiled. The throttle moved freely over the full range. The part-power trim stop was in the stowed (flight) position. The index mark on the Sg dome was aligned with the datum line on the bypass valve collar. Lockwire was missing from the Pg port elbow (it was removed when the pack was removed from the engine), but the elbow could not be moved by hand. Lockwire was present at all other locations. The lockwire seals were marked P&WC. Prior to testing the air adapter was removed to inspect the governor lever orifice. There was no obstruction visible in the orifice. The fuel pump outlet filter was removed and inspected. There was no debris visible in the pleats of the filter element and no significant fluid residue was present. The throttle lever maximum Ng stop screw protrusion was measured at 0.535in (the factory setting is 0.555in), indicating that it may have been adjusted prior to receipt. With the unit mounted on the test stand the air system was pressurized and checked for leaks. No leaks were evident. The unit was run at 6800RPM, with the throttle at maximum and P3 air at 125psia and the nozzle flow was monitored for ten minutes for a decrease (as would be anticipated if there was a leak in the acceleration bellows was leaking). No fuel flow decrease was observed during the monitoring period. The AFCU/MFCU pack was tested in accordance with test record sheet TR 1640 Rev. 11 (Honeywell CMM 73-20-71 original issue). The following observations were recorded (refer to the appendix for a summary of the test observations):

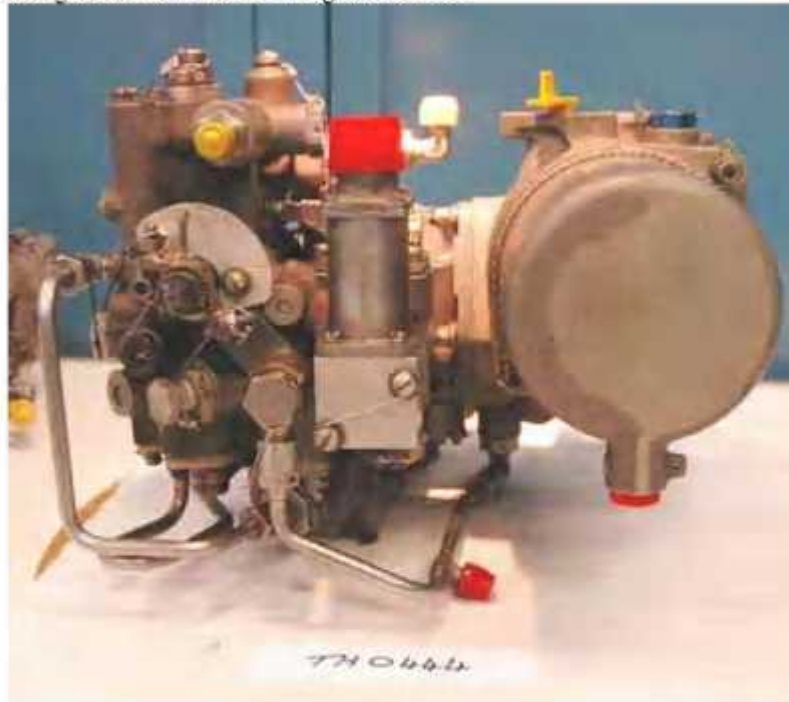
Partial disassembly of the AFCU revealed the bypass valve diaphragm was stiffening. The bypass valve and sleeve were worn. There were lateral grooves worn into the Pr regulator sleeve.

Figure 3
TH0444 fuel control and pump pack as received

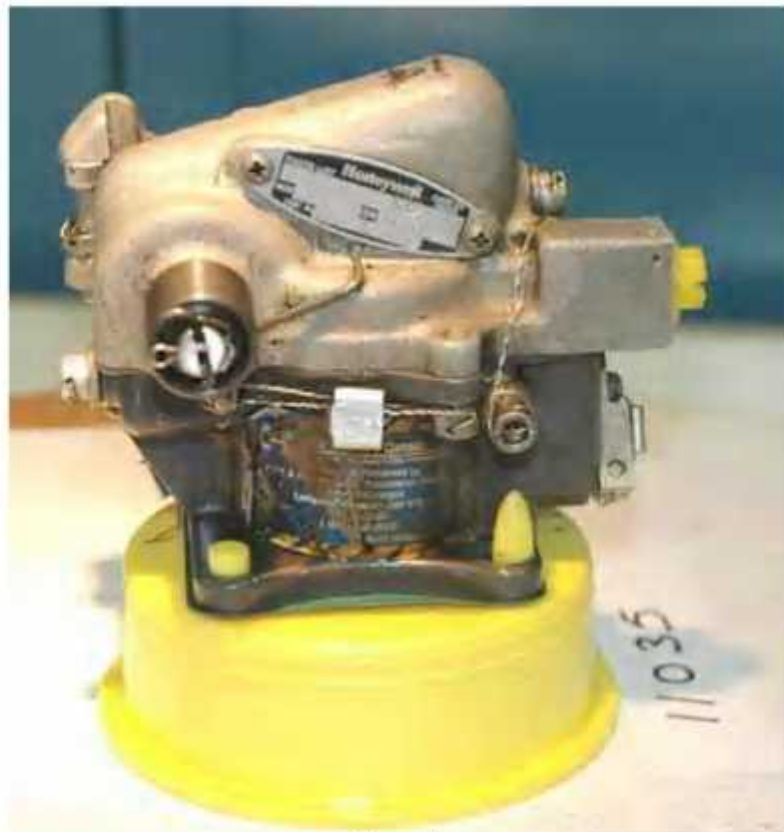
The exterior was lightly soiled. The driveshaft turned freely. The control lever moved freely over the full range and returned under the influence of its spring. There was a P&WC Accessories Business service label on the drive-body. Lockwire was present at all locations. The lockwire seals were marked P&WC. The power turbine governor (PTG) was tested in accordance with test record sheet TR5621 Rev. 05 (Honeywell CMM 73-20-69 original issue). The following observations were recorded (refer to the appendix for a summary of the test observations):

Test point 3 & 6: the Pr-Pg pressure was above the CMM maximum limit.

Figure 4
TH0852 (No. 1) power turbine governor as received

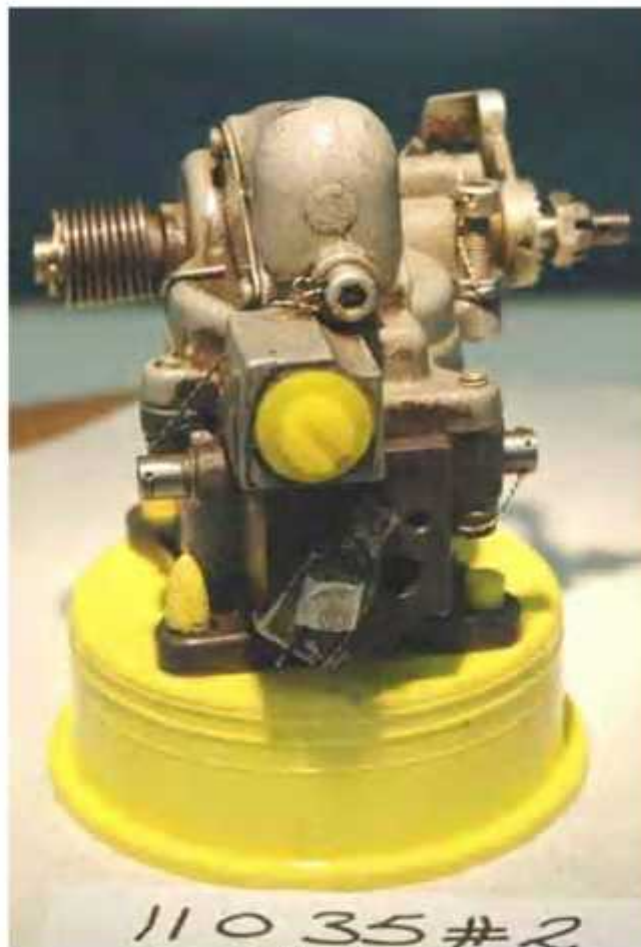
The exterior was lightly soiled. The driveshaft turned freely. The control lever moved freely over the full range and returned under the influence of its spring. Lockwire was present at all locations. The lockwire seals were marked P&WC. The power turbine governor (PTG) was tested in accordance with test record sheet TR5621 Rev. 05 (Honeywell CMM 73-20-69 original issue). The following observations were recorded (refer to the appendix for a summary of the test observations):

Test point 3 & 6: the Pr-Pg pressure was above the CMM maximum limit.

Figure 5
TH0444 (No. 2) power turbine governor as received

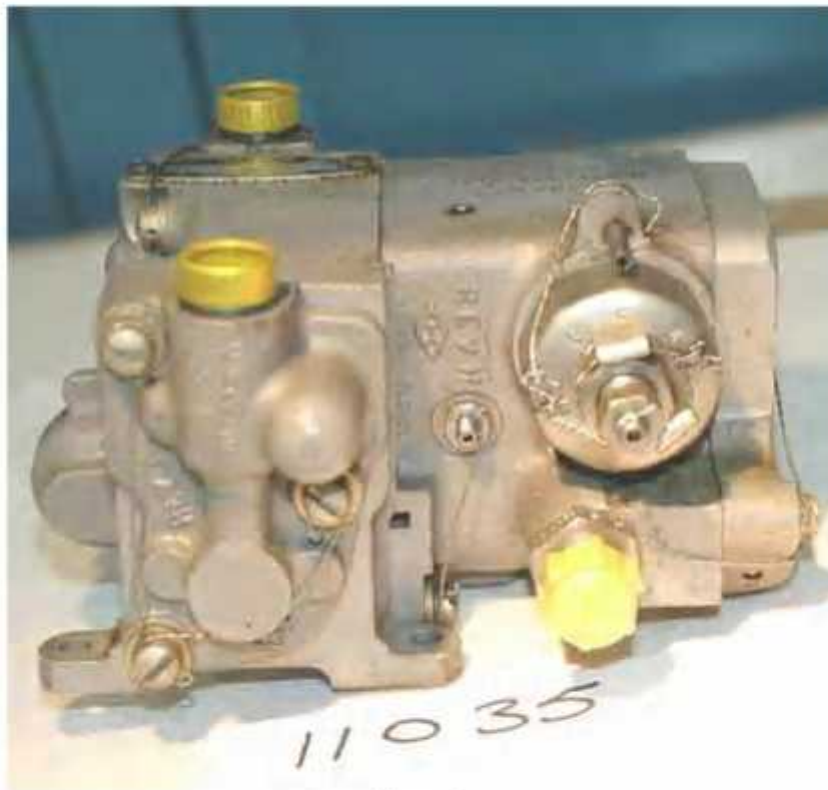
Test point 2.01 Nominal torque limiter setting at position 5: the No. 1 Pr-Pg was above the CMM maximum limit

Test point 3.02 Fine limiter adjustment check: the pressure in the No. 1 & 2 bellows that was required to achieve a Pr-Pg of 8.6in.Hg was above the CMM maximum limit.

Figure 6
Universal torque limiter unit as received
