AIRCRAFT ACCIDENT REPORT

(WINGS/2008/03/15/F)

Accident Investigation Bureau

**Report on the Accident Involving
WINGS, Registration 5N – JAH,
Bushi Village, Obalinku.
(Near Bebi Airstrip) Obudu.
15th March, 2008.**

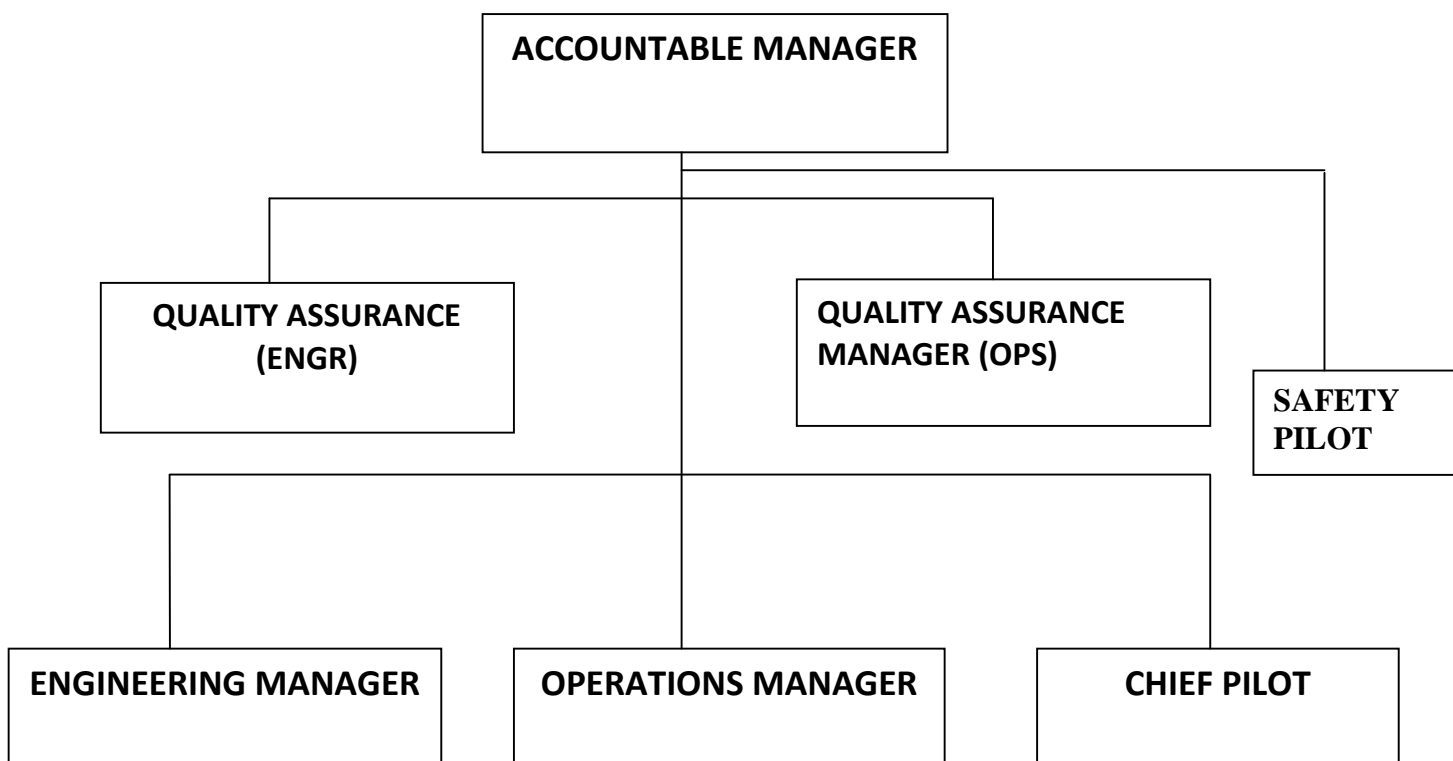
**Figure. 1.17.1.
Management Organogram**

At the time of the accident the captain of the accident aircraft was the airlines safety pilot. There were discrepancies in recency, route familiarization and the use of unapproved aeronautical chart. The airline organizational structure comprises the accountable officer who sees to the running of the company and reports to chief executive. Other post holders include the quality manager, the chief pilot and the chief engineer. See Figure 1.17.1
