# AIRCRAFT ACCIDENT REPORT

VAL/2013/12/04/F

**Report on the accident involving a Boeing 747-200 Aircraft operated by Veteran Avia Airlines Limited with nationality and registration marks EK-74798 which occurred at Nnamdi Azikiwe International Airport Abuja on 4th December, 2013.**

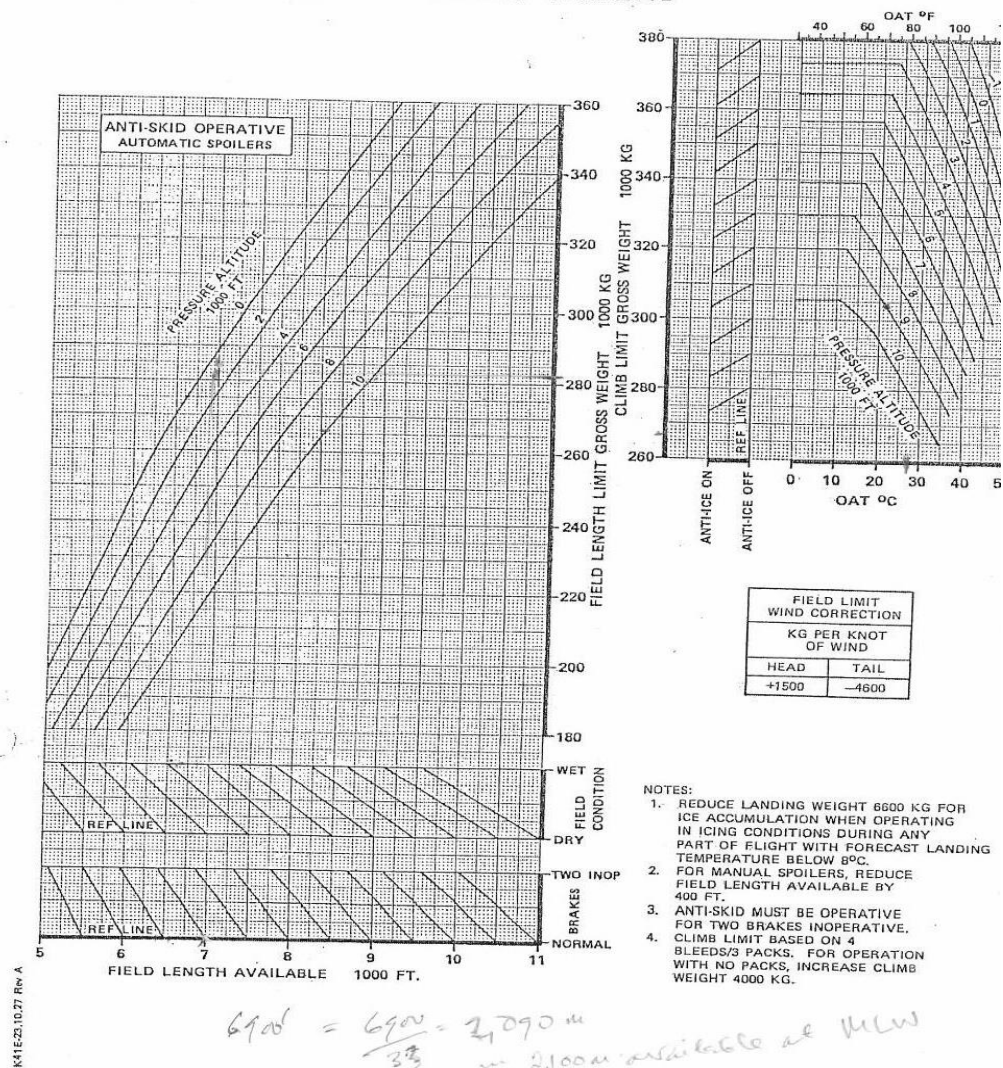
23.10.132

**BOEING 747**  
OPERATIONS MANUAL  
ANTISKID OPERATIVE
