PRELIMINARY REPORT ON SERIOUS INCIDENT INVOLVING A BOEING 737-500 AIRCRAFT WITH NATIONALITY AND REGISTRATION MARKS 5N-SYS OPERATED BY AZMAN AIR SERVICES LIMITED WHICH OCCURRED ON RUNWAY 18R, MURTALA MUHAMMED INTERNATIONAL AIRPORT, LAGOS; NIGERIA ON THE 16TH OF FEBRUARY, 2021

Registered owner and operator:	Azman Air Services Limited
Aircraft type and model:	B737-500
Manufacturer:	Boeing Aircraft Company, USA
Year of manufacture:	1997
Nationality and registration marks:	5N-SYS
Serial number:	28565
Location:	Runway 18R, Murtala Muhammed International Airport, Ikeja, Lagos.
Date and time:	16th February, 2021 at about 17:55 h (<i>All times in this report are local times UTC+1 unless otherwise stated</i>)

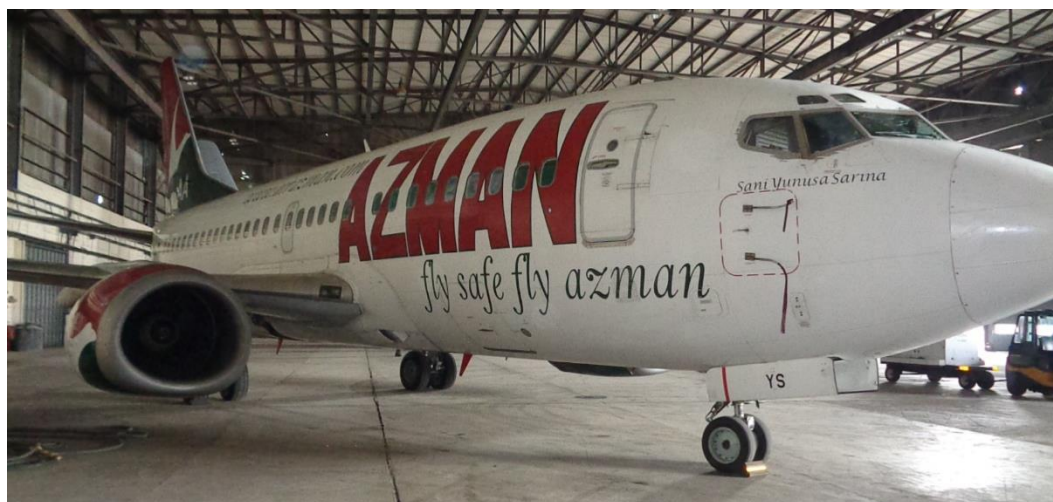
The aircraft remained on the active runway. No. 1, 2, 3 & 4 main landing gear tyres were found burst. Tyres latex were heavily worn-out with heavy canvass. Tyre debris was ingested into No 1 engine and the left rear-side of the fuselage.

Figure 1: Aircraft parked at the military hangar after tyre replacement
