AIRCRAFT ACCIDENT REPORT

**Report on the Serious Incident involving an Airbus
330-343 aircraft operated by Turkish Airlines Inc. with
nationality and registration marks TC-LOL which
occurred at Port Harcourt Intl. Airport, Omagwa,
Rivers State, Nigeria
On 31st December 2019**

Aircraft accident report number: TURKISH/2019/12/31/F

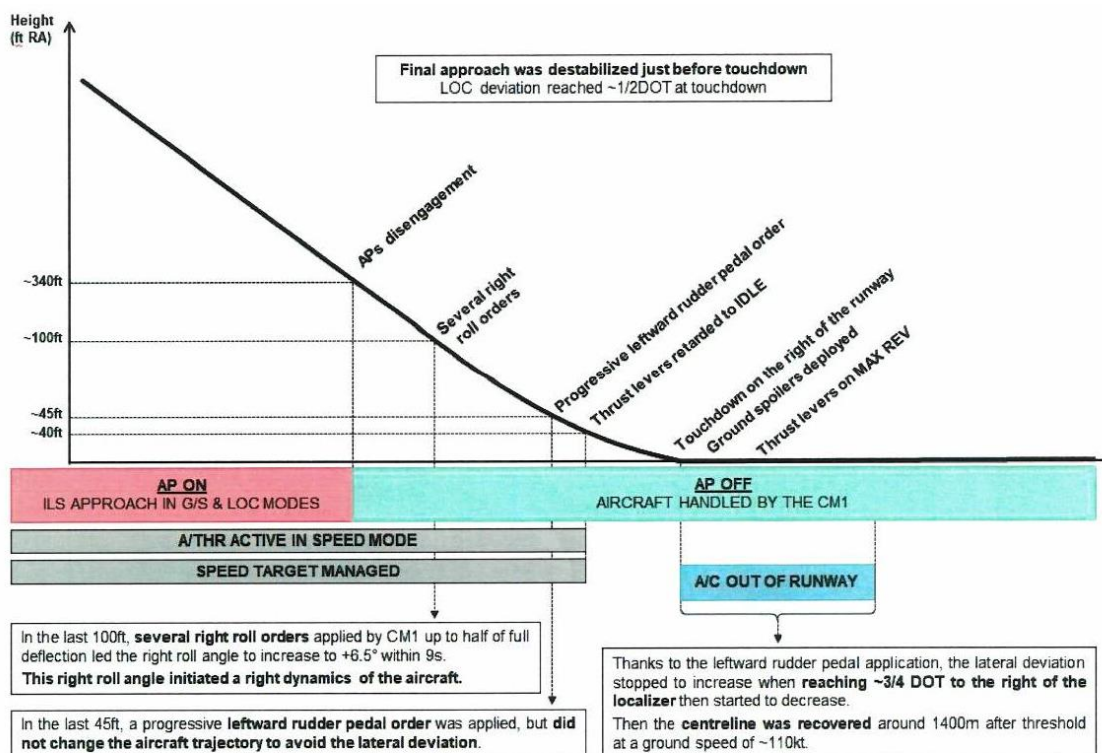
Figure 4: Overview of the approach from auto pilot disengagement

An independent analysis of the flight data was requested from Aircraft manufacturer, Airbus, by the operator via the Turkish Transport Safety Investigation Centre. Findings from the Airbus report are also referenced.

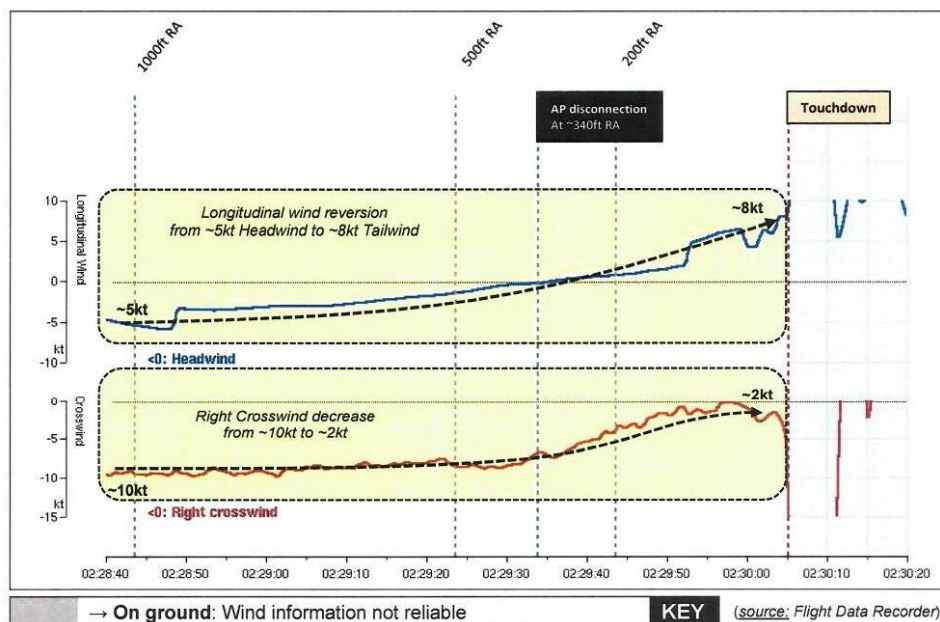
Figure 4 – Reconstructed wind along the runway axes

The wind reconstruction is computed on runway 3 axes, based on:
