# AIRCRAFT ACCIDENT REPORT

SEA/2018/10/04/F

**Final Report on the Accident involving Air Tractor AT-401B aircraft with nationality and registration marks 5N-BTV, operated by Skypower Express Airways Nigeria Limited, which occurred at Rukubi village 90 NM South-East of Abuja; Nigeria on 4th October, 2018.**

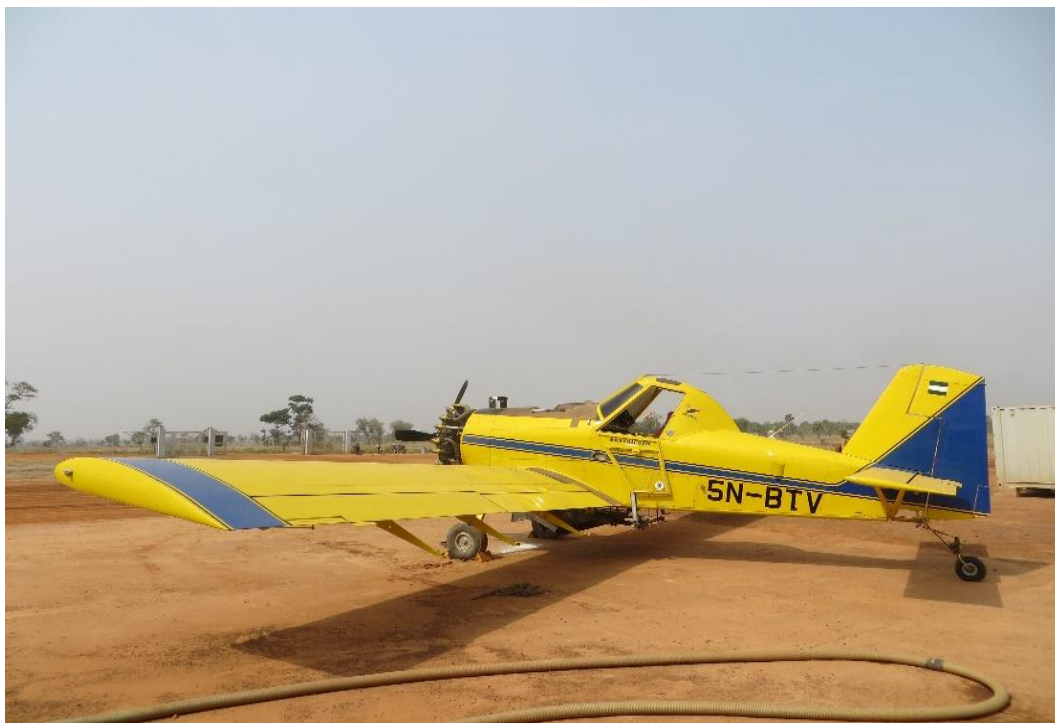
**Figure 1:** AT-401 aircraft (5N-BTV)

The Air Tractor 401B is a family of agricultural aircraft, certified for single pilot operation. It is a low-wing monoplane, conventional landing gear with taildragger configuration. A three bladed propeller radial engine is mounted on the nose of the aircraft. A chemical hopper is provided between the firewall and the cockpit.

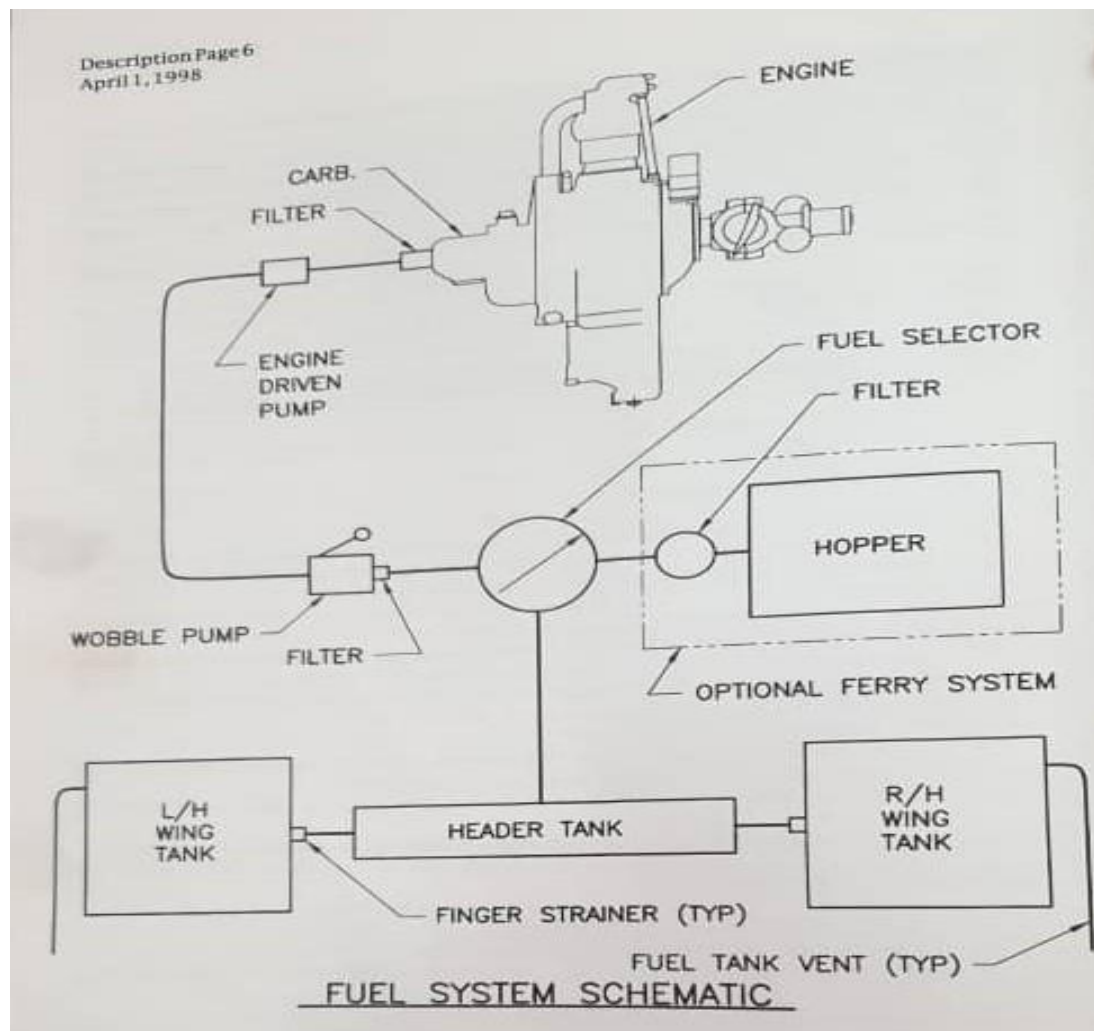
**Figure 2:** AT 401 fuel system schematic

*There are four water traps in the fuel system; one in the each wing tank, one in the header tank, and one in the wobble pump. These drains should be activated daily. Each fuel tank has an overboard venting located near the wing tip. With both tanks completely filled, it is possible during the flight to vent a small amount of fuel overboard by skidding the aircraft or rolling sharply. Fuel type for the AT 401 is the aviation grade 80/87 minimum octane gasoline, if this fuel is not available, use the next highest grade aviation gasoline, up to and including 100 octanes. Under no circumstance should aromatic fuel be used.*

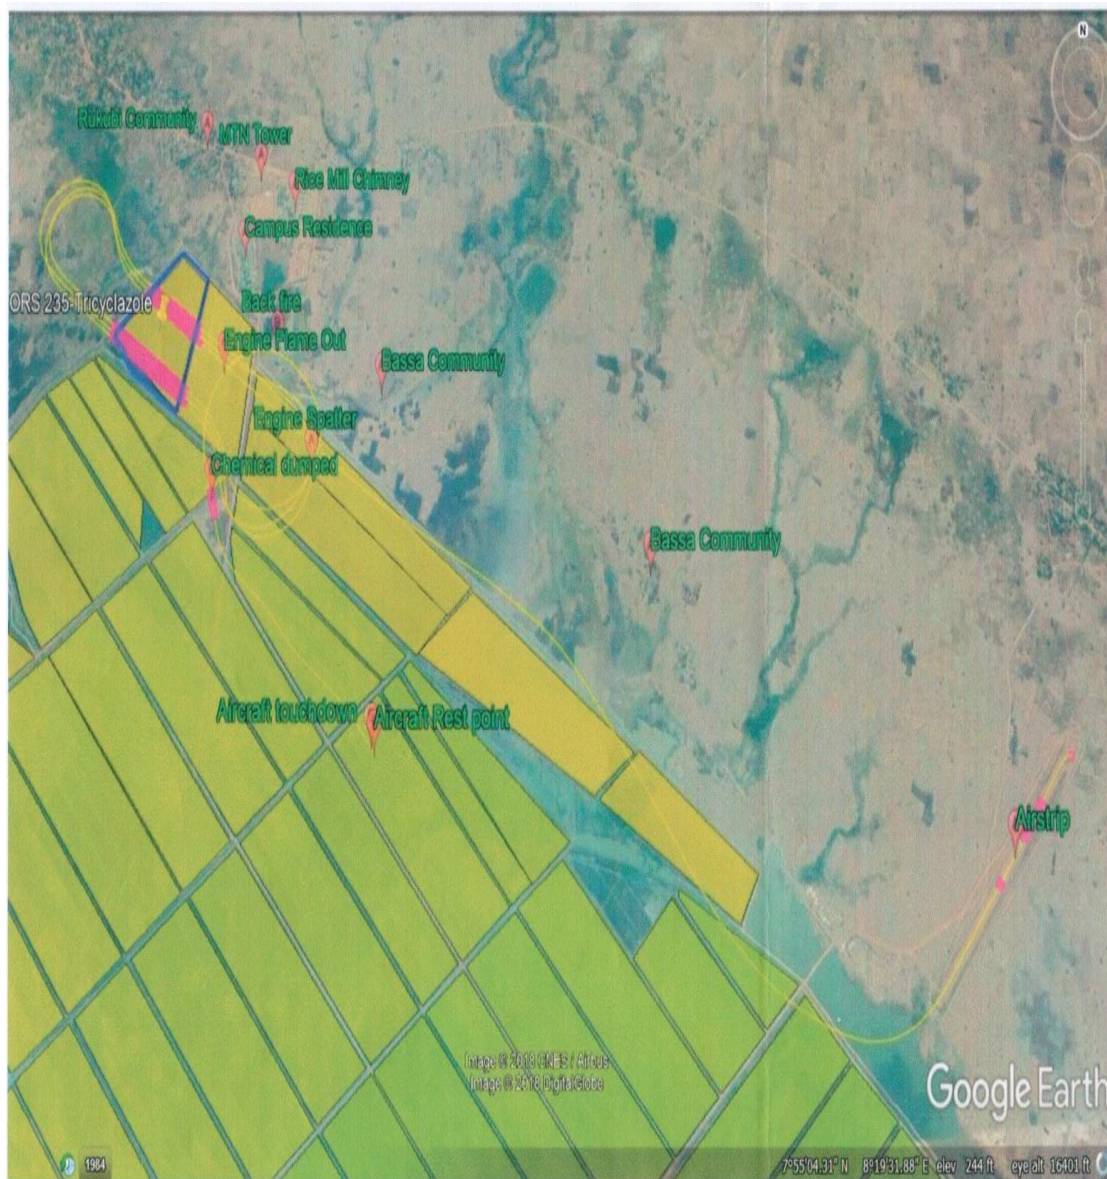
### Appendix 1: Olam Ondorie Nucleus Rice Farm and

The aircraft impacted the ground in a marshy undulating rice farm designated as N803, 3.5 km to the airstrip, with the right main landing gear first, followed by the left main landing gear at about three meters from the point of first impact. The right main landing wheel broke off from its attachment seven meters from the point of impact and was found 24 meters from the first point of impact. A detached section of the spray boom was also located eight meters from the first point of impact. One of the propeller blades remained intact while the remaining two were bent rearwards. The left wing tip leading edge impacted the ground causing substantial damage to the wing. The aircraft flipped over, 38m from the first point of impact and remained generally intact. See Appendix 1: Olam Ondorie Nucleus Rice Farm.
