SUMMARY OF ACCIDENT

ADC AIRLINES (LIBERIA) 5N-BBE-DC-9-31

18 AUGUST 1994

JAMES SPRIGGS PAYNE AIRFIELD

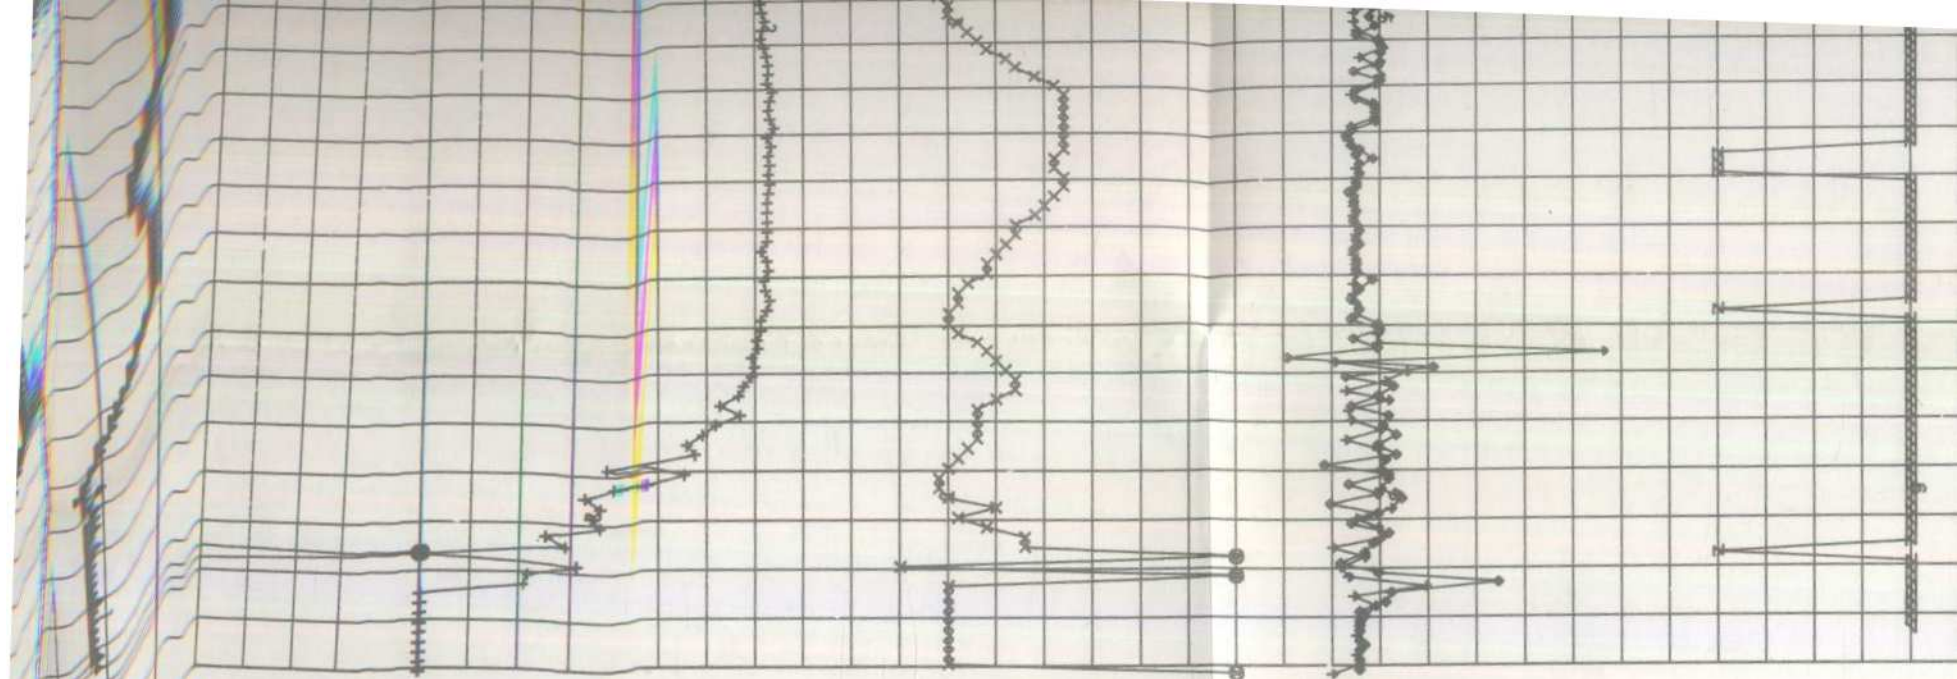
NATIONAL TRANSPORTATION SAFETY BOARD
OFFICE OF RESEARCH AND ENGINEERING
WASHINGTON, D. C.

LOCATION:	SPRIGGS PAYNE AIRFIELD, WONROY	RECORDER Y/Y: F800
DATE	18/8/94	RECORDER S/N: 272
AIRCRAFT:	DC-9-30, SN-68E	(DENT. NO. : -
OPERATOR:	ADC AIRLINES	REPORT NO. : -
FLT. NO.:
