## **AIRCRAFT ACCIDENT REPORT**

**PAAN/2012/10/27/F**

**Report on the Accident Involving  
Pan African Airlines Nigeria Limited (PAAN), Bell 206  
L4 Helicopter with Registration 5N - BFF, At Chevron  
Okan Production Platform, Escravos Offshore, Delta  
State which occurred on 27<sup>th</sup> October, 2012.**

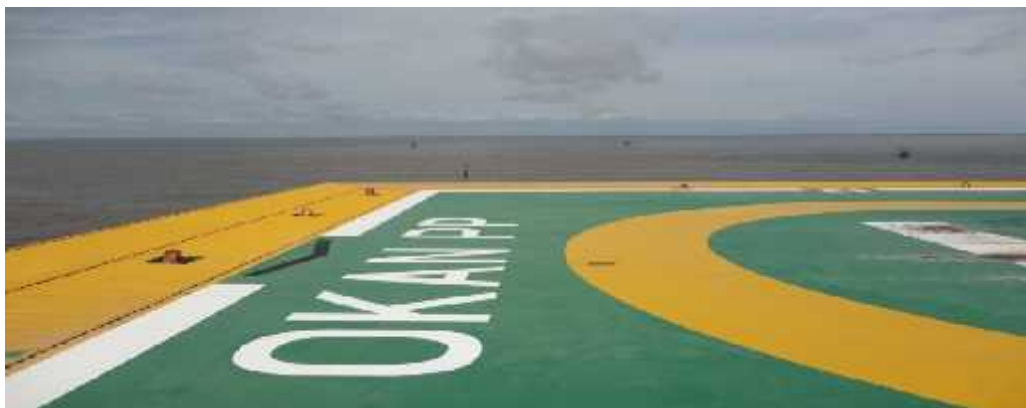
Fig.1.10a: Picture showing the Lower Deck of OKAN Production Platform where the Helicopter took off.

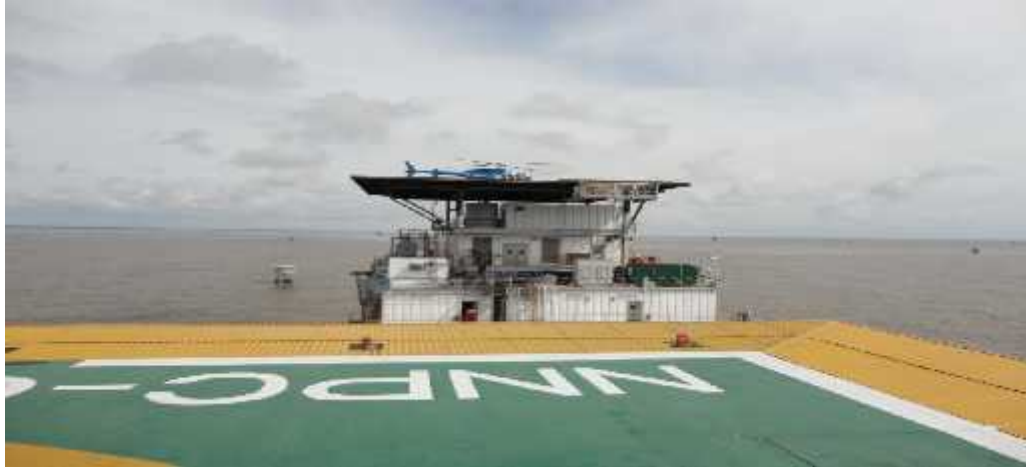
Fig.1.10b: picture showing the relative positions of the two helidecks of OKAN Production Platform

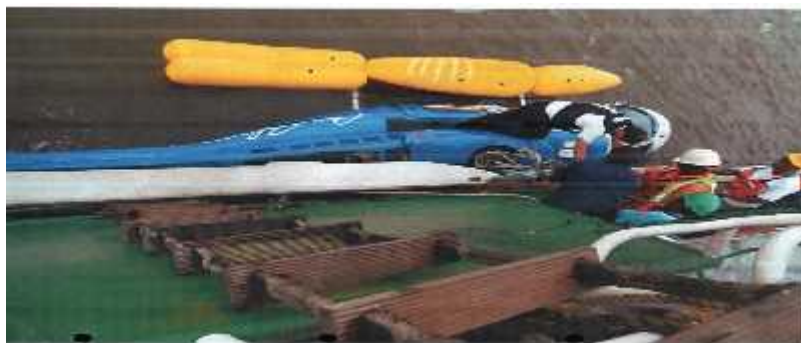
Fig.1.15a: Picture Showing the Rescue Operation being carried out.

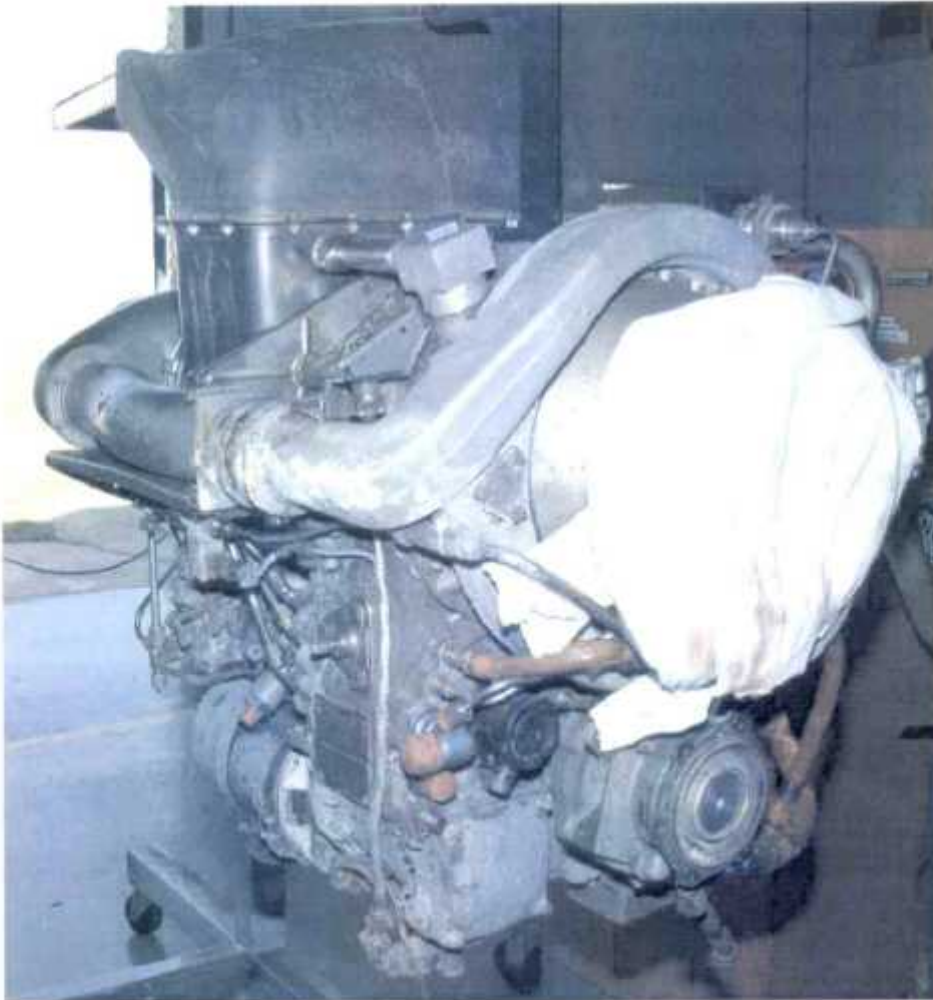
Photo 1 Engine General

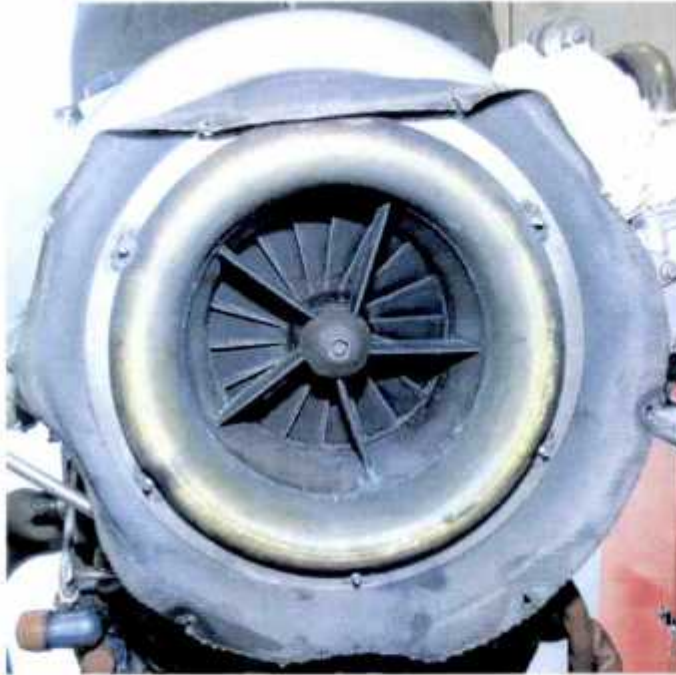
Photo 2 Compressor Inlet

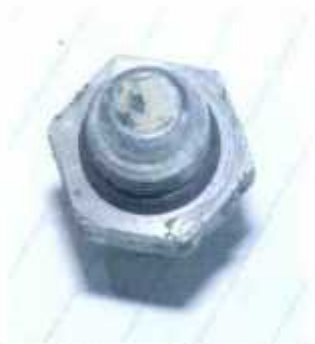
Photo 5 Lower Magnetic Chip Detector

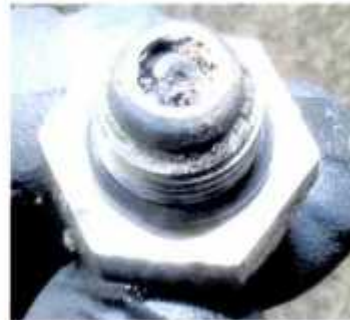
Photo 6 Upper Magnetic Chip Detector

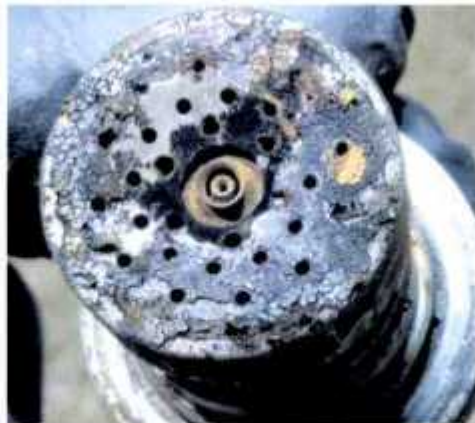
Photo 7 Fuel Nozzle

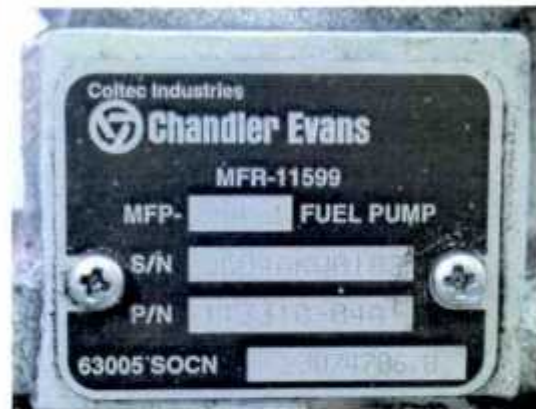
Photo 11 Fuel Pump Data Plate

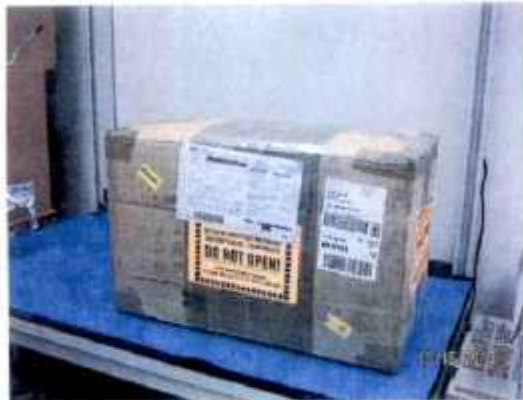
Figure AI-1: Shipping container

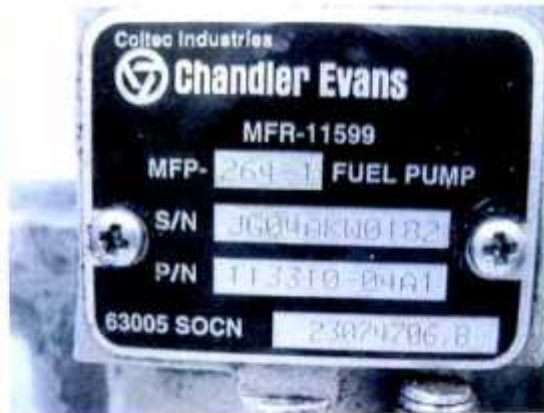
Figure AI-8: Identification plate

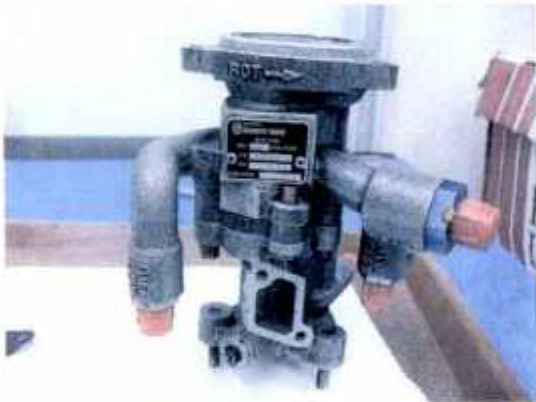
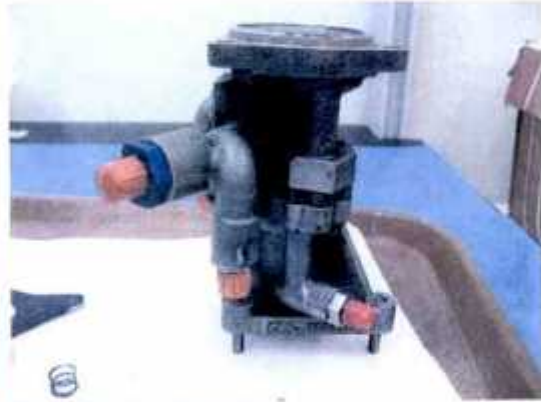
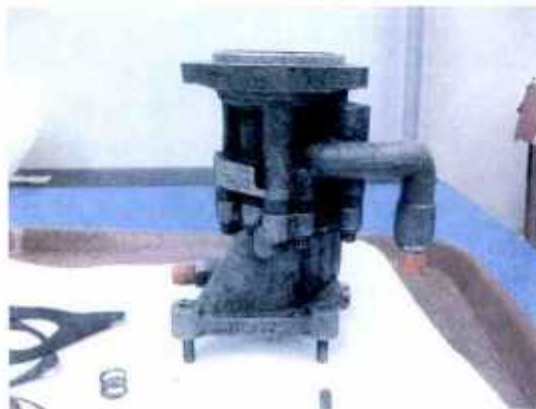
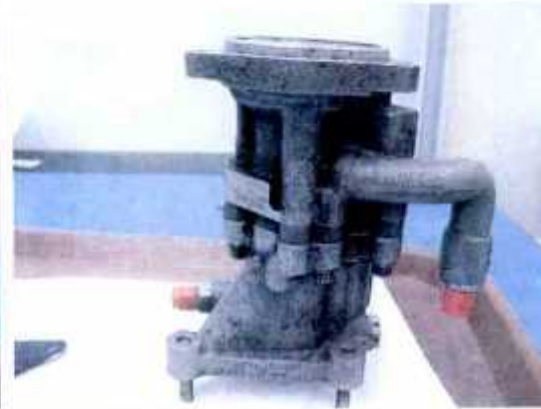
Figure AI-9: Pump body

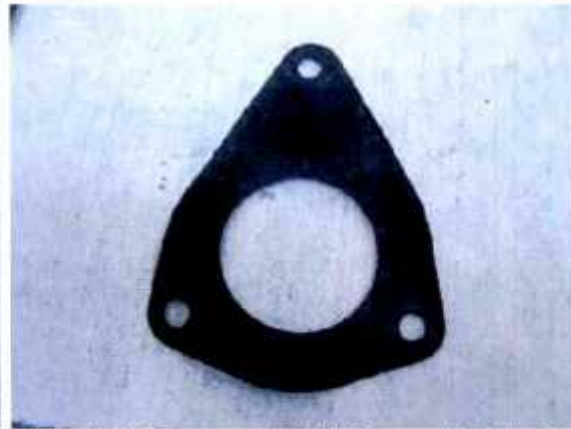
Figure AI-16: Pump / control interface gasket (side 1)

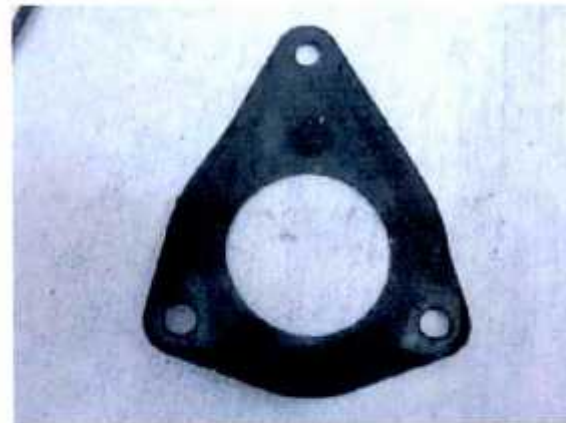
Figure AI-17: Pump / control interface gasket (side 2)

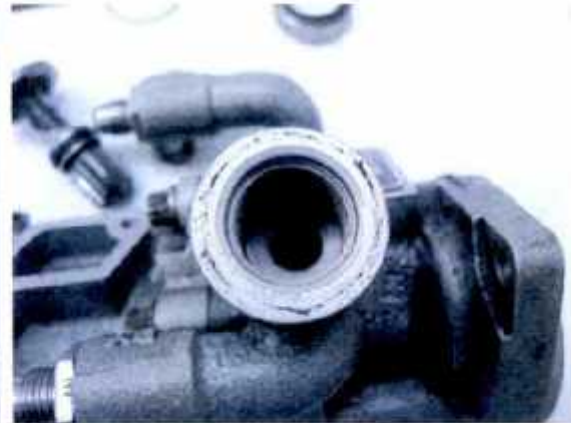
Figure AI-18: Gear inlet port

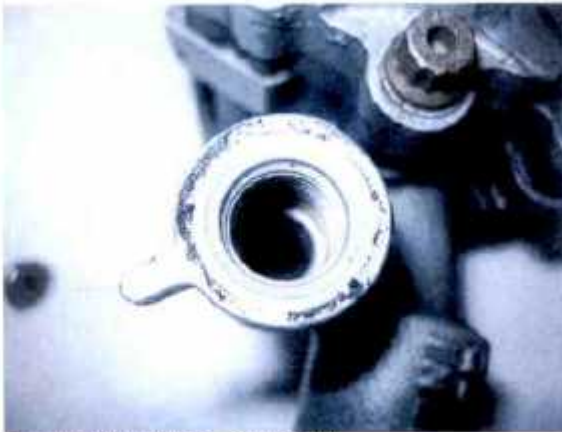
Figure AI-19: Bypass return port

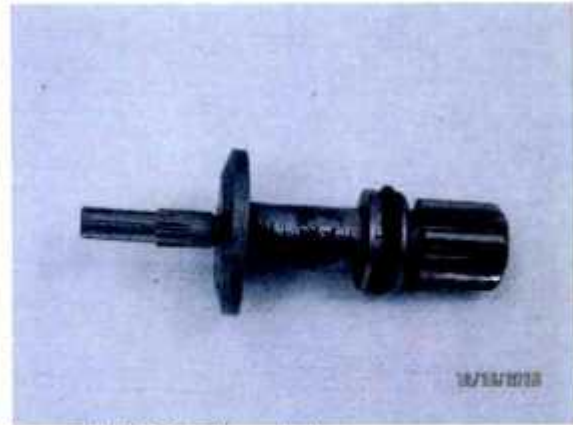
The fuel pump main drive shaft external splines, which mate to the internal splines of the pump driver gear, were severely worn. The wear was significant enough to decouple the fuel pump main drive shaft from

*Severe spline damage was noted on the fuel pump driveshaft. The result of this damage could be a loss of pressurized fuel to the engine and subsequent power loss.*

Figure AI-22: Main drive shaft

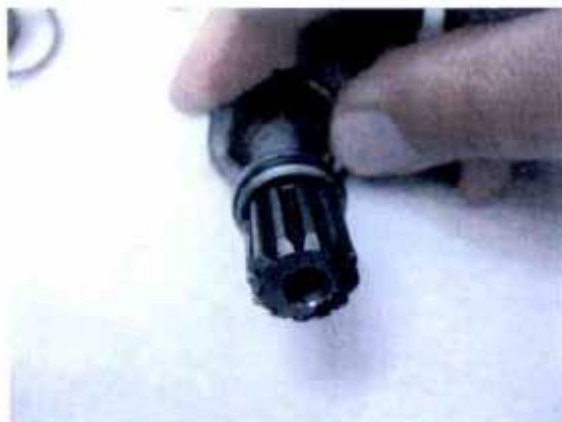
Figure AI-23: Main drive shaft outboard spline

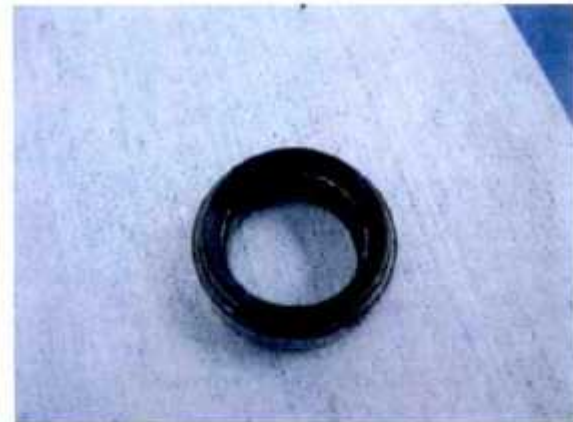
Figure AI-24: Main drive shaft seal

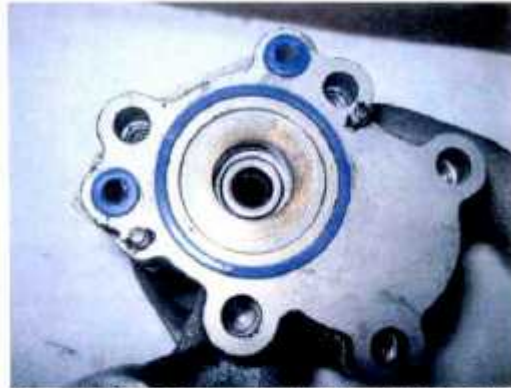
Figure AI-26: Main pump / control drive housing interface

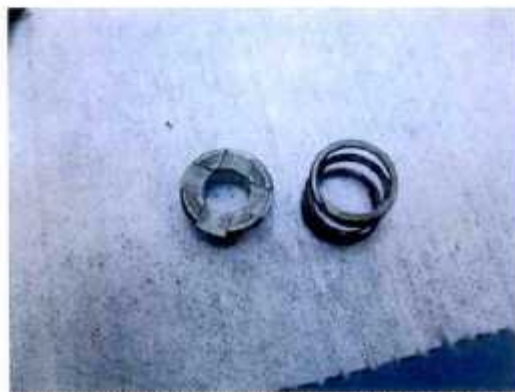
Figure AI-27: Main drive shaft loading spring and seat

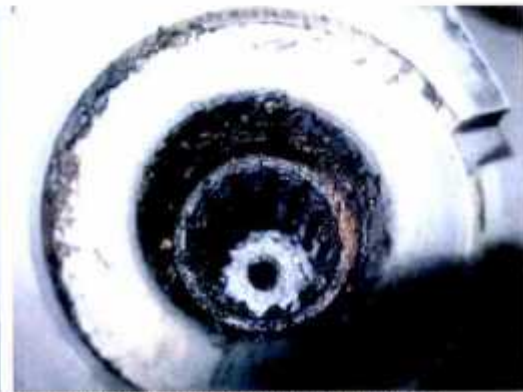
Figure AI-28: Control drive shaft output spline

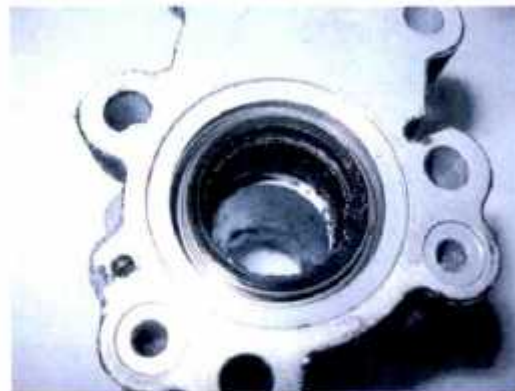
Figure AI-29: Control drive shaft seal

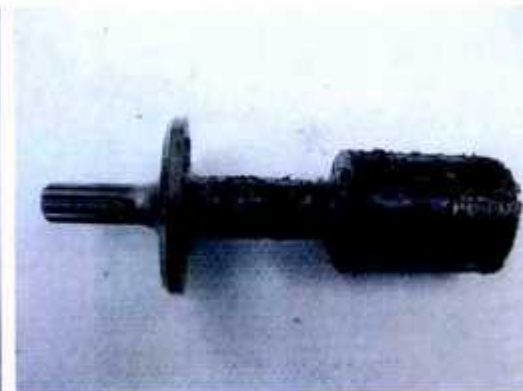
Figure AI-30: Control drive shaft (removed)

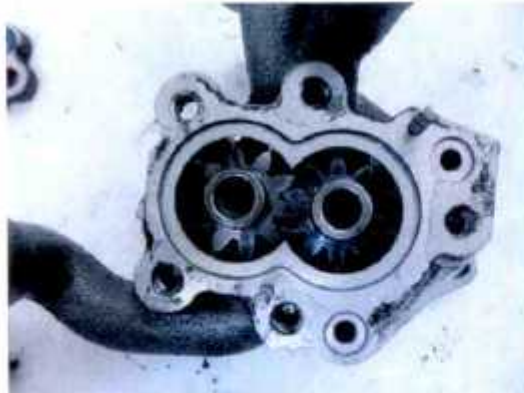
Figure AI-33: Pump gears with fixed bearings removed

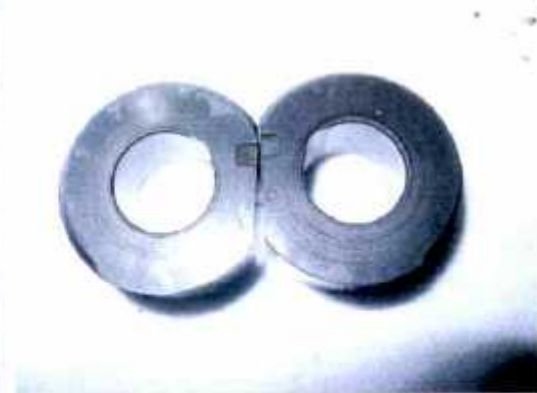
Figure AI-34: Fixed bearings

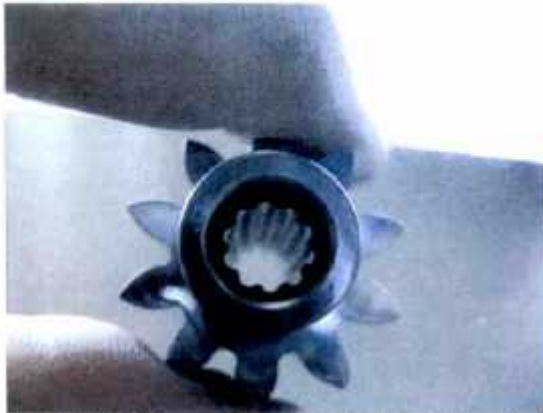
Figure AI-37: Pump driver gear spline (main drive shaft end)

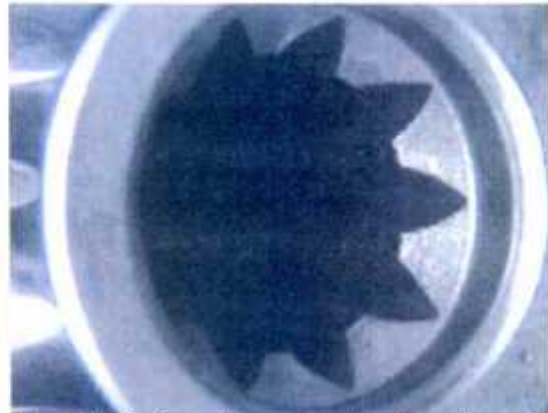
Figure AI-38: Pump driver gear spline (main drive shaft end, 10X)
